### Final Report

In 2018, the rock culvert located in Mill Creek, Salt Lake County, Utah was replaced. This roadway services about 165,000 vehicles a year along with a large number of cyclists and pedestrians. The original culvert was installed in the 1930's by a Civilian Conservation Corp. The original structure was in a state of disrepair and had created a fish migration barrier. The structure required heritage mitigation because of its historic character.

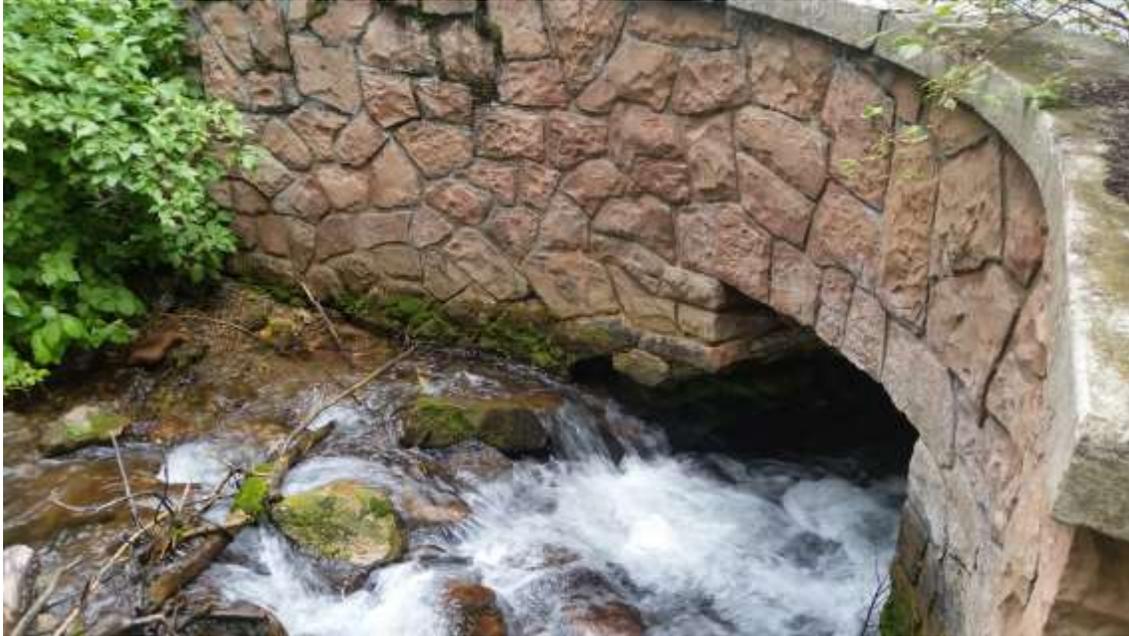
Figure 1. Photo of upstream inlet of the rock culvert structure replaced, 25 July 2017.

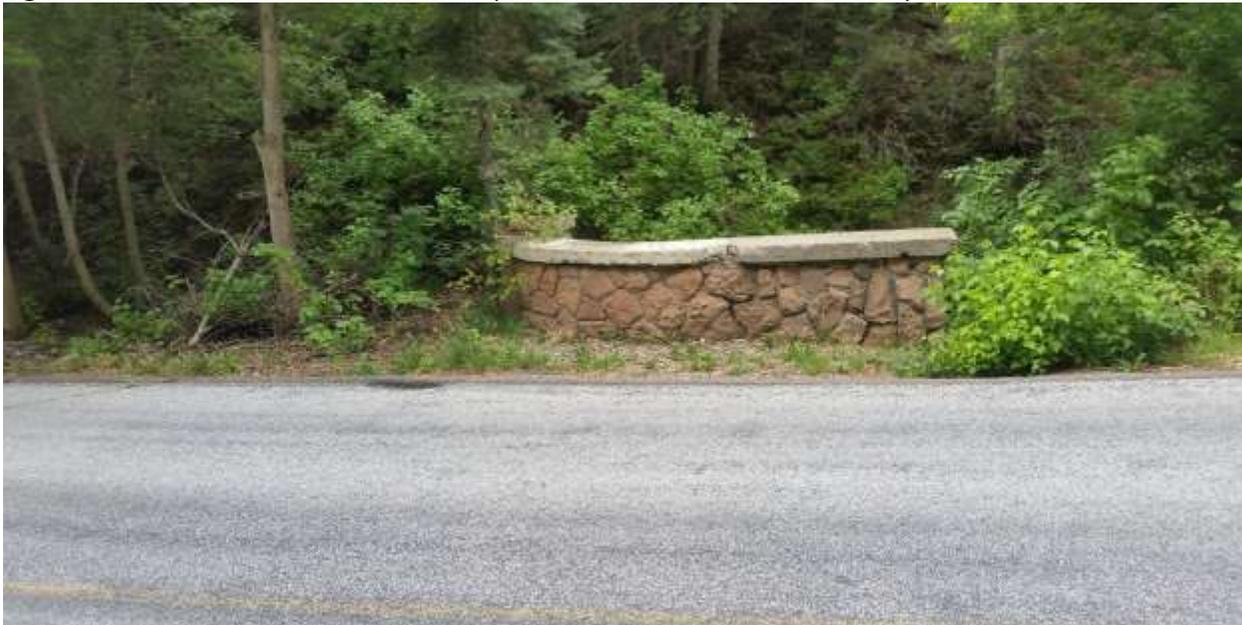
Figure 2. Road view of structure on the upstream end of rock culvert, 25 July 2017.

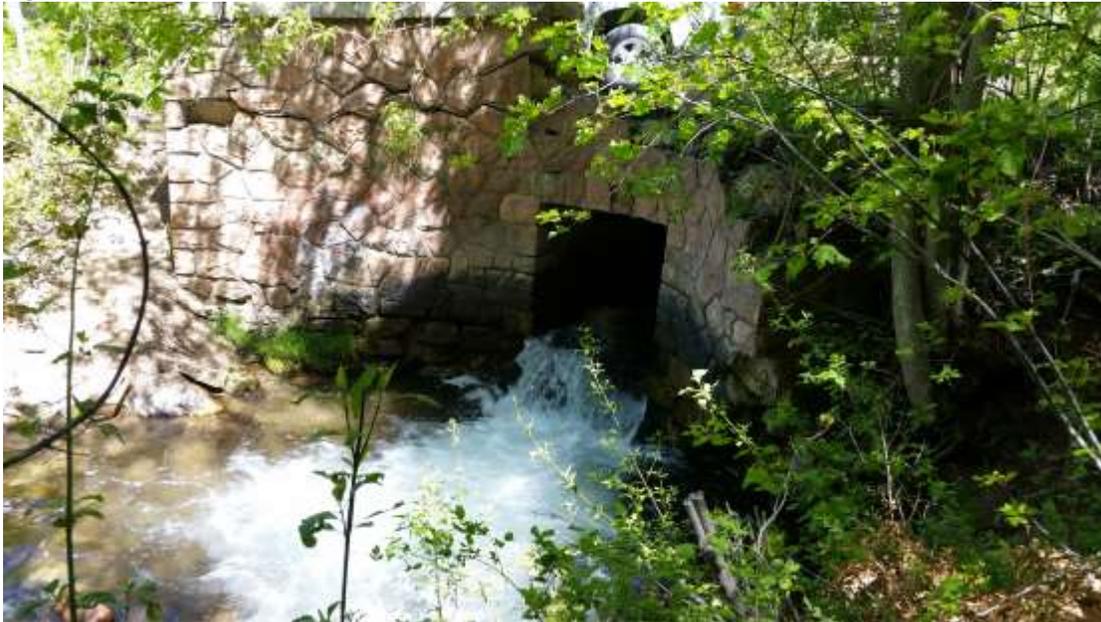
Figure 3. Photo of downstream outlet of the rock culvert structure replaced, 25 July 2017

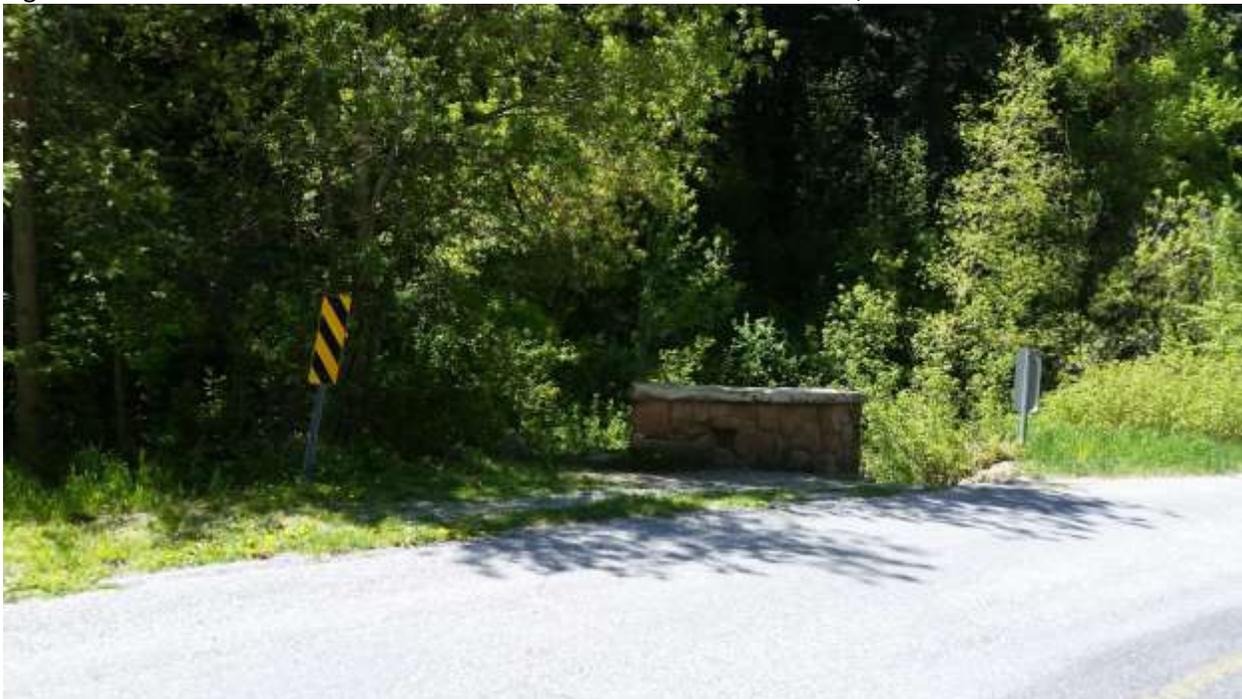
Figure 4. Road view of structure on the downstream end of rock culvert, 2 June 2015.

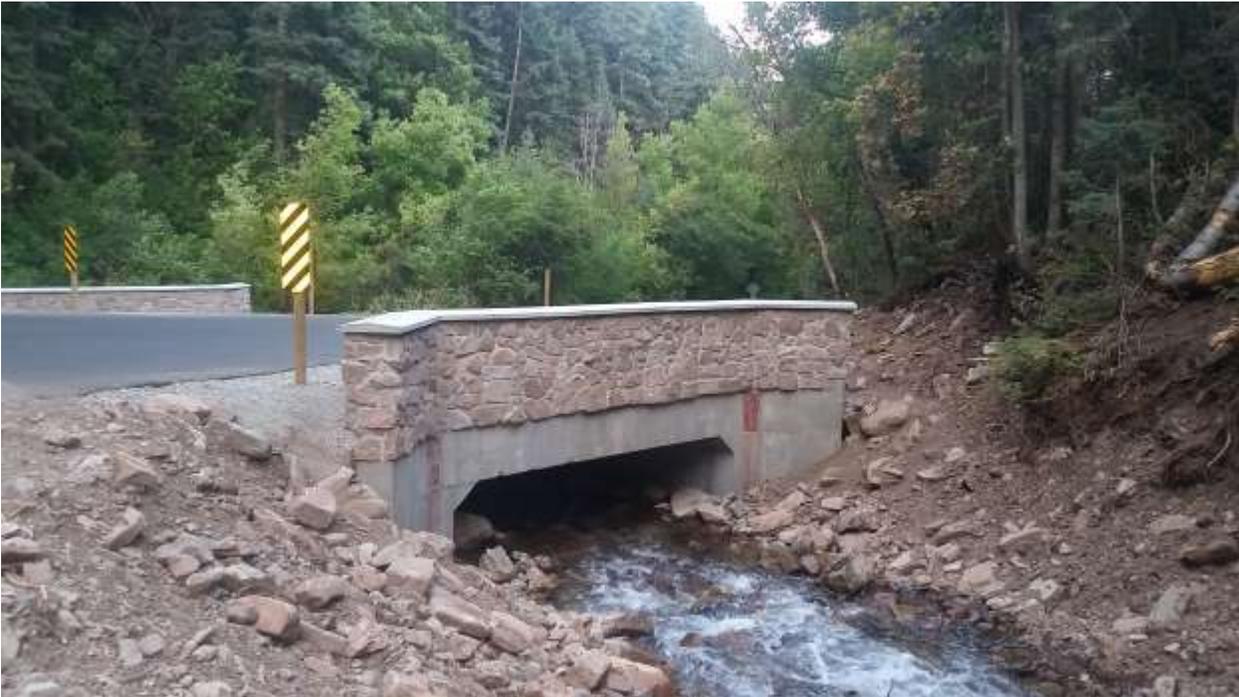
Figure 5. Photo of upstream inlet of the rock culvert structure replaced 25 July 2018.

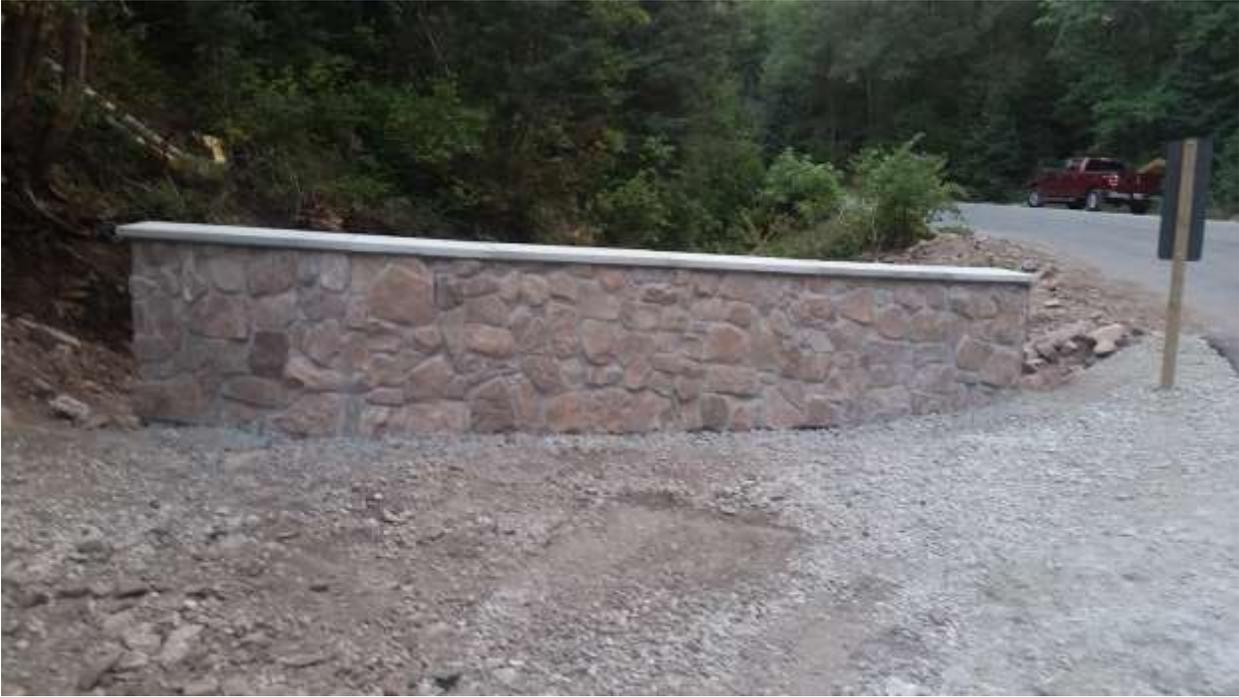
Figure 6. Road view of structure on the upstream end of rock culvert, 25 July 2018.

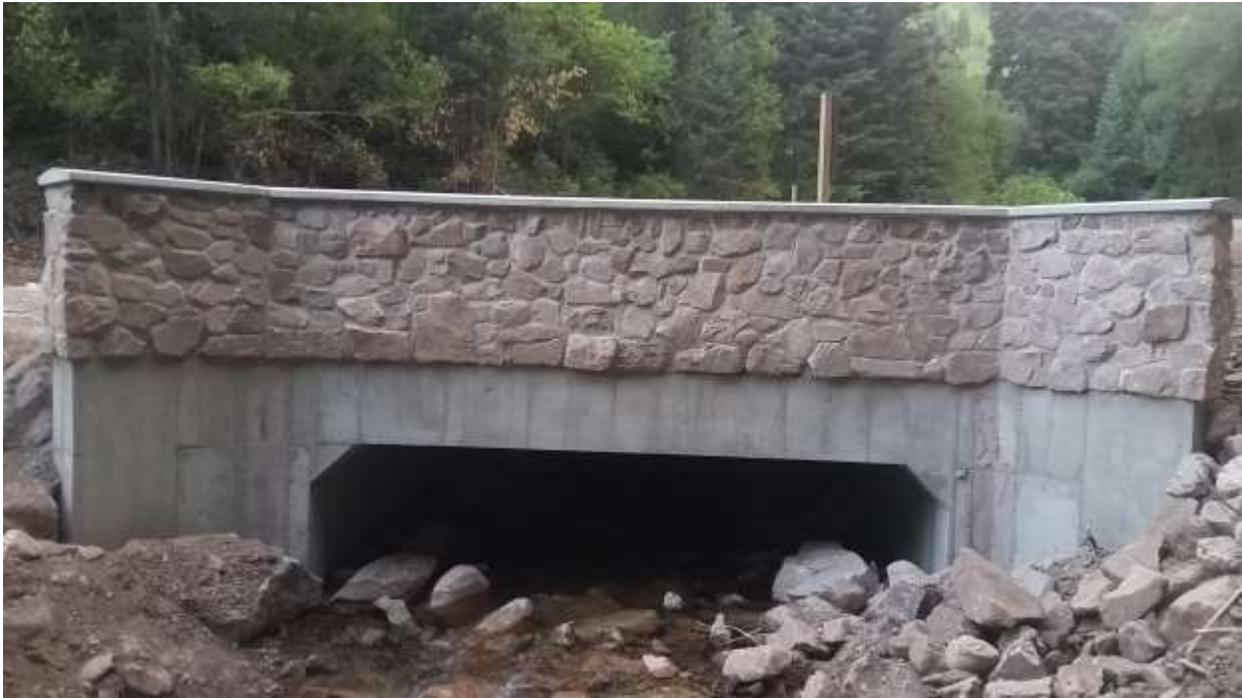
Figure 7. Photo of downstream outlet of the rock culvert structure to be replaced, 25 July 2018

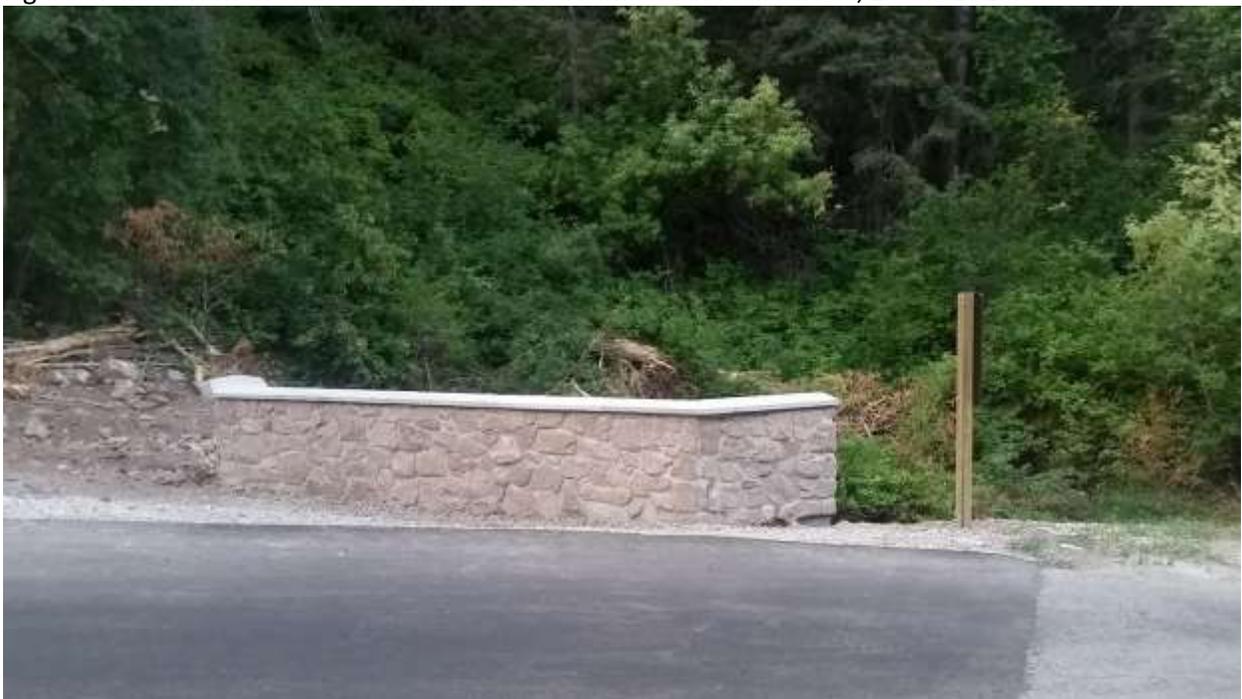
Figure 8. Road view of structure on the downstream end of rock culvert, 2 June 2018.

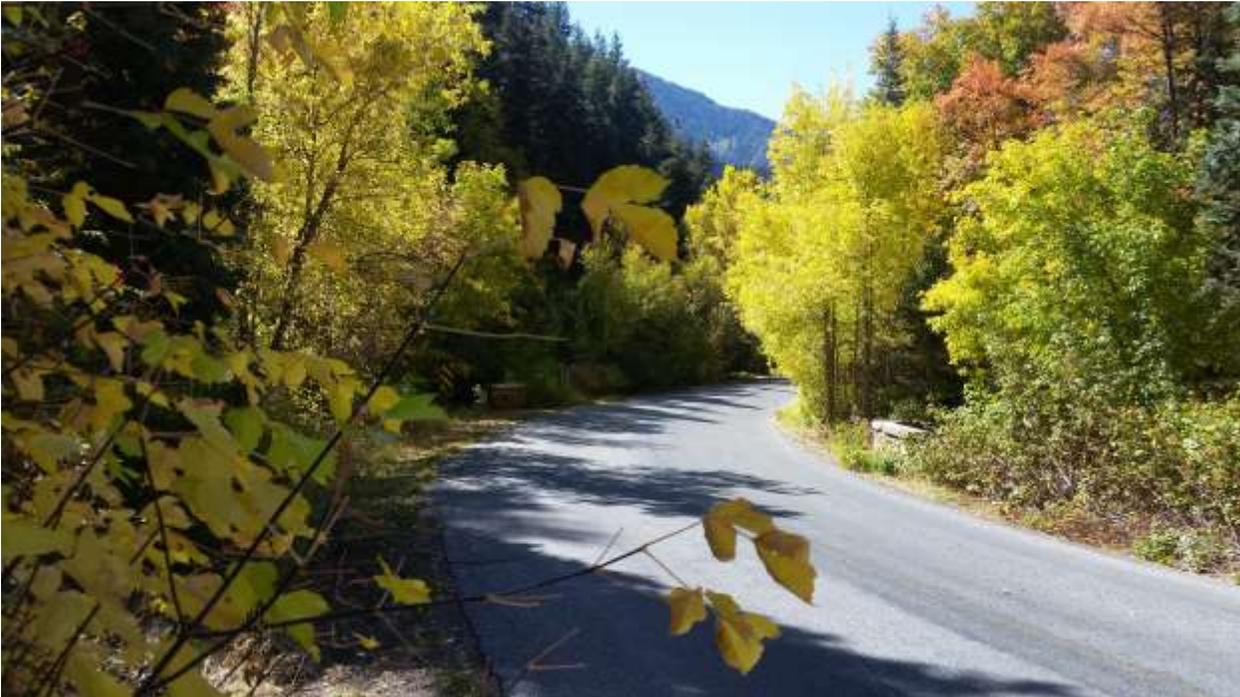
Figure 9. Photo of roadway prior to reconstruction of the rock culvert, 28 September 2016.

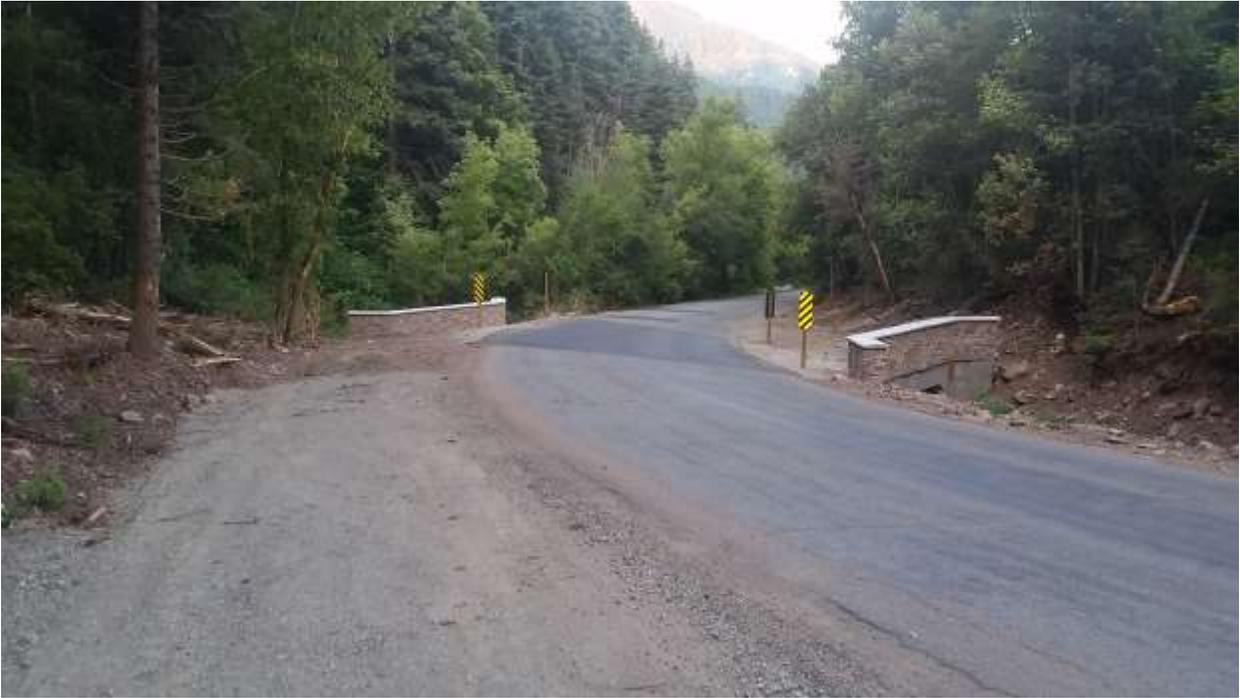
Figure 10. Photo of roadway after construction of the rock culvert, 15 August 2018

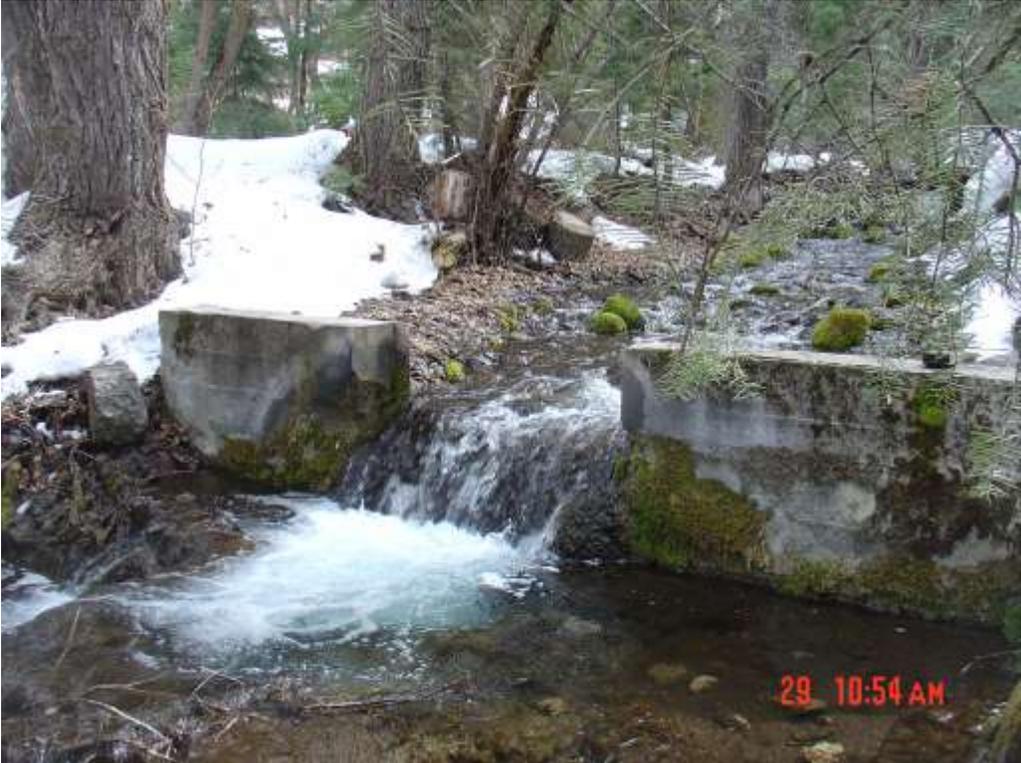
Figure 11. Photo of weir prior to removal in 2018 in Porter Fork, Mill Creek Drainage, Salt Lake County, Utah.

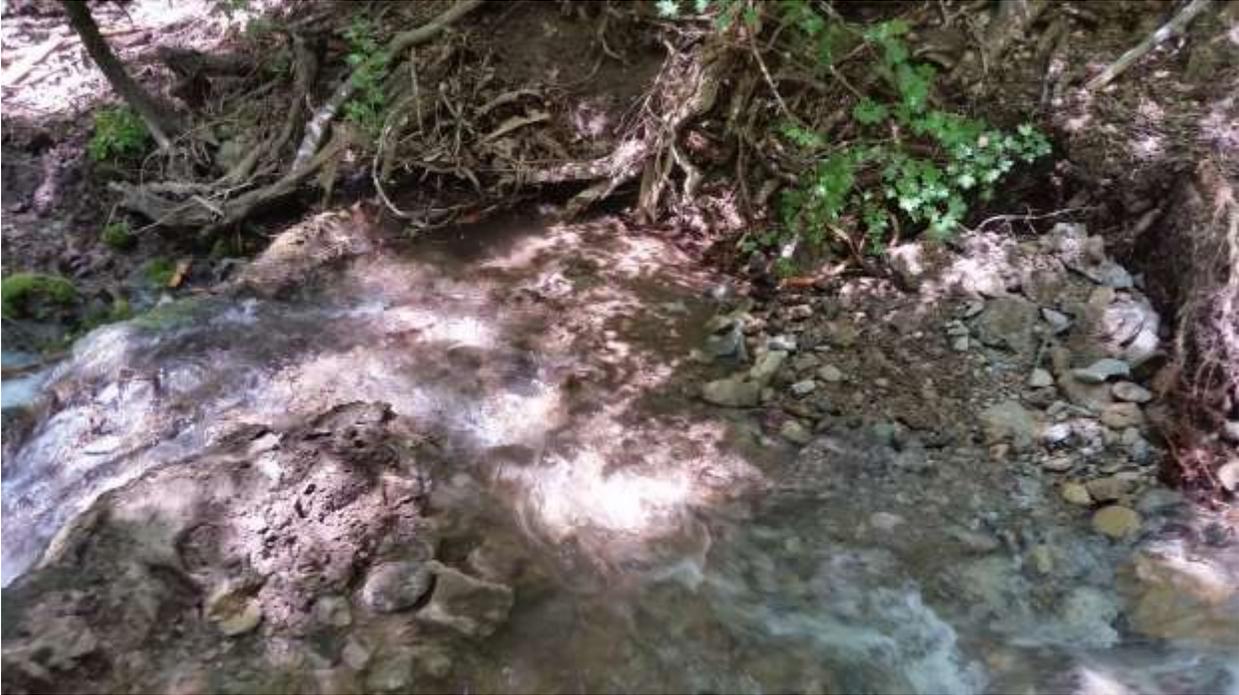
Figure 12. Photo of weir site after the removal of the weir in June 2018.
