Vermilion River Project #2

Miners Gulch Reach

2018 Post Run-off Monitoring Report

February 4, 2019

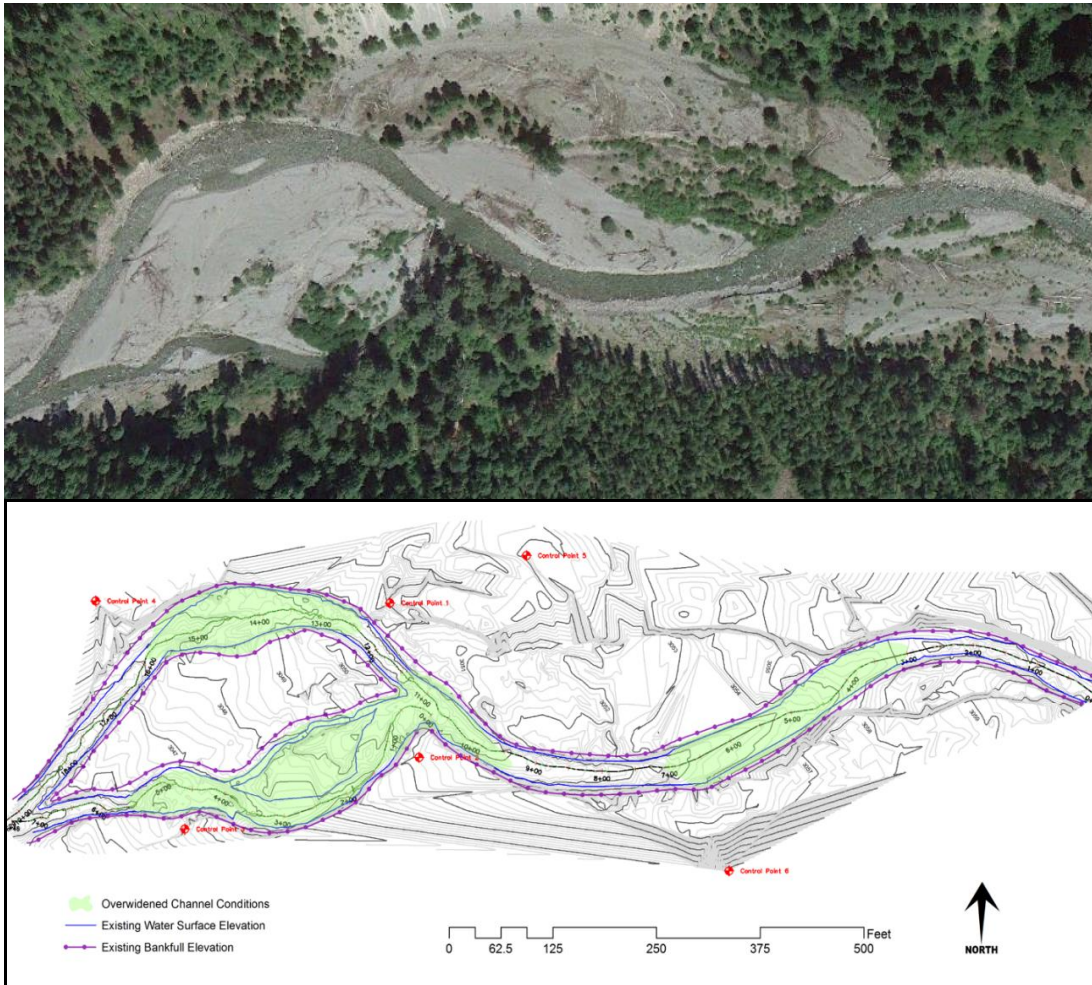
Figure 2.0 2013 aerial photograph and topographic mapping of the pre-project existing condition in the Miners Gulch project area.

The aquatic habitat complexity consisted of an overwidened riffle and minimal, functional in-channel Large Woody Debris (LWD). Historic placer mining, and the ensuing larger magnitude flood events, most recently the 1996 event, along with the over-bankfull type flooding that occurred during the spring of 2008, were directly linked to the degraded condition of this reach.

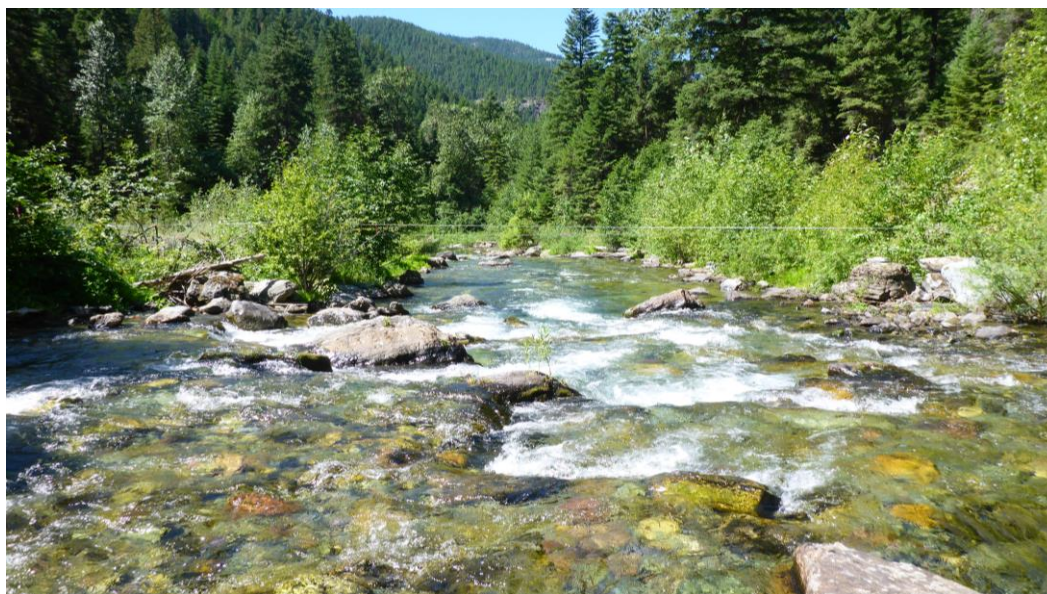
Figure 3.0 Existing reference channel conditions above the Miners Gulch reach of the Vermilion River

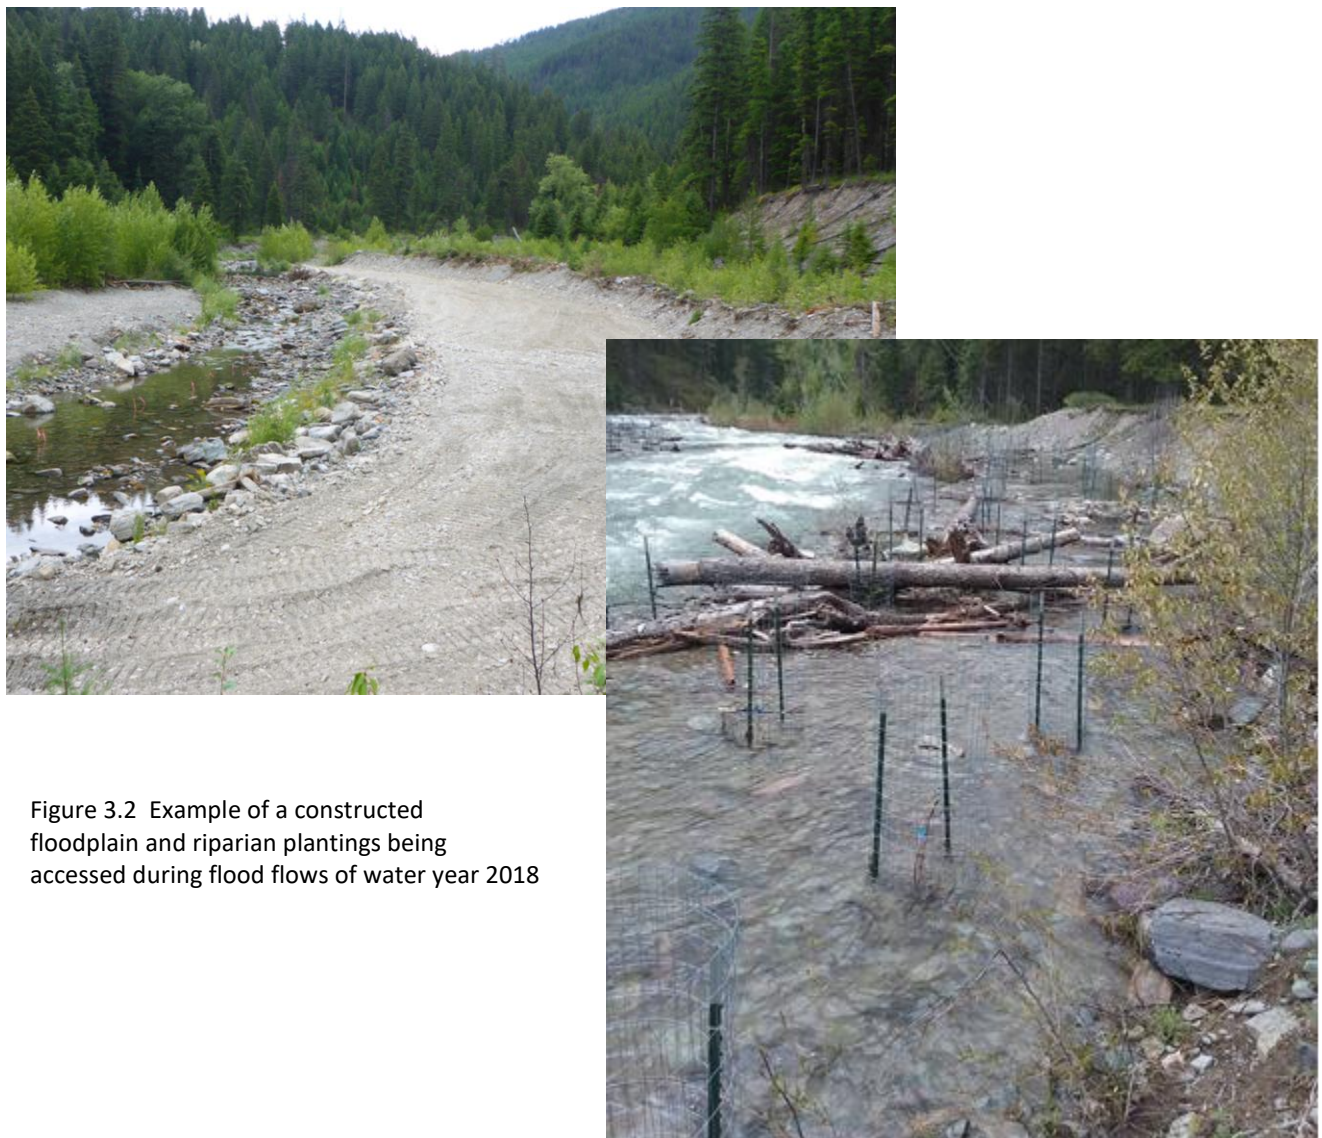
Figure 3.2 Example of a constructed floodplain and riparian plantings being accessed during flood flows of water year 2018

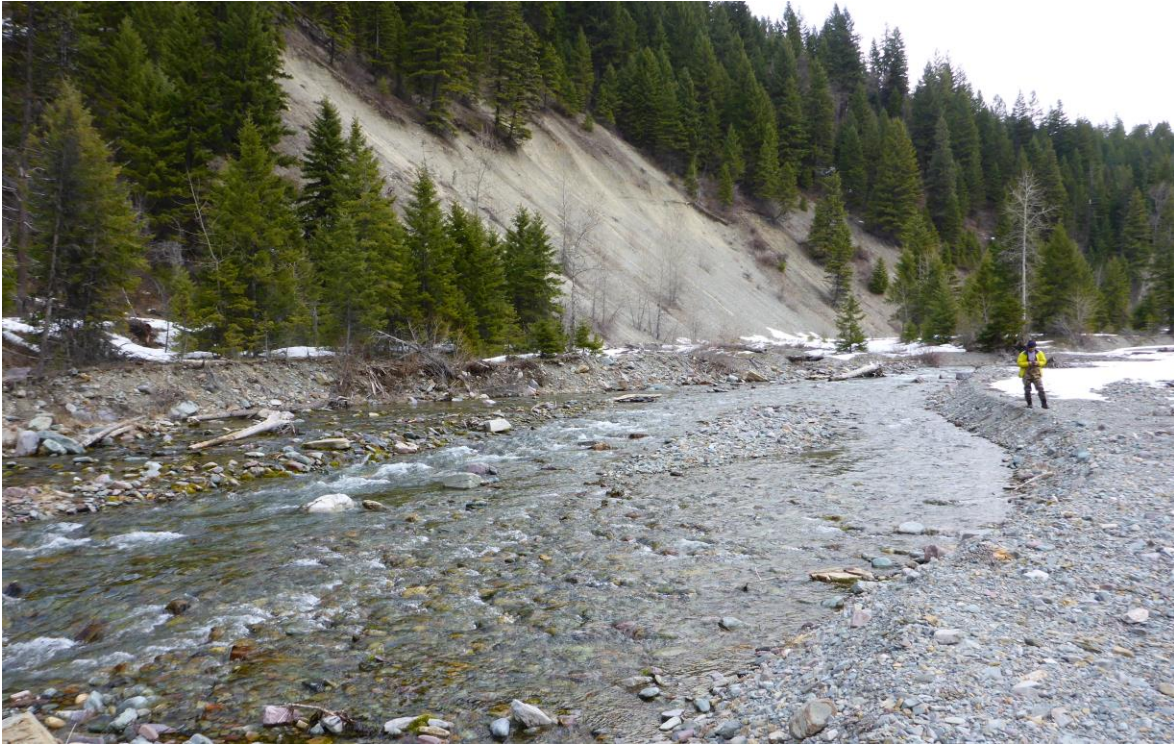
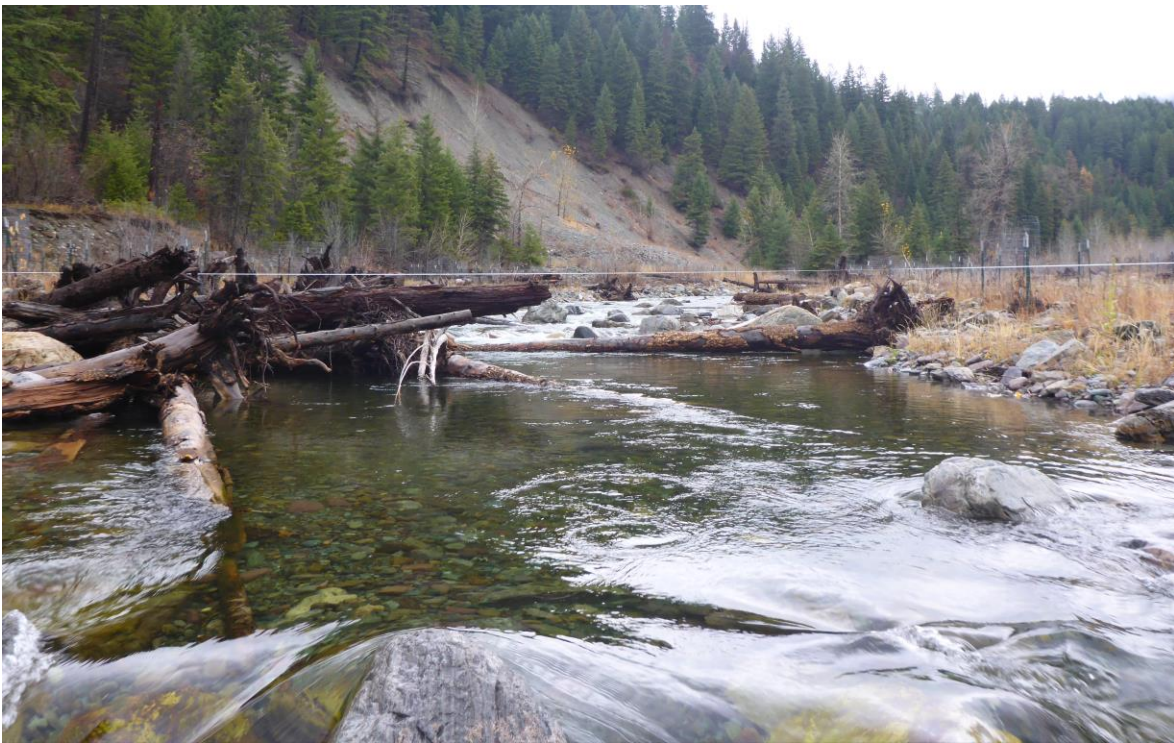
The newly constructed channel contains cobble/boulder near bank habitat as well as large wood to add complexity to the stream corridor. This placed material provided for grade control and pool tail stabilization. All structures incorporated the final channel shaping to appropriate channel dimensions which were based on applicable local reference data. These techniques helped to protect adjacent banks by reducing localized shear stress and positioning the thalweg in a more historic location within the reach. The channel pattern was designed to allow the river to utilize as much of the valley as thought feasible. By constructing a wider floodplain area for this portion of the Vermilion it was foreseen that this technique would allow for more riparian vegetation to become established as well as aid in sediment and debris transport.

Figure 4.3 Pre-project (4/2014 –top) and most recent (11/2018 – bottom) photos of channel conditions at station 11+25 of the project reach.

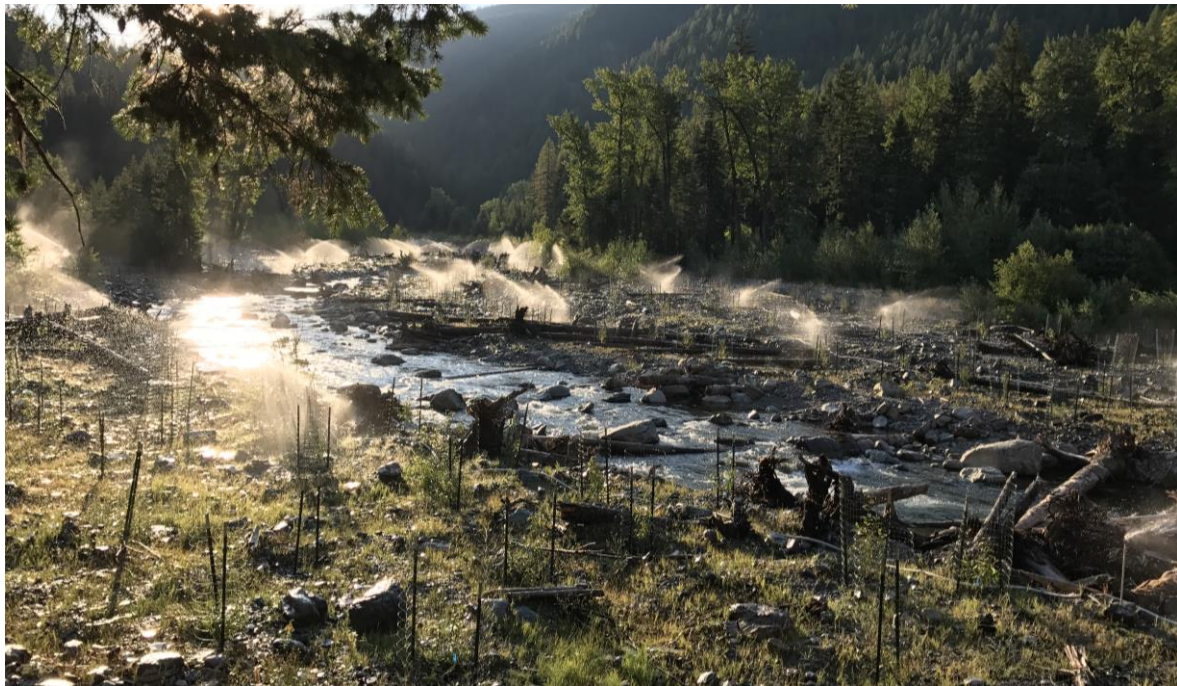
Irrigation was considered critical to the survival of the plantings on the well-drained alluvial floodplain. A watering target of 1" of water per week was applied to the riparian area. Approximately 4 hours of pump run-time were needed to apply this quantity of water. Various gravity fed and drip systems were considered but due to the coarse soil texture little lateral spread of moisture from emitters was expected. To provide water to directly seeded species as well as encourage natural seedling establishment, a sprinkler system was required to distribute the water over the entire planting area. Sampling cups were used to ensure adequate water was applied at each watering. Roughly 7 acres were irrigated during the summers of 2017 and 2018.

Figure 5.0 Irrigation of the planted riparian vegetation with fenced enclosures on the constructed floodplain.

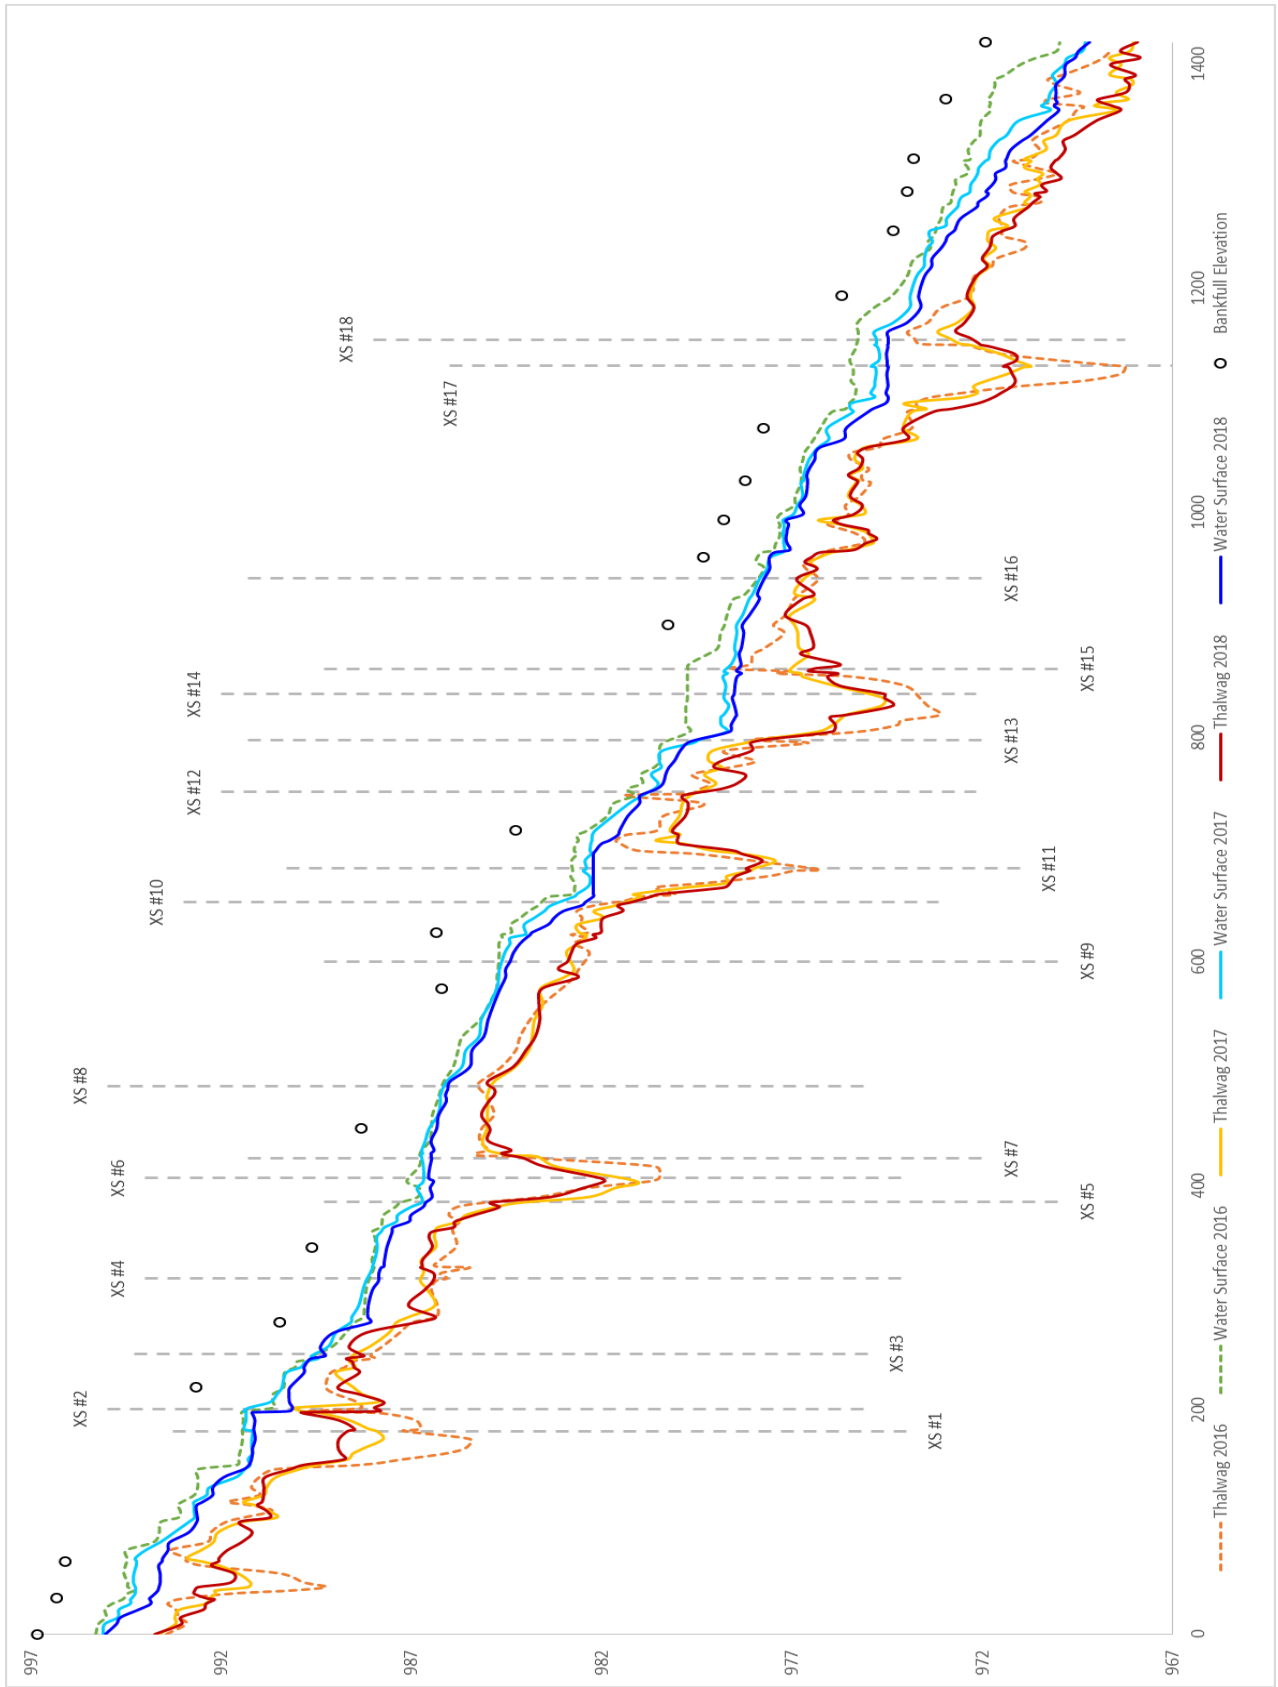
Changes in channel elevation were noticed in certain design features. The as-built channel went through a cleansing flow upon the first substantial run-off event post construction in 2016. None of these changes led to loss of integrity in structure or bank strength. In the more constricted areas changes led to the slight down cutting around the mid-channel boulder features. These areas were constructed to narrow the channel and provide for the “run” type features that aide in pool maintenance and function. The boulder and cobble placements in these areas have moved slightly and margin elevations have deepened. The cobble “throats” were designed to move under bankfull or higher flow and have slightly. These areas were further monitored through the next event cycle of 2018 and little change is occurring. Additional pool habitat formed in areas below the constructed cobble pool tails in 2017 while maintaining the same water surface elevation. The glide or pool tail areas seem to be sorting material. Very little deposition occurred throughout the reach. Most other changes related to the ebb and flow of natural sediment transport and was expected. Although very similar in terms of water year to that of 2017 (see Figure 7.1) the channel bottom within the project reach seemed to have somewhat sustained through the 2018 runoff season. Slight changes in channel features were observed mostly within the 1st year of runoff. A few pools and glides noticed some filling of material leading to less overall depth. All of the pools seem to have stabilized after the second runoff cycle of 2018. Riffles maintained grade and dimensions such as width and depth. Wood structures at the lower end of the project reach seemed to have collected more material and created additional lateral pool volume from that of the previous two years.

Figure 7.1 Vermilion Miners Gulch project reach longitudinal profile of 2016, 2017 and 2018.

It could be expected that as long as sediment is being transported through the system some degree of channel fluctuation will occur through each runoff cycle. The descriptor that explains whether or not the channel elevation has maintained through the monitored flow events is the overall change in reach slope post run-off. As is displayed in Table 7.7 the mean slope of the channel did not change with the 2017 or 2018 flow events and related sediment transport, nor did the planned structures create active headcutting or channel avulsions.

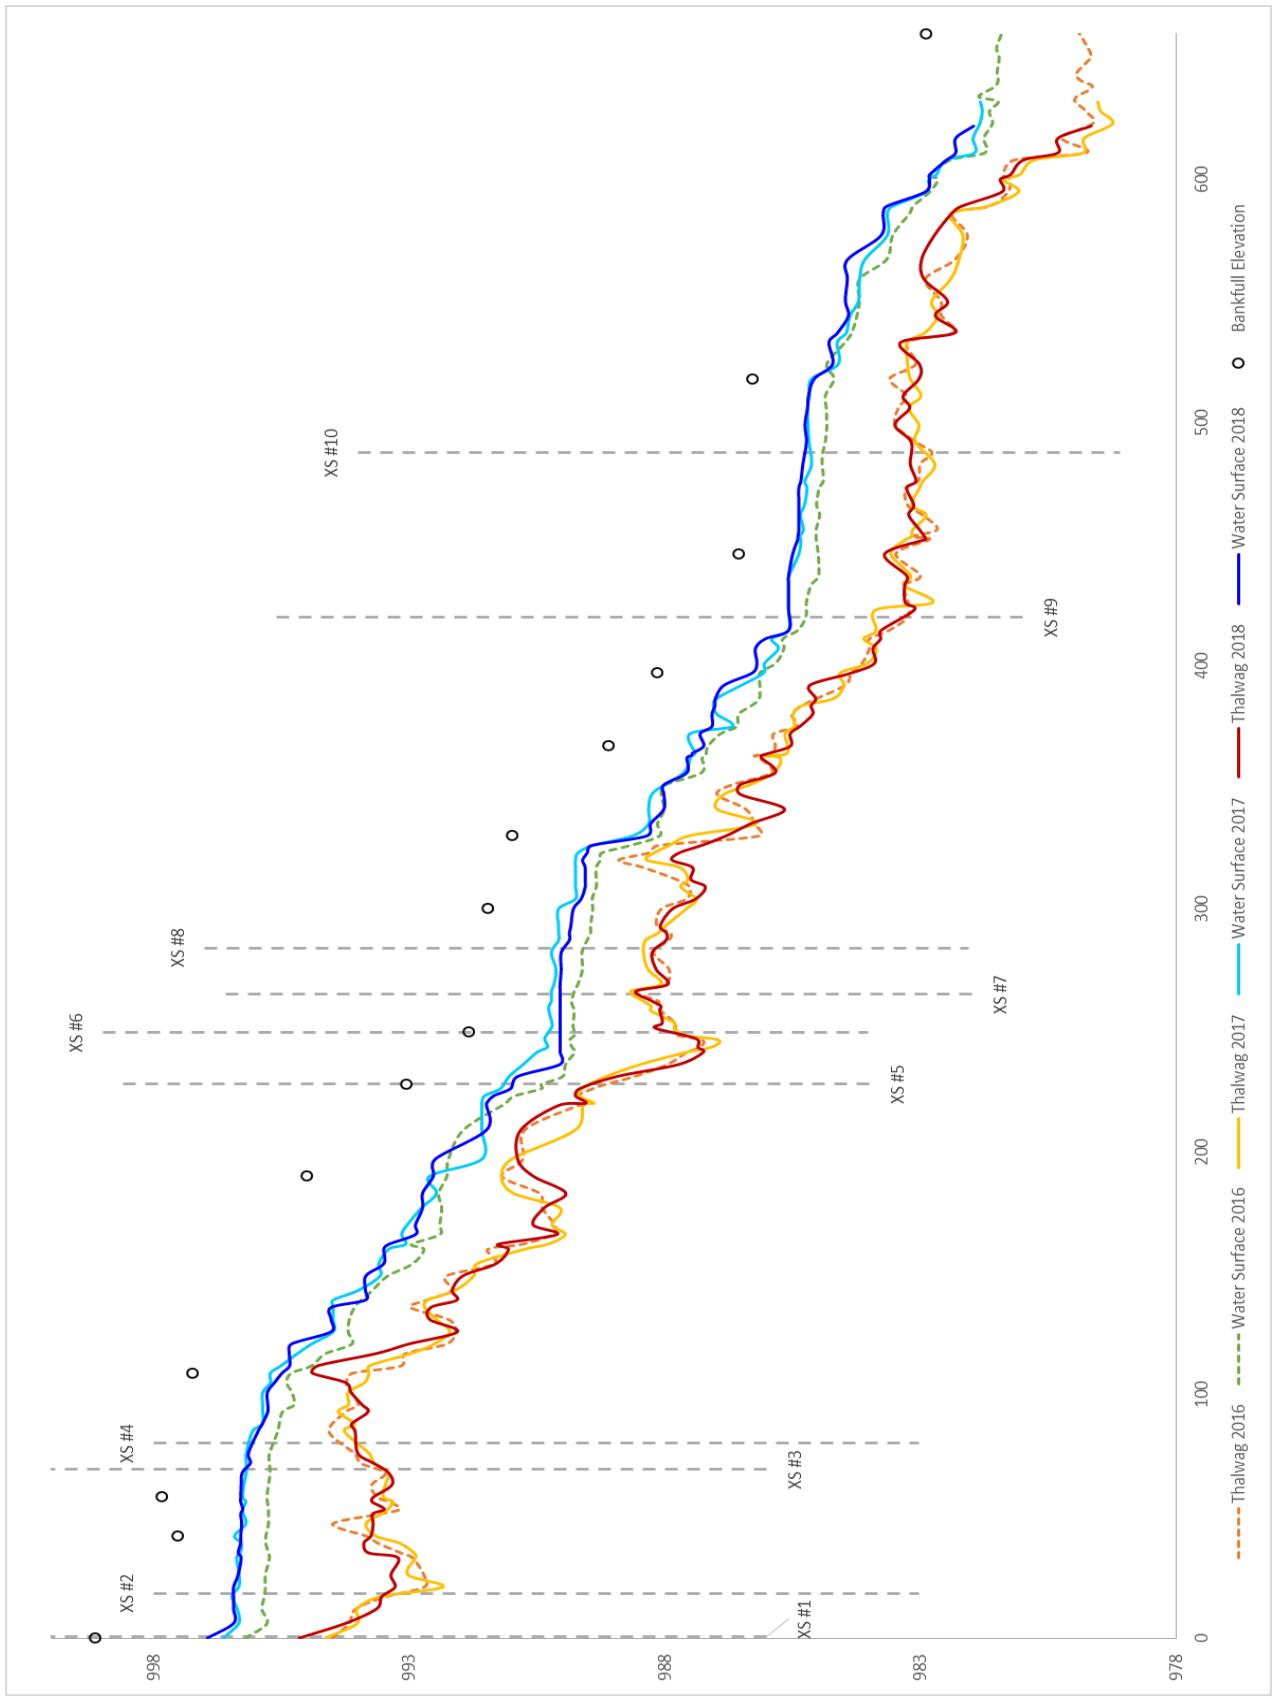
Vertical stability measured by water surface facet slopes within the reference reach changed slightly through the monitored runoff period. All changes were within expected tolerances and very similar to changes monitored within the as-built project reach. Both reaches were subject to the same flow regime in both 2017 and 2018.

Figure 7.2 Vermilion reference reach longitudinal profile of 2016, 2017 and 2018.

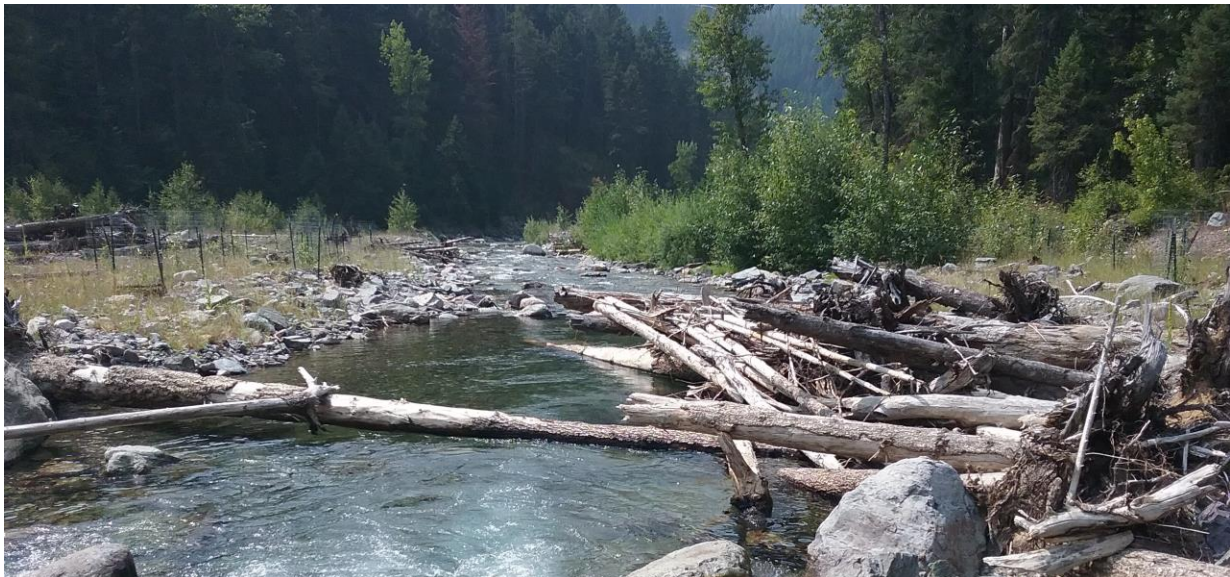
The 2016 survey of the project reach captured a total of 327 pieces of LWD which equaled 1485 pieces per mile. The average length of each piece was 19 feet with a diameter of 8 inches. Almost all of these additions were a product of project activities. During the summer of 2018 the reach was re-examined and wood tallies at that time displayed an additional 33 pieces that had been recruited and transported from upstream sources during two average runoff cycles. These additions had average lengths of 7 feet and a diameter of 7 inches. The initial project related wood structures were intended to provide for LWD additions that not only created channel complexity but also provided an assembly for capturing and retaining upstream woody material that historically would pass through this reach during flood flows. In terms of retaining large wood the designs employed are yielding positive results.

Figure 7.4 Example of the large wood additions within the project subsequent two runoff cycles in the Vermilion River (white wood).

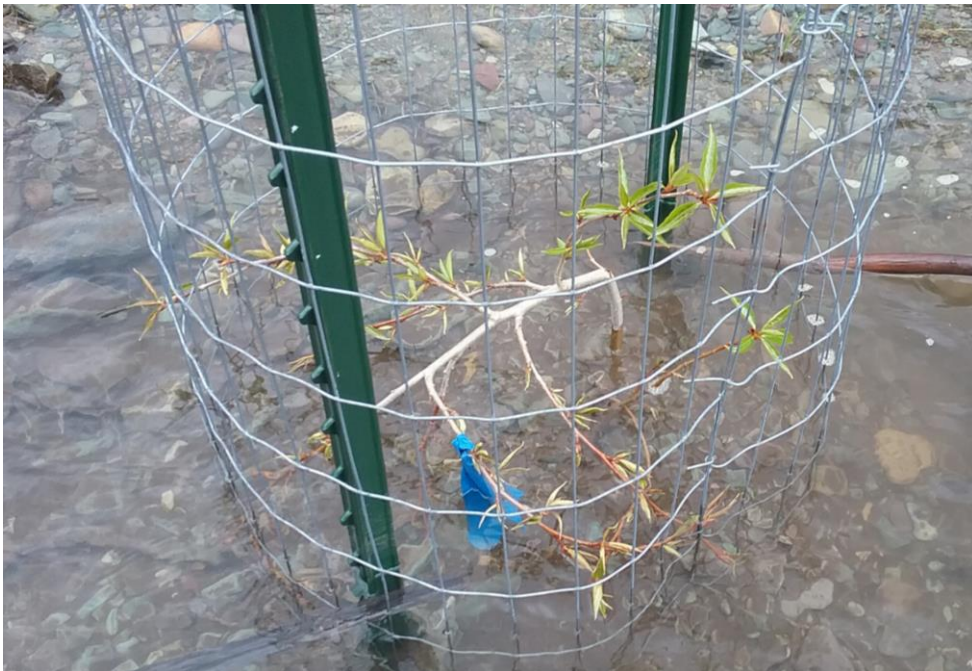
Almost all of the plantings survived within the first season after planting. Approximately 55% of the planted Black Cottonwood trees were slightly compressed from heavy snow within the constructed browse enclosures. Although all of these trees survived, maintenance was needed to help prop the plantings upright. Observations during the fall of 2018 confirmed these techniques helped to maintain the integrity of the stand.

Figure 7.5 Example of a bent cottonwood bole related to heavy snowfall in the immediate floodplain.
