Coal Creek Sediment Reduction and Bank Stabilization

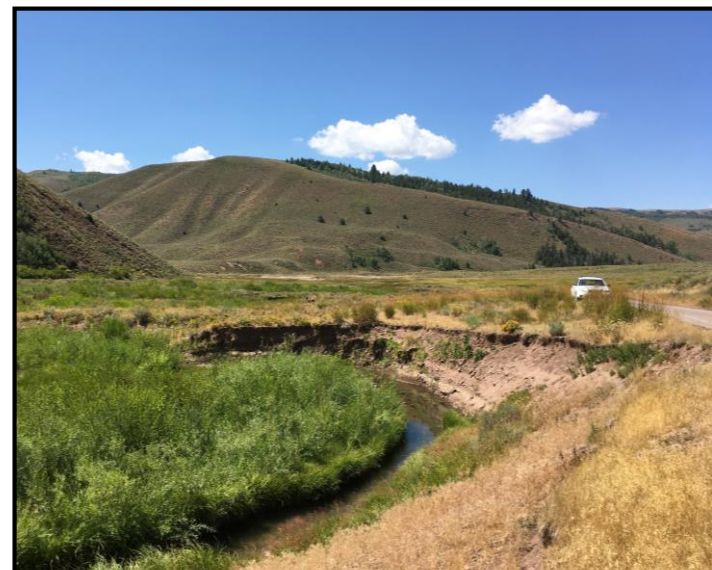
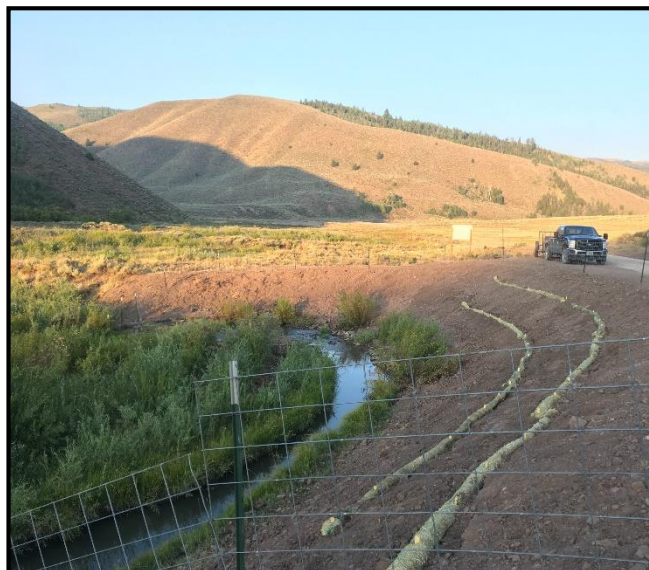
Photos from before (left) and after (right) bank re-sloping and construction of a bankfull bench to reduce sediment inputs from a large eroding bank.

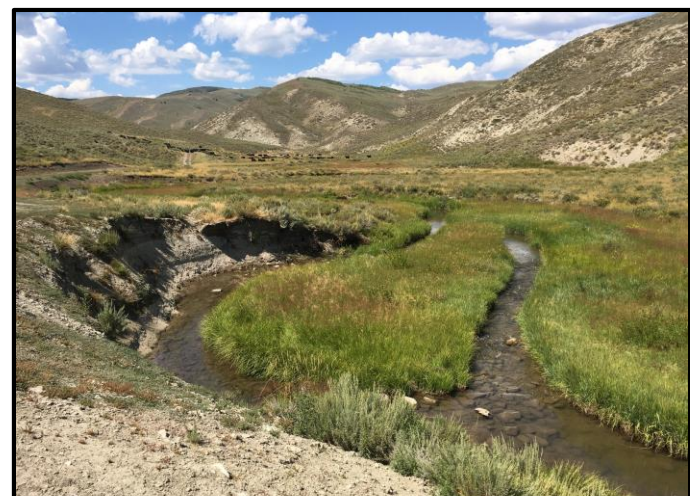
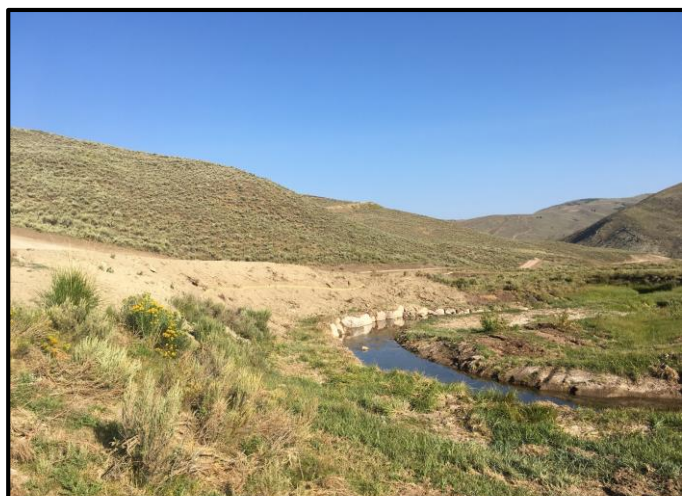
Before/after of a channel reconstruction to reduce high near-bank stress and erosion; a backwater in the former river right channel now provides juvenile fish rearing habitat.

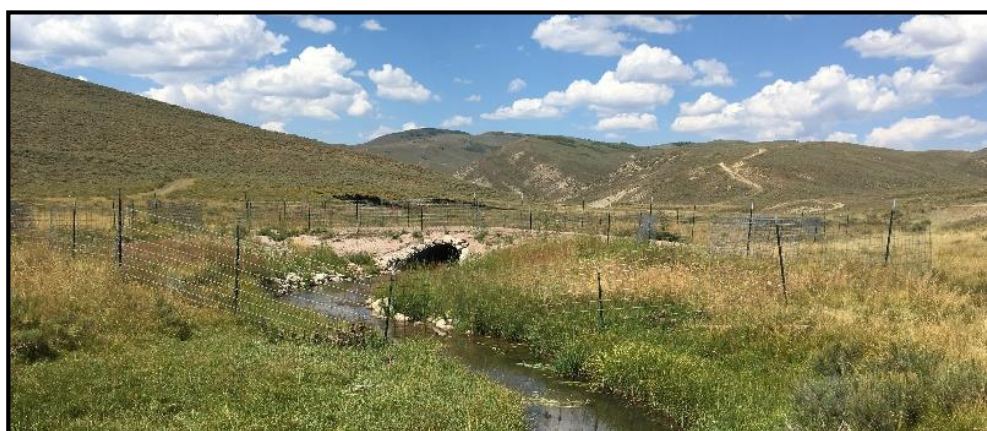
A vehicle ford on Little Muddy Creek was replaced with a bottomless arch culvert to improve stream function and road safety at this site.
