FINAL REPORT:

Dry Cottonwood Cross-boundary Trout Conservation

Clark Fork Coalition
Box 7593
Missoula, MT 59807

Western Association of Fish and Wildlife Agencies
Western Native Trout Initiative
Small Grant Project Agreement No. 2016-SG11

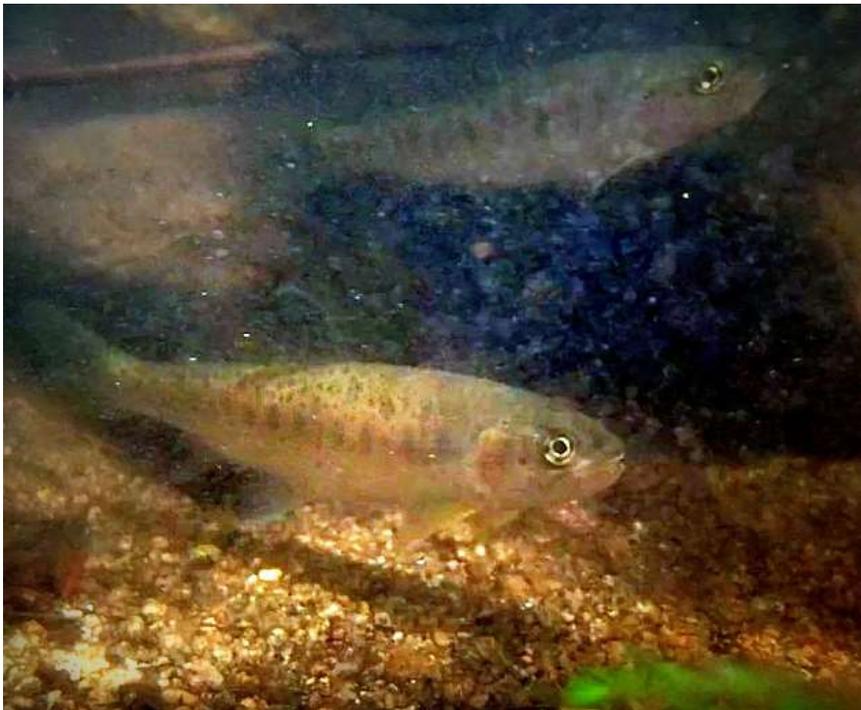
Westslope cutthroat trout below a culvert barrier in Dry Cottonwood Cr.

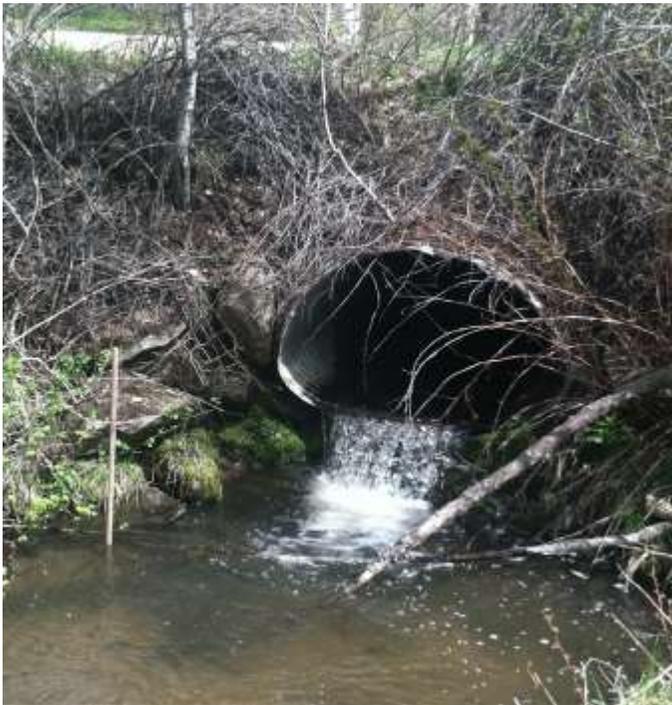
North Fork Dry Cottonwood Road 85 culvert to be replaced with AOP culvert in summer, 2018.

- 8) Clark Fork Coalition moved forward decisively in 2017 to remove the fish passage barriers on Dry Cottonwood Creek and improve degraded riparian habitat. In spring, 2017, the CFC put out a bid for replacement of the North Fork of Dry Cottonwood Road 85 culvert, to improve fish passage. The contract with the low bidder was signed in fall, 2017, and the construction is scheduled for summer, 2018 (full funding has been secured). The CFC hired an engineer to begin working on the design for a fish-passage friendly culvert on the South Fork of Dry Cottonwood Road 8634 crossing, which is a complete fish passage barrier. By January, 2018, this design was completed and full funding for construction was secured with State and Federal grants (working with the Forest Service). The South Fork culvert replacement will be bid out in spring, 2018 and constructed in fall, 2018.

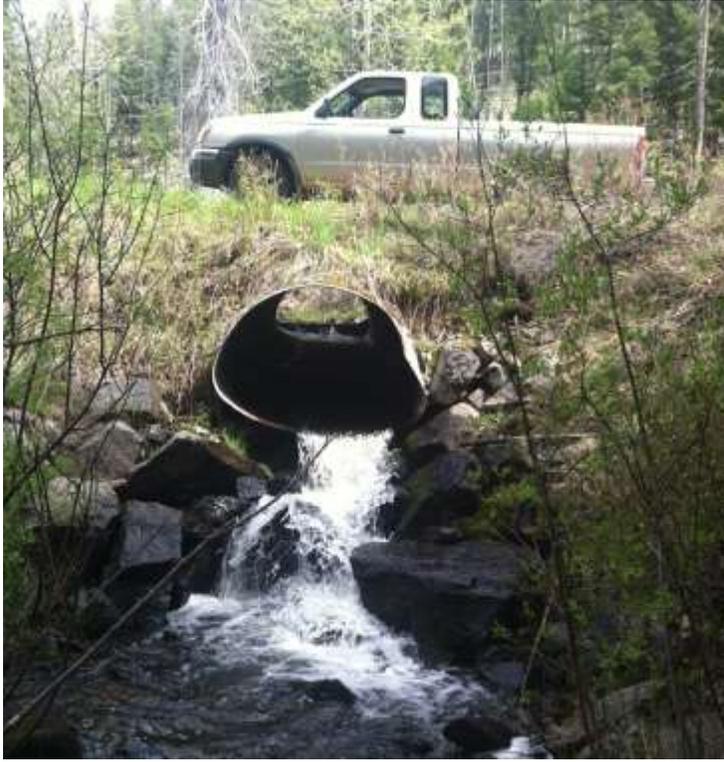
South Fork Dry Cottonwood culvert on Road 8634 scheduled for replacement in fall, 2018. Now in final design process, and full construction funding is secured.
