FINAL REPORT:

Dry Cottonwood Cross-boundary Trout Conservation

Clark Fork Coalition
Box 7593
Missoula, MT 59807

Western Association of Fish and Wildlife Agencies
Western Native Trout Initiative
Small Grant Project Agreement No. 2016-SG11

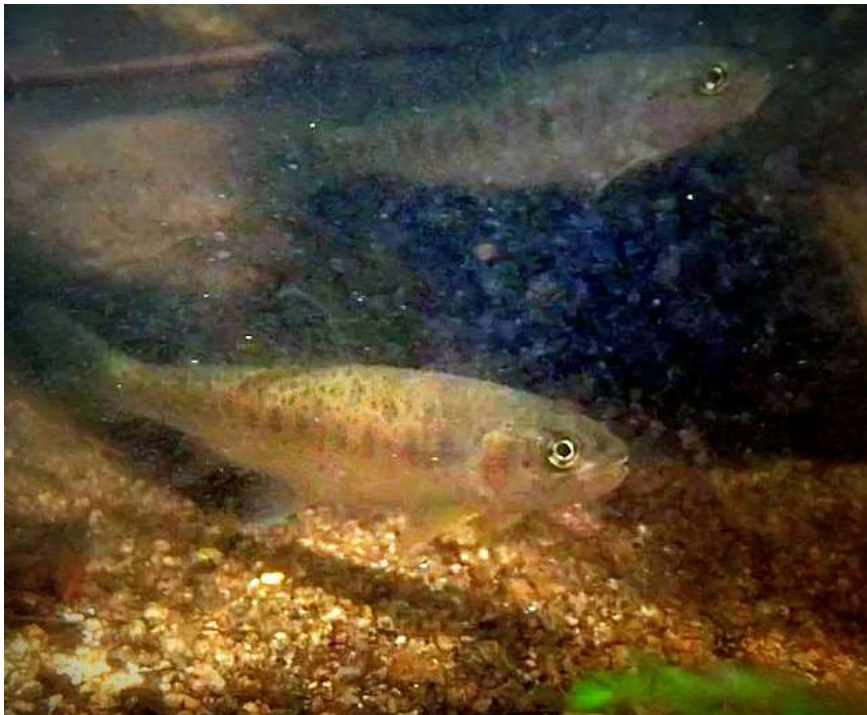
Westslope cutthroat trout below a culvert barrier in Dry Cottonwood Cr.

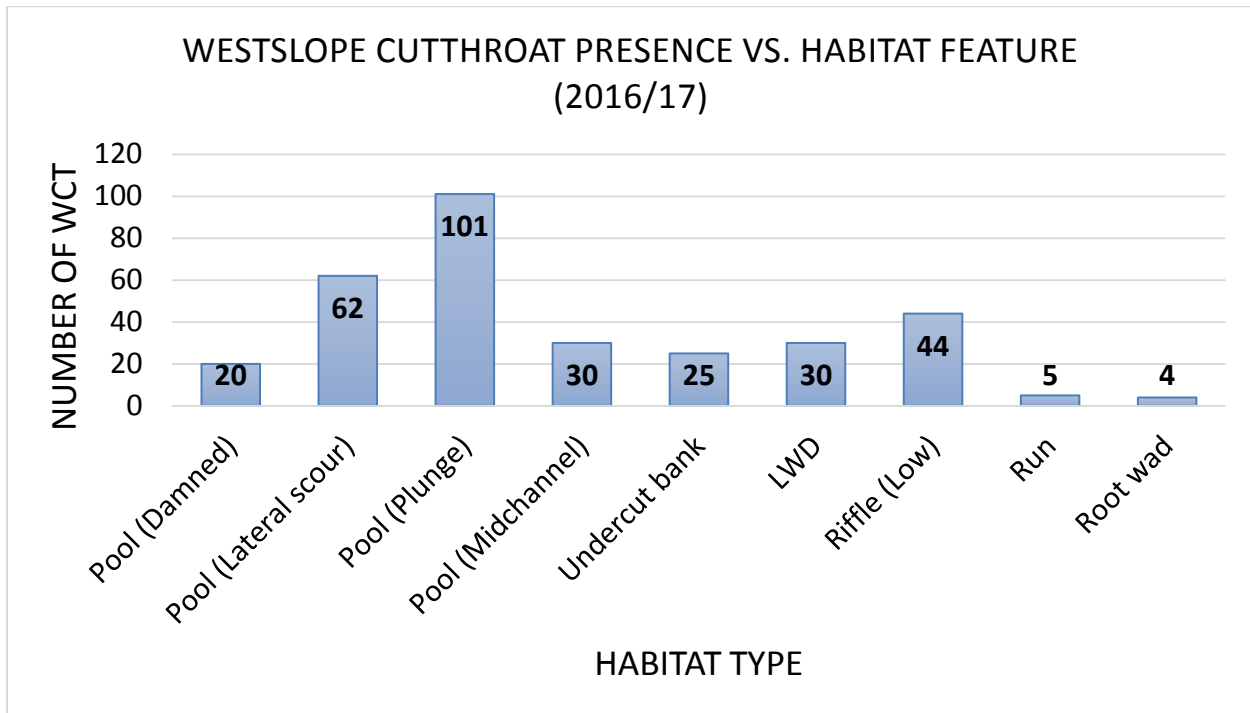
TABLE 2: WESTSLOPE CUTTHROAT USE OF HABITAT FEATURES IN DRY COTTONWOOD CREEK

It is clear from snorkel survey data (see Table 2 below) that a habitat feature of great importance in the Dry Cottonwood drainage is frequency of pools, particularly deeper pools (plunge pools and lateral scour pools). Another habitat feature which we cannot adequately sample with snorkeling is beaver ponds. There is a large beaver pond complex on the mainstem of Dry Cottonwood about 2 miles above the river. Snorkeling and hook & line fishing has shown a good population of westslope cutthroat trout in this pond, including specimens approaching 300 mm. length, or about twice the length of adults which are found in the mainstem stream. But visibility and cover prohibit a good count of fish in these ponds by snorkeling. Another active beaver pond complex was discovered in the lower South Fork of Dry Cottonwood in 2017, during our riparian assessment stream walk. Although initial population counts in our South Fork sample sites were low, we believe the beaver complex is the best fish habitat in the South Fork, and combined with the other habitat available in the South Fork, helps provide justification for connecting this occupied cutthroat trout habitat with the habitat lower in the drainage.

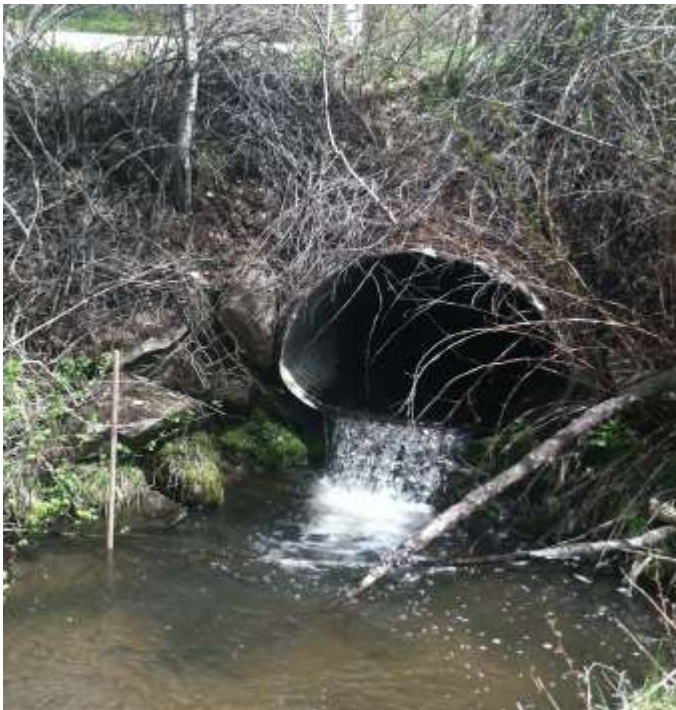
North Fork Dry Cottonwood Road 85 culvert to be replaced with AOP culvert in summer, 2018.

- 8) Clark Fork Coalition moved forward decisively in 2017 to remove the fish passage barriers on Dry Cottonwood Creek and improve degraded riparian habitat. In spring, 2017, the CFC put out a bid for replacement of the North Fork of Dry Cottonwood Road 85 culvert, to improve fish passage. The contract with the low bidder was signed in fall, 2017, and the construction is scheduled for summer, 2018 (full funding has been secured). The CFC hired an engineer to begin working on the design for a fish-passage friendly culvert on the South Fork of Dry Cottonwood Road 8634 crossing, which is a complete fish passage barrier. By January, 2018, this design was completed and full funding for construction was secured with State and Federal grants (working with the Forest Service). The South Fork culvert replacement will be bid out in spring, 2018 and constructed in fall, 2018.

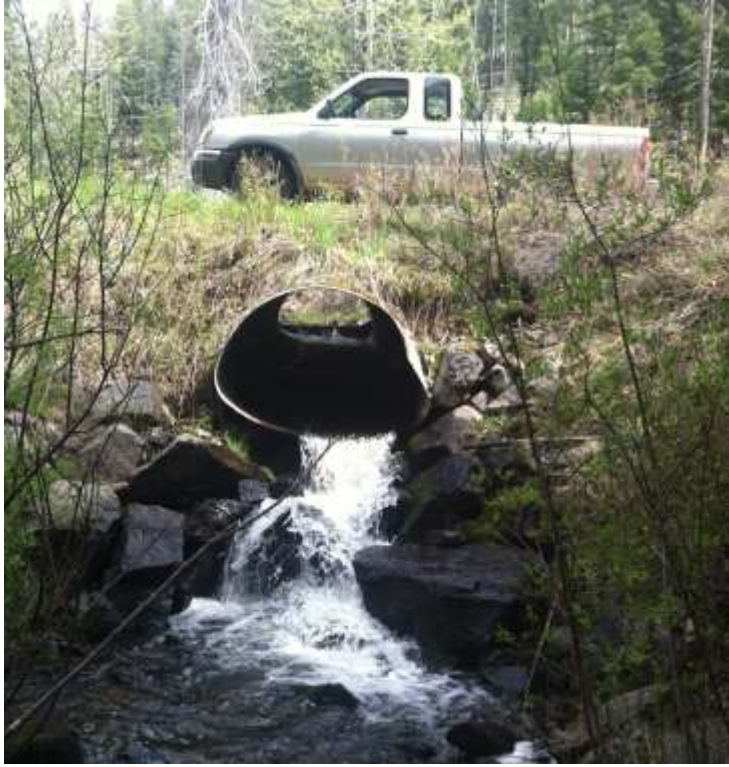
South Fork Dry Cottonwood culvert on Road 8634 scheduled for replacement in fall, 2018. Now in final design process, and full construction funding is secured.
