Subject: Final performance report F17AC00002

Over the course of 2016 and 2017, the Miners Gulch Stream and Riparian Restoration Project was completed successfully. This project reconstructed 1,600 feet of stream channel on the Vermilion River along with the surrounding floodplain, and also featured an extensive revegetation effort. The goals of this project were to restore a degraded segment of stream and floodplain in order to improve habitat for native Bull Trout and Westslope Cutthroat Trout.

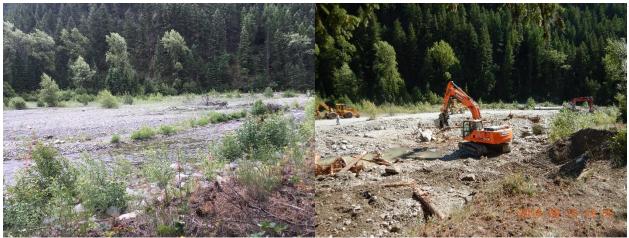
Figure 1. A section of the Miners Gulch Reach of the Vermilion River pictured prior to channel reconstruction is shown on left and excavator reconstructing the same section is on the right.

In 2016, the "dirtwork" of channel and floodplain reconstruction was completed. A local contracting firm, Elk Creek Contracting, was awarded the construction and materials contract for the completion of this project and completed all in-channel construction work between July 15 and August 23. The Miners Gulch reach of the Vermilion River was reconstructed according to project designs as described in our funding proposal. Channel work was completed under the supervision of Forest Service Hydrologist Craig Neesvig and met the Forest Service's specifications. Figures 1-3 show the result of this channel reconstruction work.

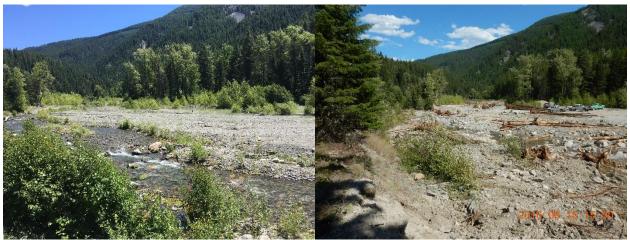
Figure 2. Pointing upstream from the same location where photos were taken in Figure 1, the left shows the stream channel and floodplain prior to channel reconstruction work and the right shows the stream channel and floodplain during the middle of implementation.

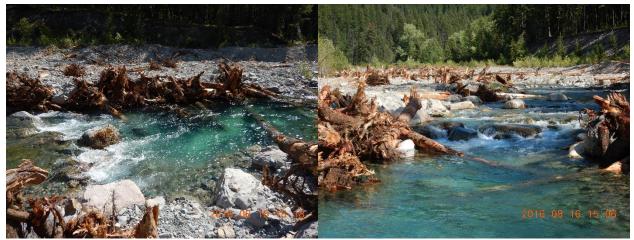
Figure 3. Completed channel reconstructed with rock and log structures and newly created pool habitat in the Miners Gulch reach of the Vermilion River.

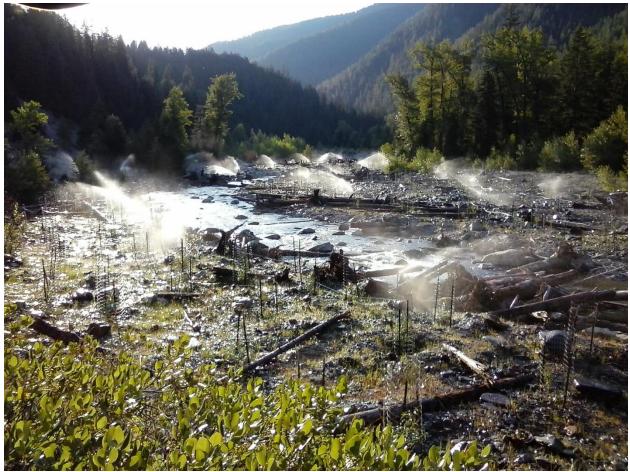
Figure 4. Extensive re-vegetation effort through the riparian area and disturbed floodplain is irrigated during summer 2017. Photo credit: Erich Pfalzer, Kootenai National Forest - Cabinet Ranger District

Remaining work on the Miners Gulch Stream and Riparian Restoration Project was completed over the 2017 field season, with the implementation of an extensive re-vegetation effort along the newly constructed channel and throughout the surrounding floodplain. All materials were flown into the project site via helicopter. This included all plants (400 cottonwoods), 1600 t-posts and about 1 mile of fencing. Cages were installed around new plantings and naturally sprouting trees. Irrigation was installed throughout, and the area was watered once a week in 2017 and will continue to be watered each summer for the next two years. Figure 4 pictures this re-vegetation effort.
