Picture 1. Aerial photo of project site June, 2017.

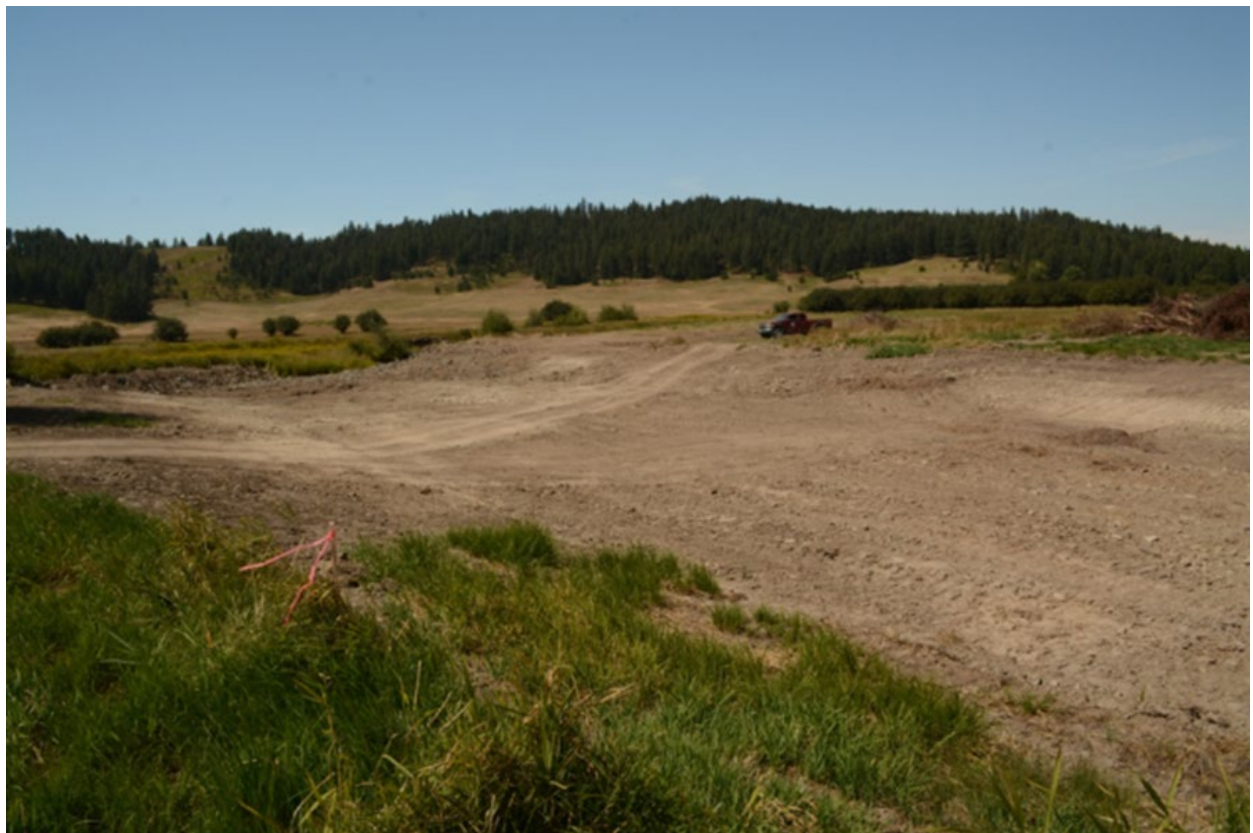
Picture 2. Constructed relief channel Aug, 2016.

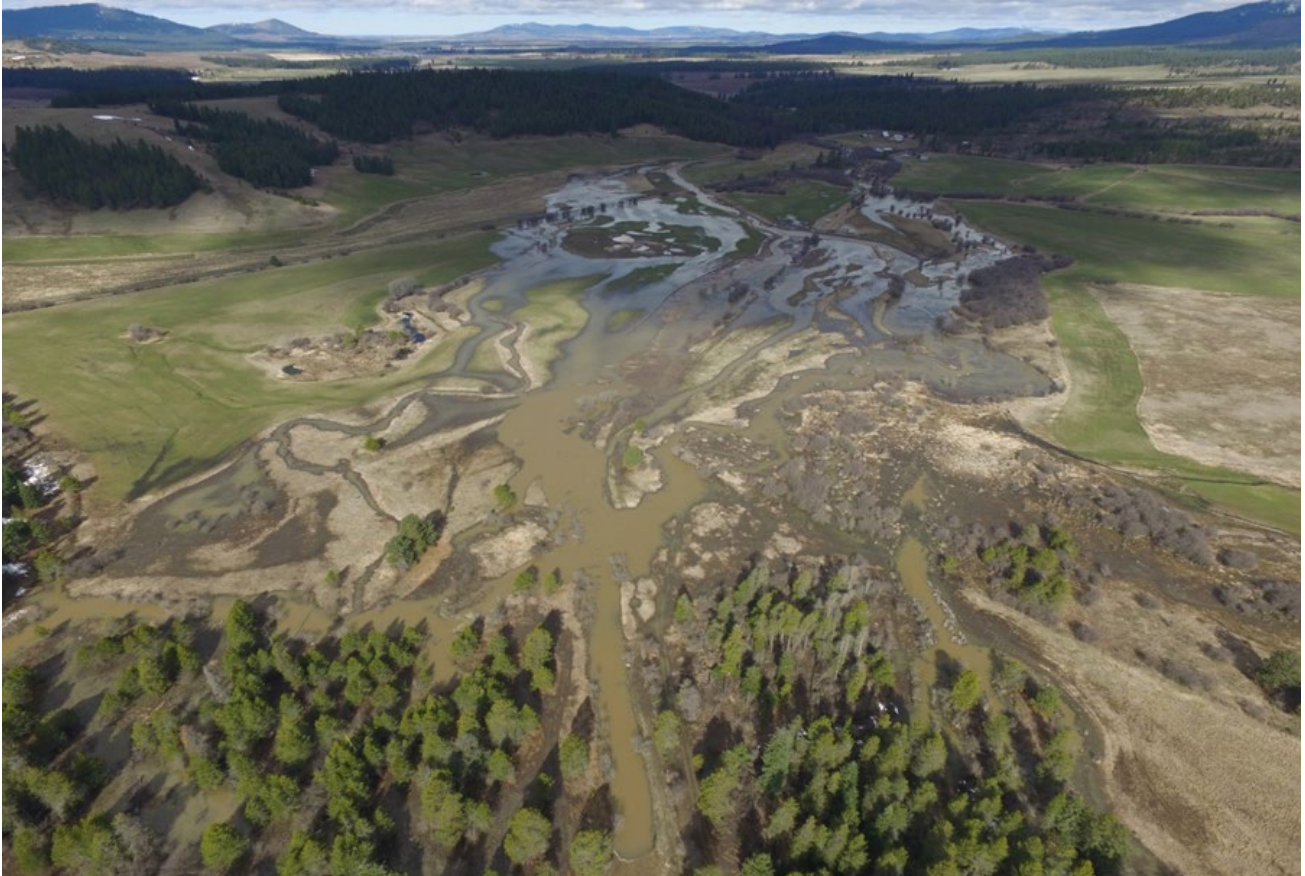
*Picture 4. After picture of project site during runoff event at approximately 300cfs, March 2017.*

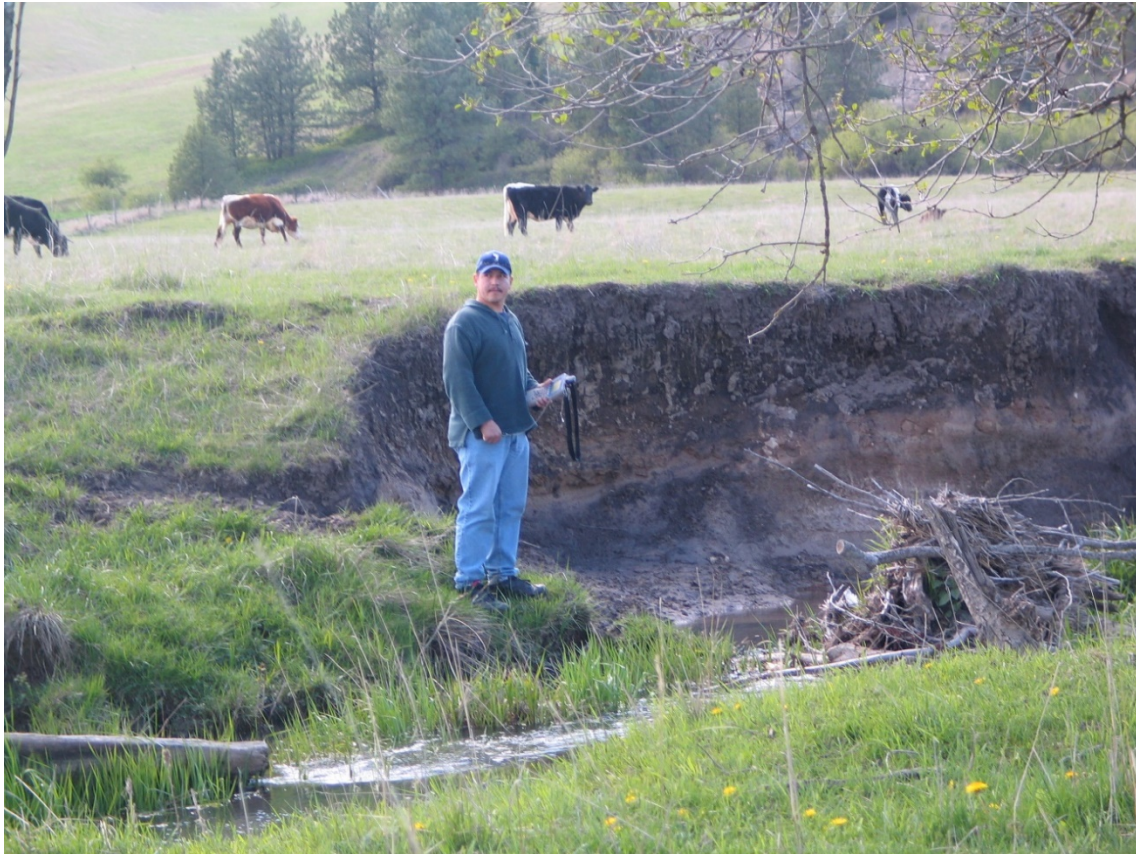
Picture 5. Portion of the channelized stream within project site prior to restoration actions. Photo taken during early summer of 2010.

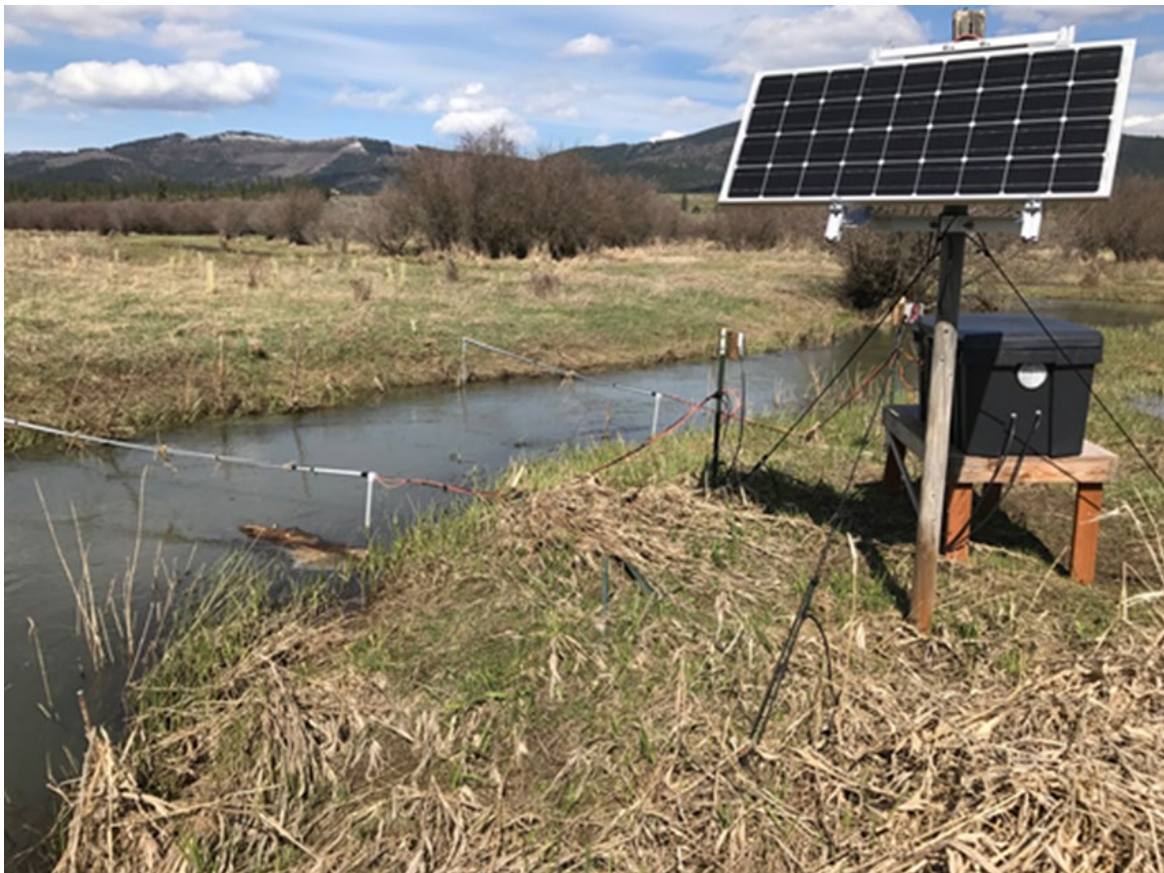
Picture 6. Portion of the newly activated relict channel and a PIT tag monitoring station after restoration was initiated, April 2017. This monitoring station was installed to determine migration timing and rearing locations of fluvial redband trout within the project reach. Protected tree plantings are in the background of the photo.
