## Western Native Trout Initiative Project Completion Report

**Project Title: Yankee Run Creek LWD Restoration Project**

**Grantee Organization: Coquille Watershed Association**

## **WNTI Project Completion Report - Yankee Run Creek LWD Restoration Project**

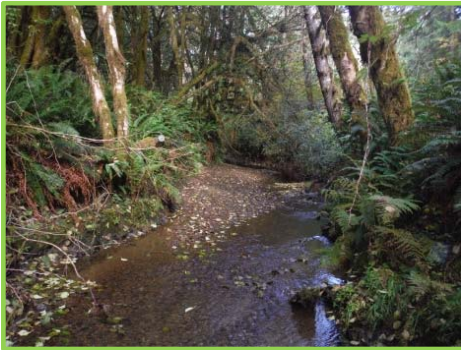
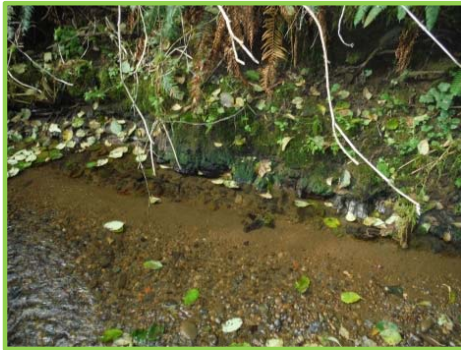
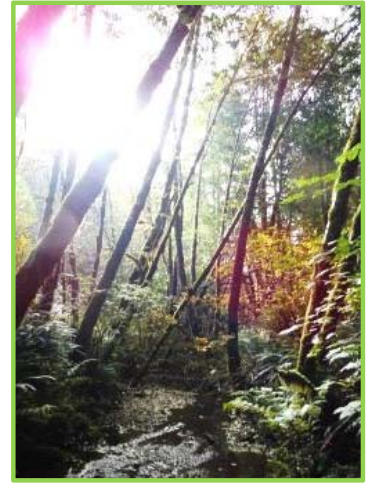
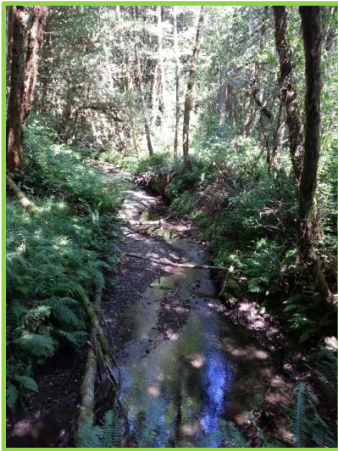
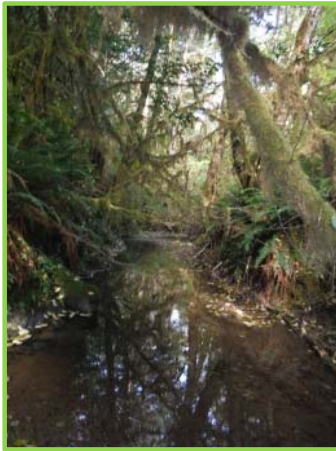
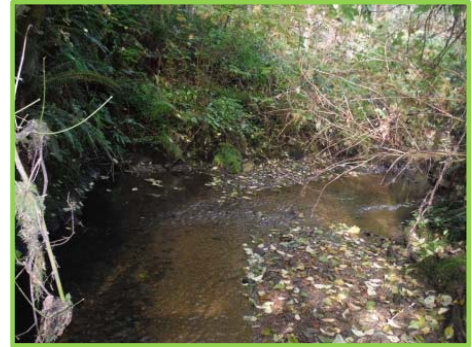
**Yankee Run Instream pre-photos:**

Sites Y-21-4 through Y-32-6, Yankee Run & Right Fork Yankee Run, August-September 2013

Yankee Run: Channel, substrate, gravel bed, canopy & creek conditions:

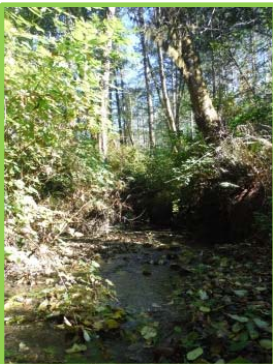
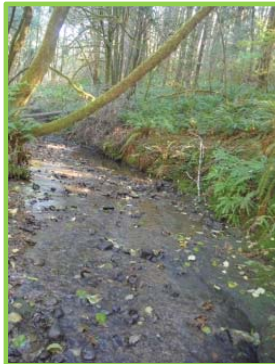
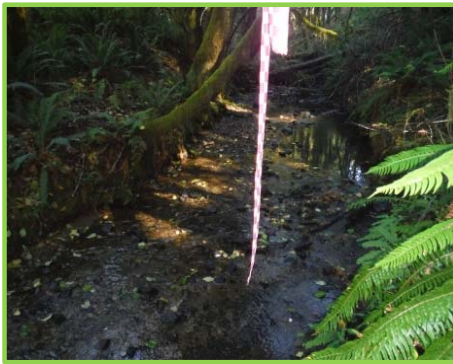
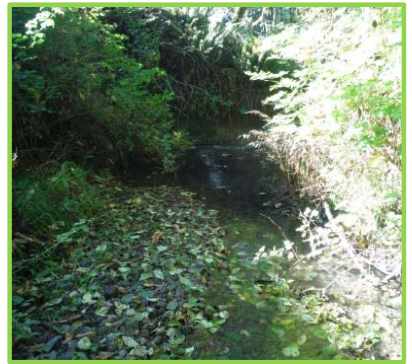
Right Fork Yankee Run: Areas needing pool development & LWD:

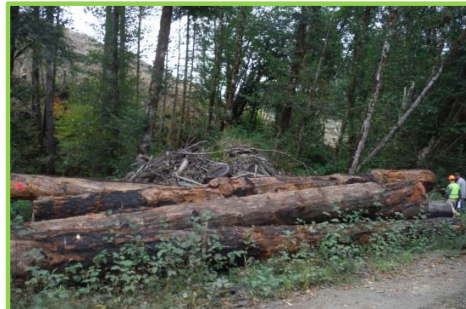
Large logs staged for placement:

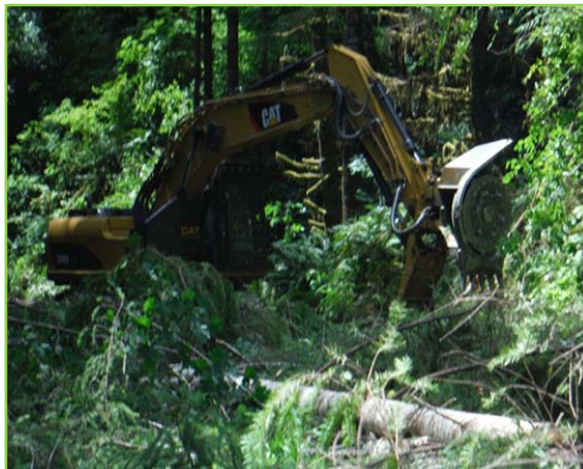
Excavator had a grinder head to mulch limbs

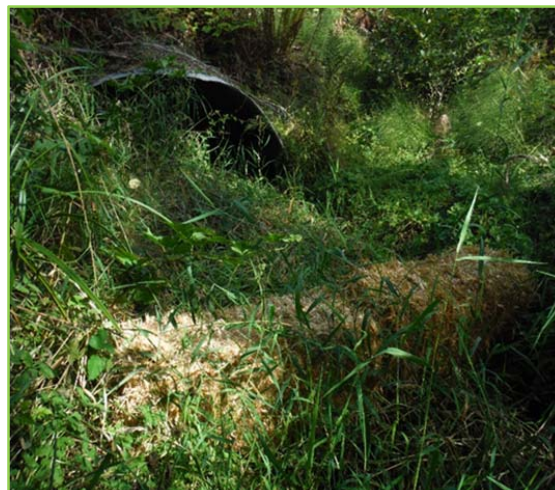
Sediment controls were placed throughout the project

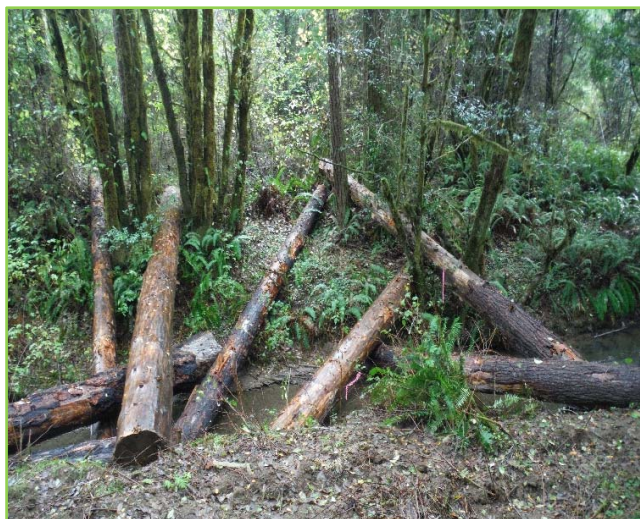
**Instream implementation photos, August-September 2014:** Site 47 is the farthest upstream structure and Site 4 is the furthest downstream

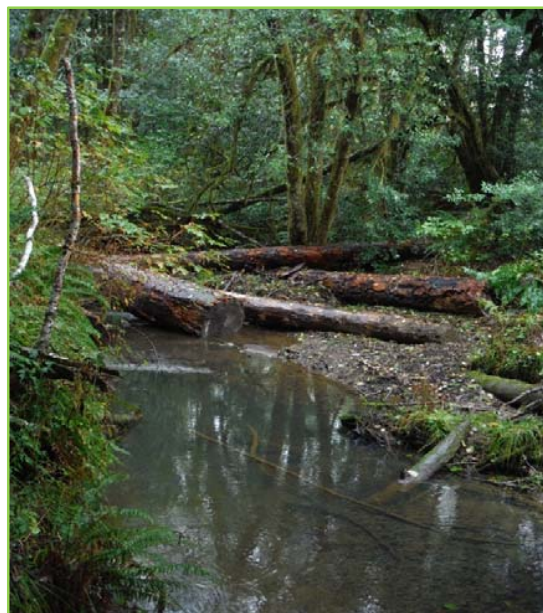
Sites 11-14 were adjusted to take advantage of better access points. Site 13 was relocated to where Site 12 was originally selected, and Site 12 was shifted down stream approximately 50 yards. Log numbers were also adjusted to 5 each on both Sites 12 & 13, with 2 additional logs on Site 11 and 4 additional logs on Site 14.
