For: Western Native Trout Initiative From: Trout Unlimited, Upper Deschutes Initiative, Oregon

Final Completion Report for Crazy Creek and Deep Creek Restoration Project, June 2015:

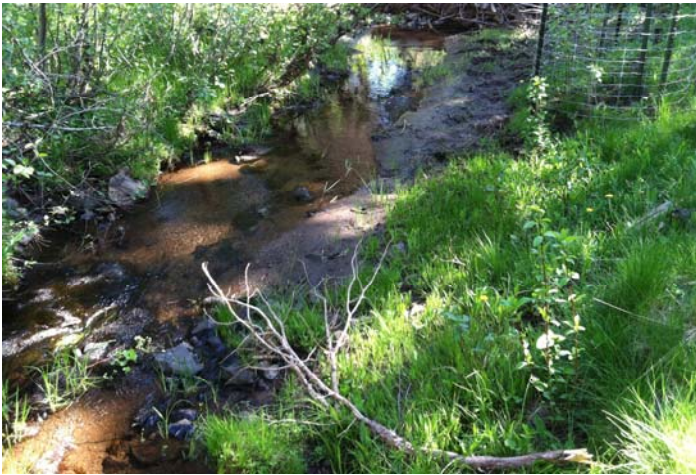
Image 1 of the conditions which have changed, showing fine sediment collection and vegetation growth/recovery.

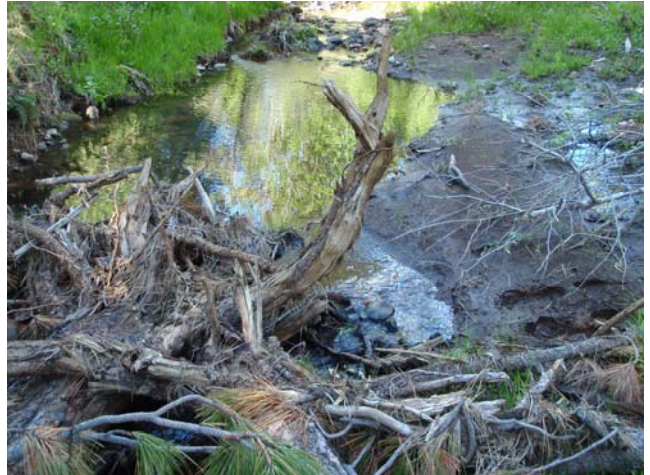
Image 2 of the conditions which have changed, showing fine sediment collection upstream of new structure.

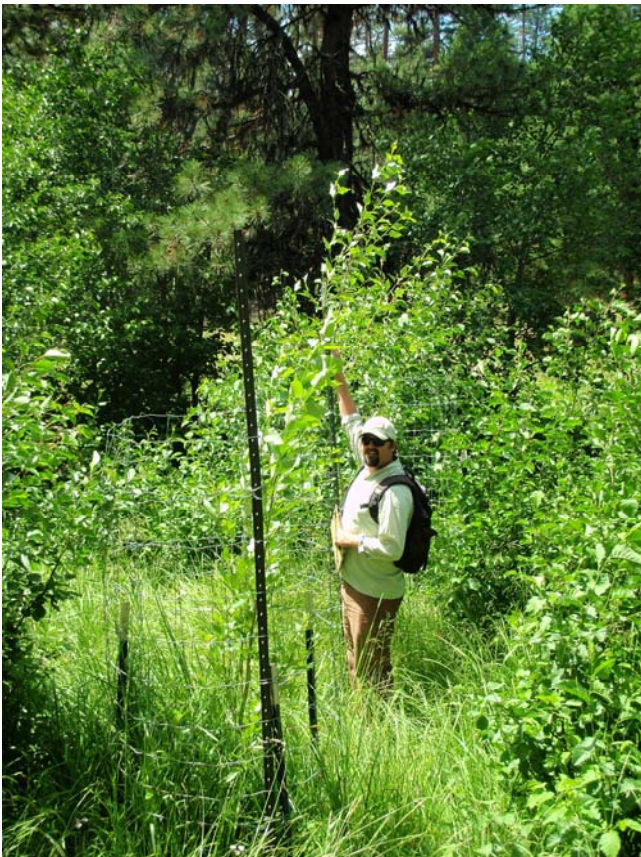
Image 1 of one of our larger potted cottonwoods growing in the floodplain of the improved channel.

- Approximately 50 acres in the riparian corridor was planted with willows, alder and other native tree and shrub species. Spacing and species diversity have mimicked reference sites. Larger material has and will be protected unless site conditions do not warrant such (see photos of the cottonwood added to the site and early growth and establishment).

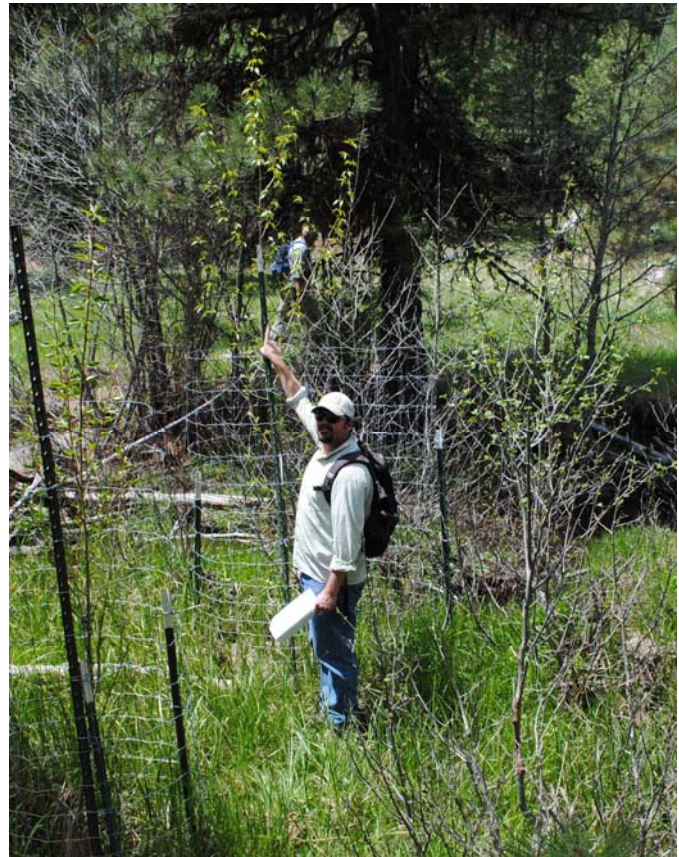
Image 2 of the same cottonwood, showing one year of growth, with 2 feet added, and caging functioning well.

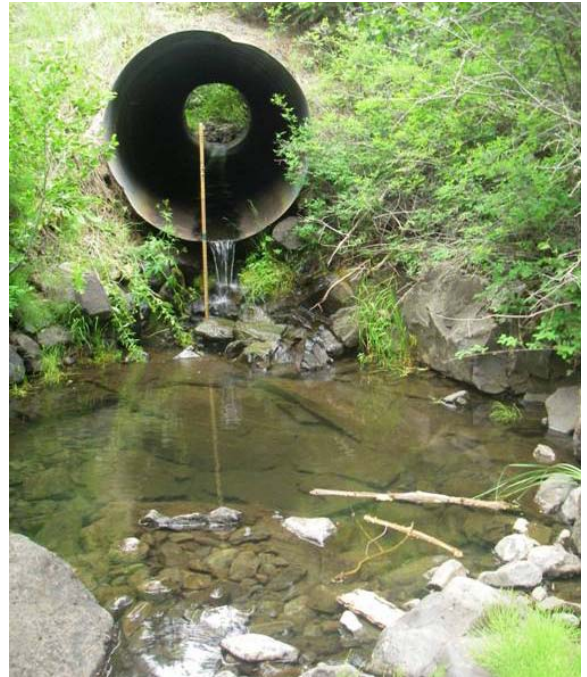
Photo of Perched Culvert before replacement

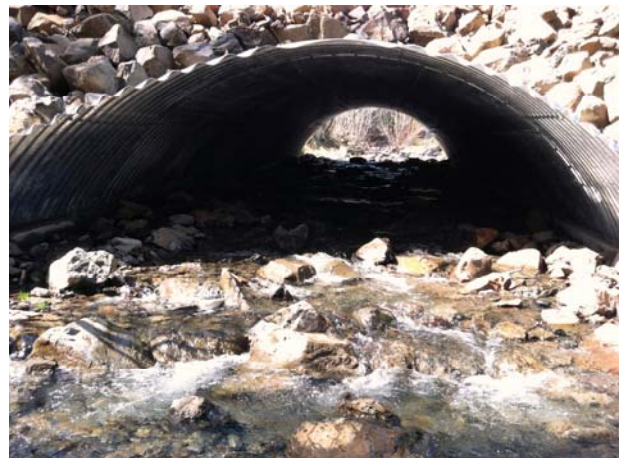
Photo of new bottom arch culvert and sediment

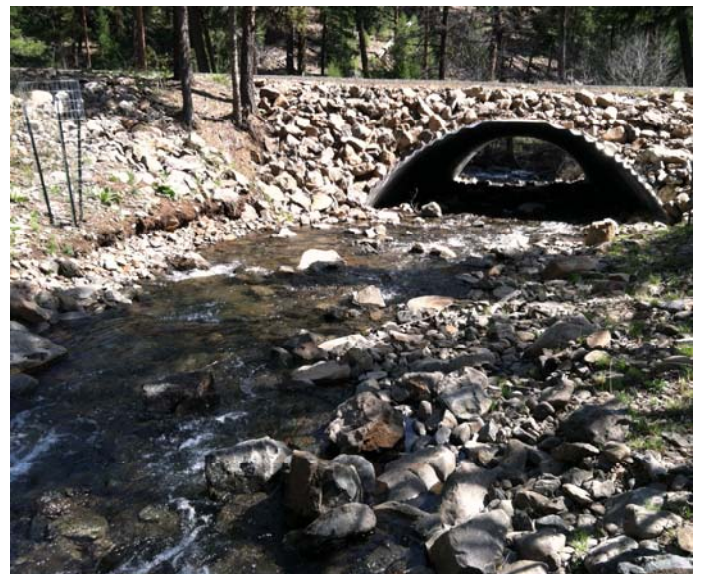
Photo of improved Crazy Creek channel into culvert
