## **Wolf Creek Barrier Reconstruction Completion Report**

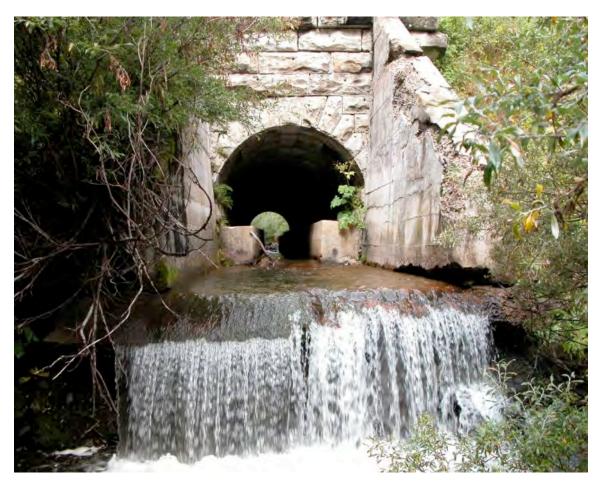
Rio Grande cutthroat trout are the only native trout species found in the Rio Grande drainage of south central Colorado. This once abundant species is now found primarily in high elevation headwater streams in Colorado and New Mexico, including 30 streams on the Rio Grande National Forest. One of the historic populations of Rio Grande cutthroat trout on the forest had been protected from nonnative trout by a railroad culvert that was constructed in 1882. The railroad culvert had an outfall drop of approximately 3.5 feet, which had been adequate to prevent invasion by undesirable nonnative trout until a deep scour pool formed below the pool. Trout surveys conducted in 2006 and 2007 documented a few brown trout above the culvert. It is believed that the scour pool provide habitat that enable brown trout to jump the existing outfall.

Wolf Creek Barrier before project completion:

The goal of this project is to construct a concrete splash pad where the scour pool has formed and construct concrete walls to support the existing concrete culvert outfall pad and stabilize the stream banks on either side of the splash pad. Engineered drawings have been designed to construct the splash pad/walls and were let out for bid. The project was awarded to a contractor to be completed in 2009, but work had to be delayed until 2010 due to weather conditions.

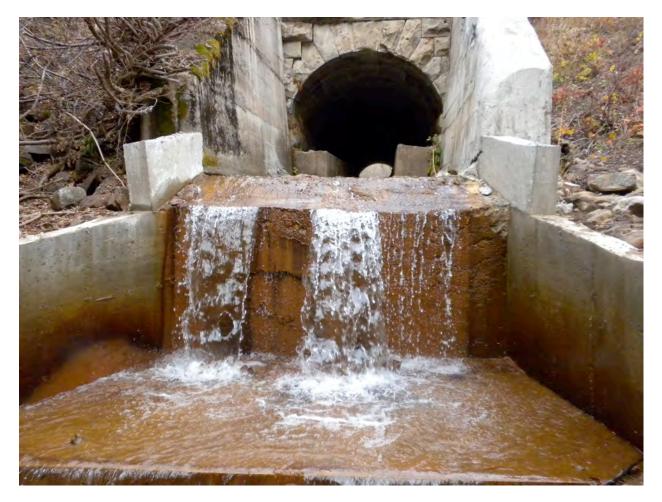
Wolf Creek Barrier after completion:

The project was completed in 2010.
