# 2023 "Waters to Watch" - Spread Creek (Wyoming) Fish Passage Project, Phase 2

**Purpose of the project:** Spread Creek, located outside of Jackson Hole, Wyoming, traverses through relatively pristine National Forest and National Park lands before joining the Upper Snake River approximately 15 miles below Jackson Dam. Spread Creek showcases a diversity of life histories for native Snake River Cutthroat (Yellowstone Cutthroat Trout subspecies) trout important to the resilience of the population and species into the future. The lower section serves as a migration corridor for large, fluvial fish, while the upper portion of Spread Creek serves as important spawning and rearing habitat for fluvial fish and year-round habitat for resident fish.

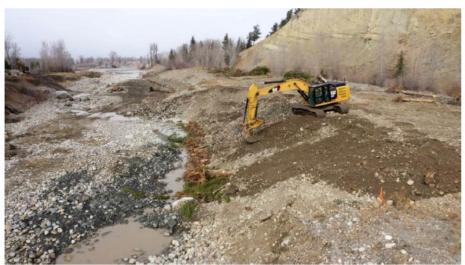
Photo 1. Bank stabilization structures using a combination of wood, rock, resloping, and erosion fabric were installed in November 2021.

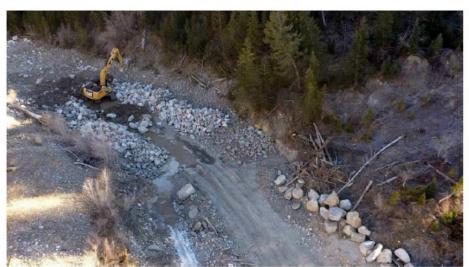
Photo 2. Large boulders were imported to create a rock ramp diversion structure in November 2021, a design expected to be much more robust than the previous diversion structure.

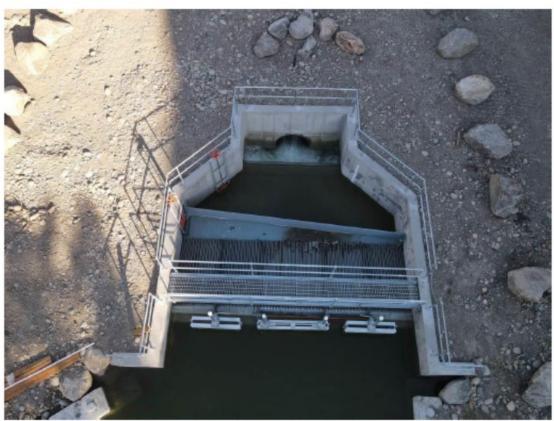
Photo 7. Spread Creek fish screen.

The project goals and objectives were met. The project addressed the fish passage barrier posed by entrainment into the Spread Creek ditches through the installation of the Corrugated Water Screen type fish screen, which now ensures that native fish can migrate the 5 miles from the Spread Creek irrigation diversion down to the Snake River confluence. It stabilized the irrigation diversion, banks, and channel located on 1,250 feet of stream in the project area (on Bridger-Teton National Forest land), thereby improving passage conditions for native fish, increasing instream habitat, and improving water quality. These improvements will also serve to maintain and protect existing infrastructure and minimize future land loss, including the protection of an established Forest Service campsite. 950 willow stakes were planted in the bank stabilization structures. Volunteers assisted with several aspects of the project, including fish rescues, willow stake harvesting, project film, and youth education. A project film was produced that is being used for additional outreach and engagement.

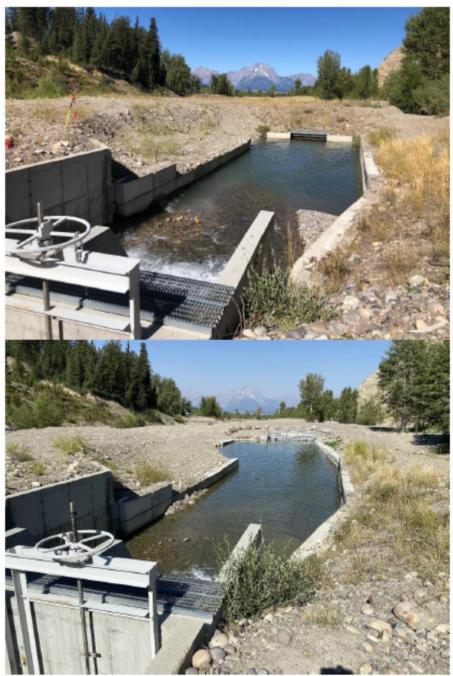
Photo Set 11. Previous headgate and sediment basin (above), expanded sediment basin and new fish screen at far end (below).
