## Rainey Creek Restoration, Bridge-to-Bridge: Phase 2

Henry's Fork Foundation-South Fork Initiative

Project Completion Report-Final Report

January 18, 2024

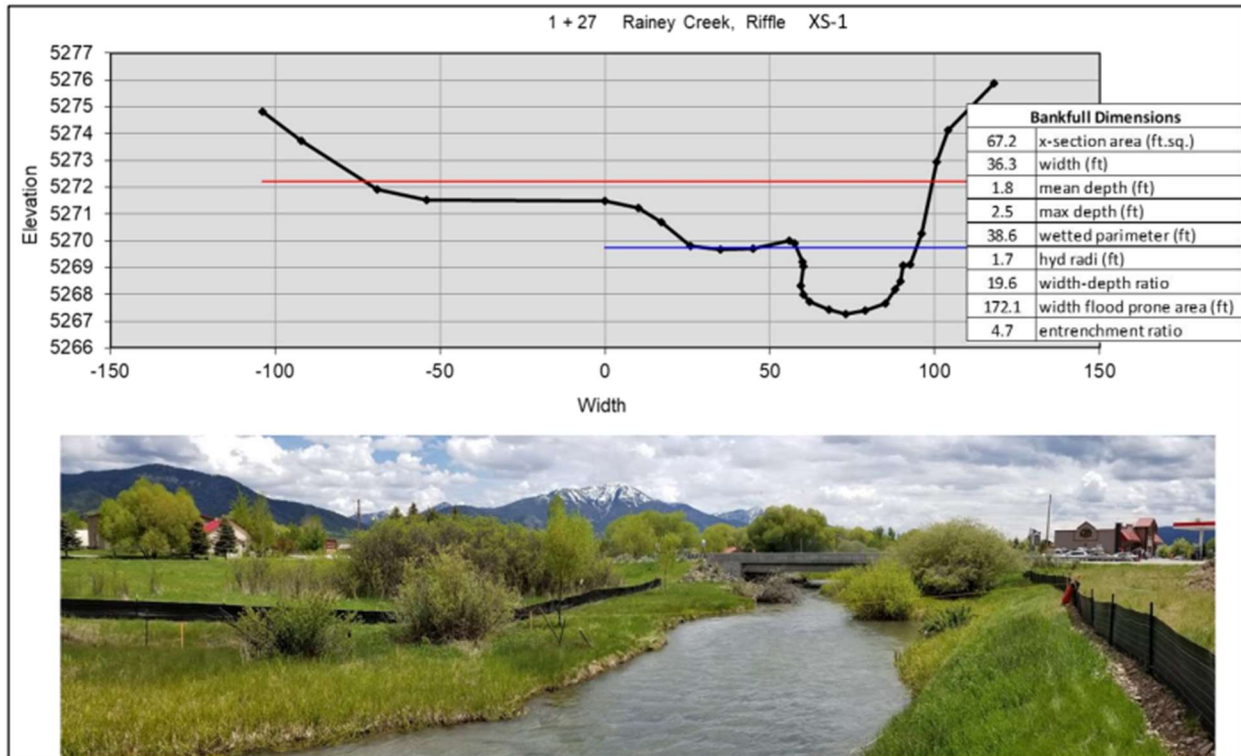
Figure 2. Example of a riffle cross section that was utilized to develop the restoration design.

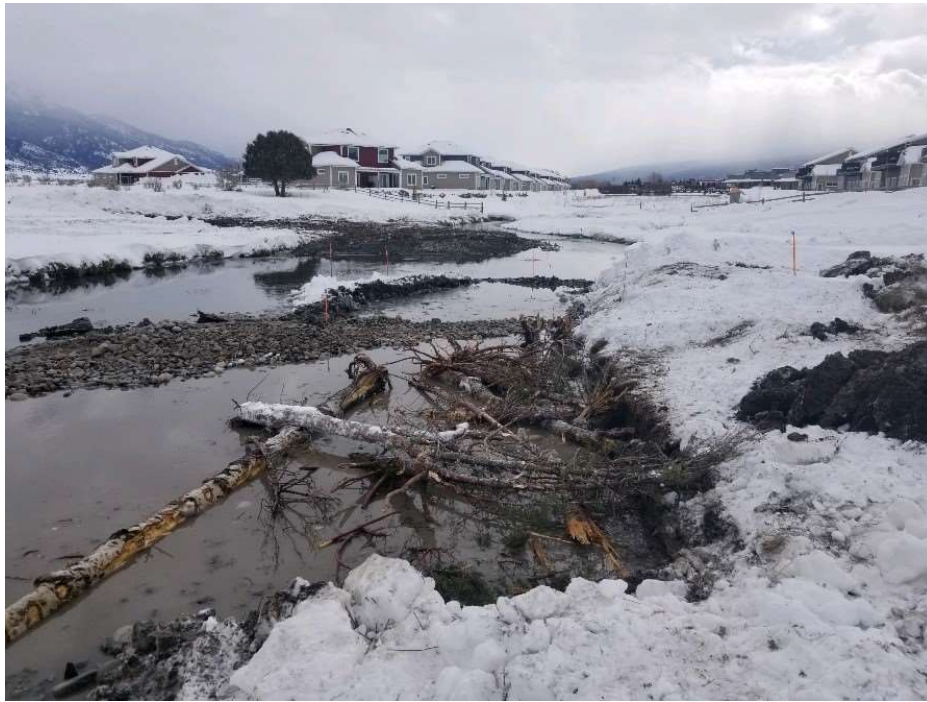
**Photo 1. Phase 2, during project implementation. Newly constructed large wood debris log structure.**

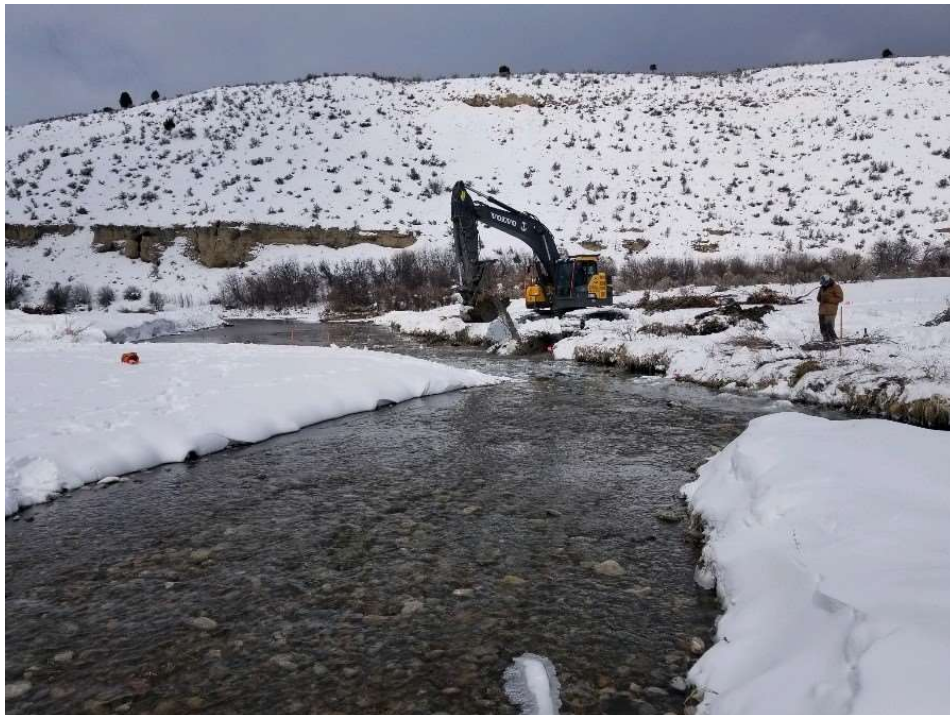
**Photo 2. Phase 2, during implementation. Rockin T construction installing large wood and modifying channel.**

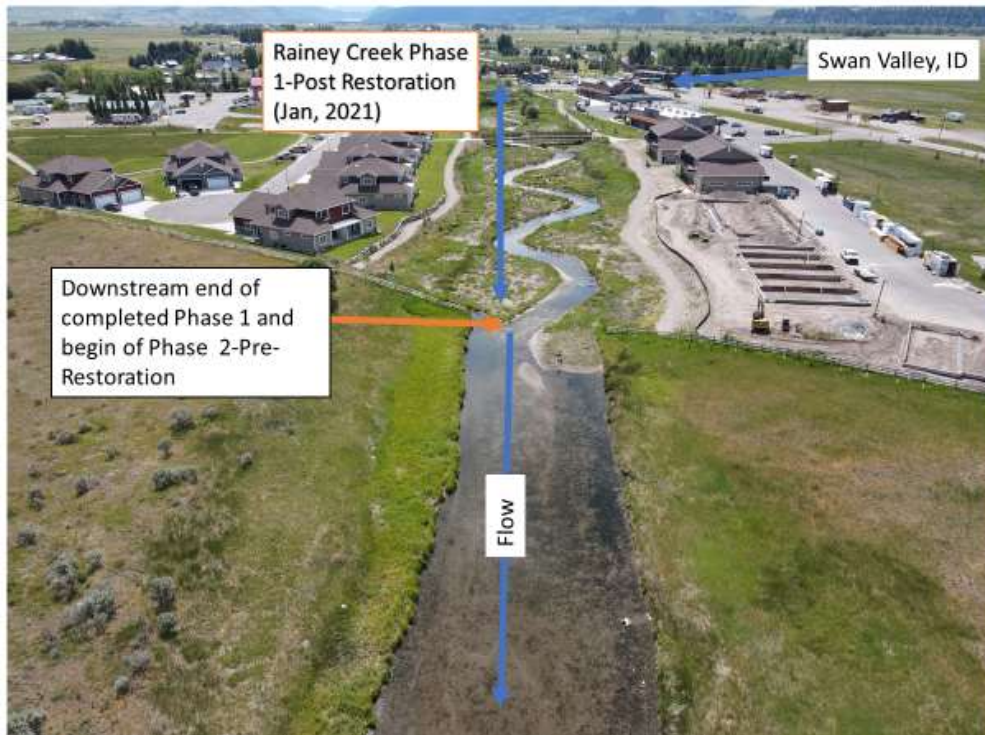
**Photo 3. Pre-Restoration. Top of Phase 2 facing upstream into recently completed Phase 1.**

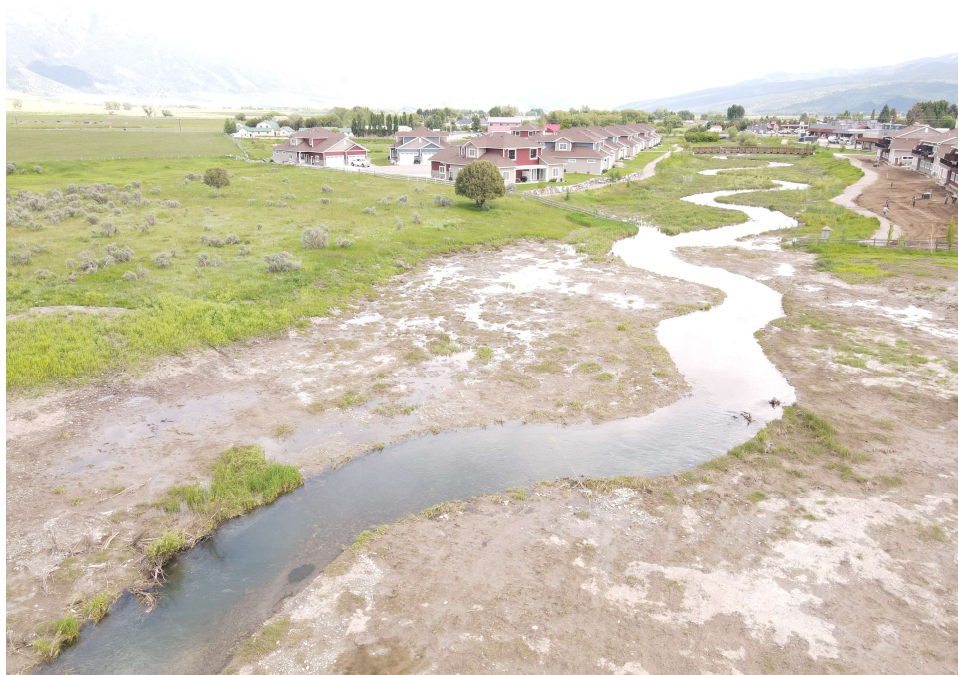
**Photo 4. Post Restoration. Looking upstream at top end of project into Phase 1**

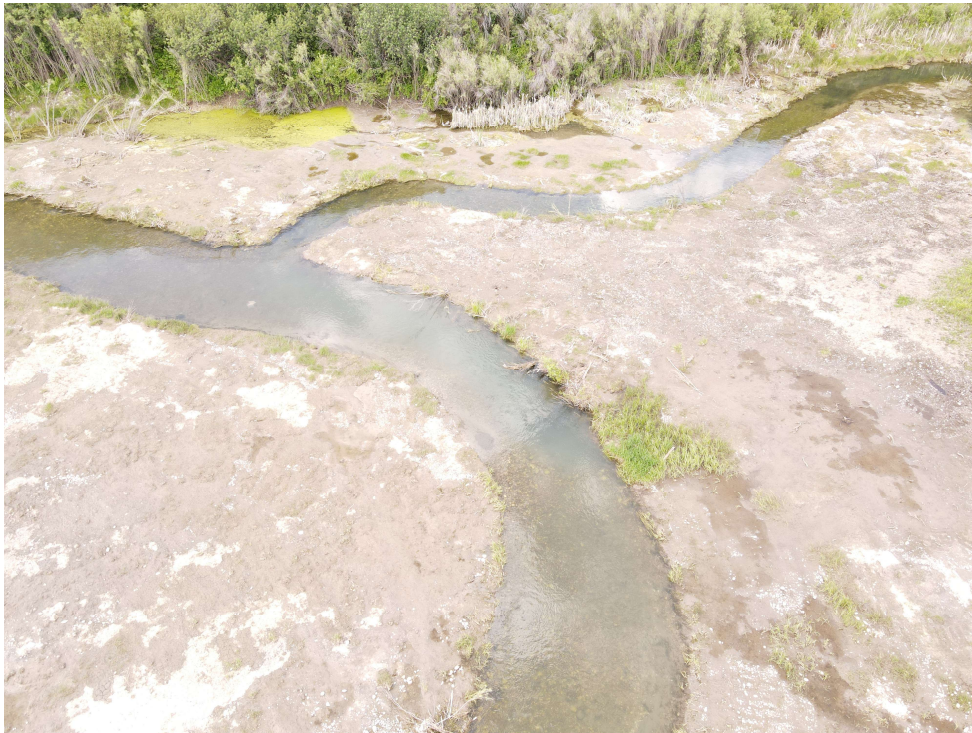
**Photo 6. Post Restoration. Facing downstream directly below Spring Creek. Notice the narrowing of channel.**

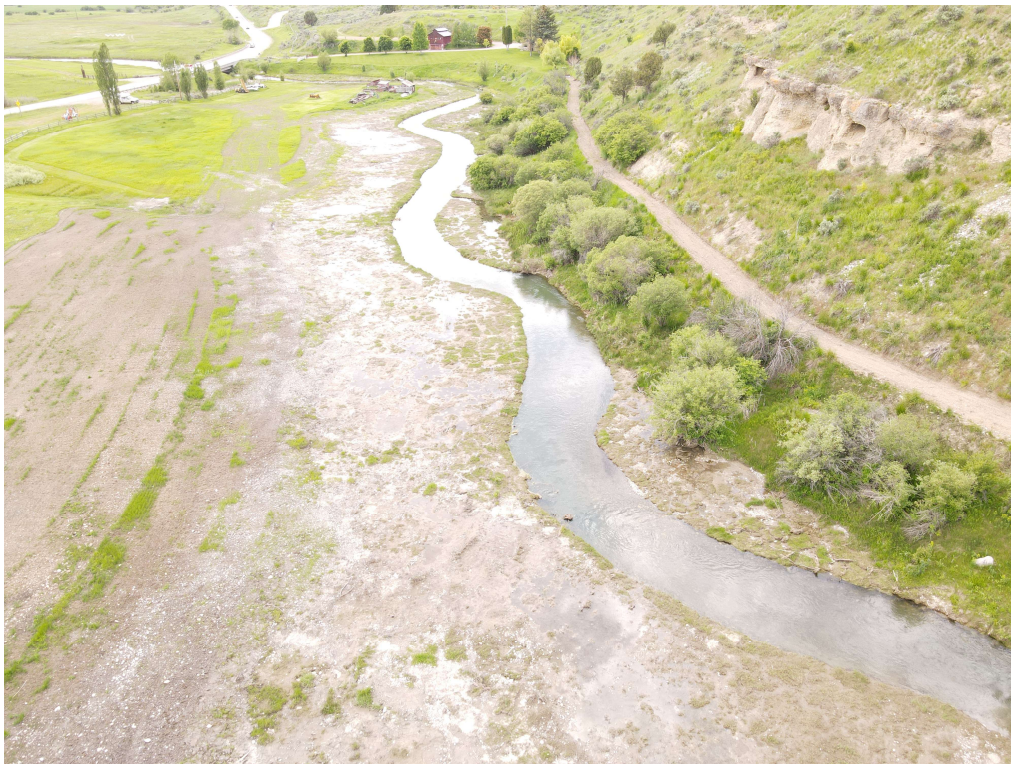
**Photo 8. Post Restoration-Phase 2. Facing downstream, Notice narrower channel with improved sinuosity and habitat (large wood added).**
