WYOMING GAME AND FISH DEPARTMENT

South Flat Creek Channel Restoration

Report

Report Type: Final Report

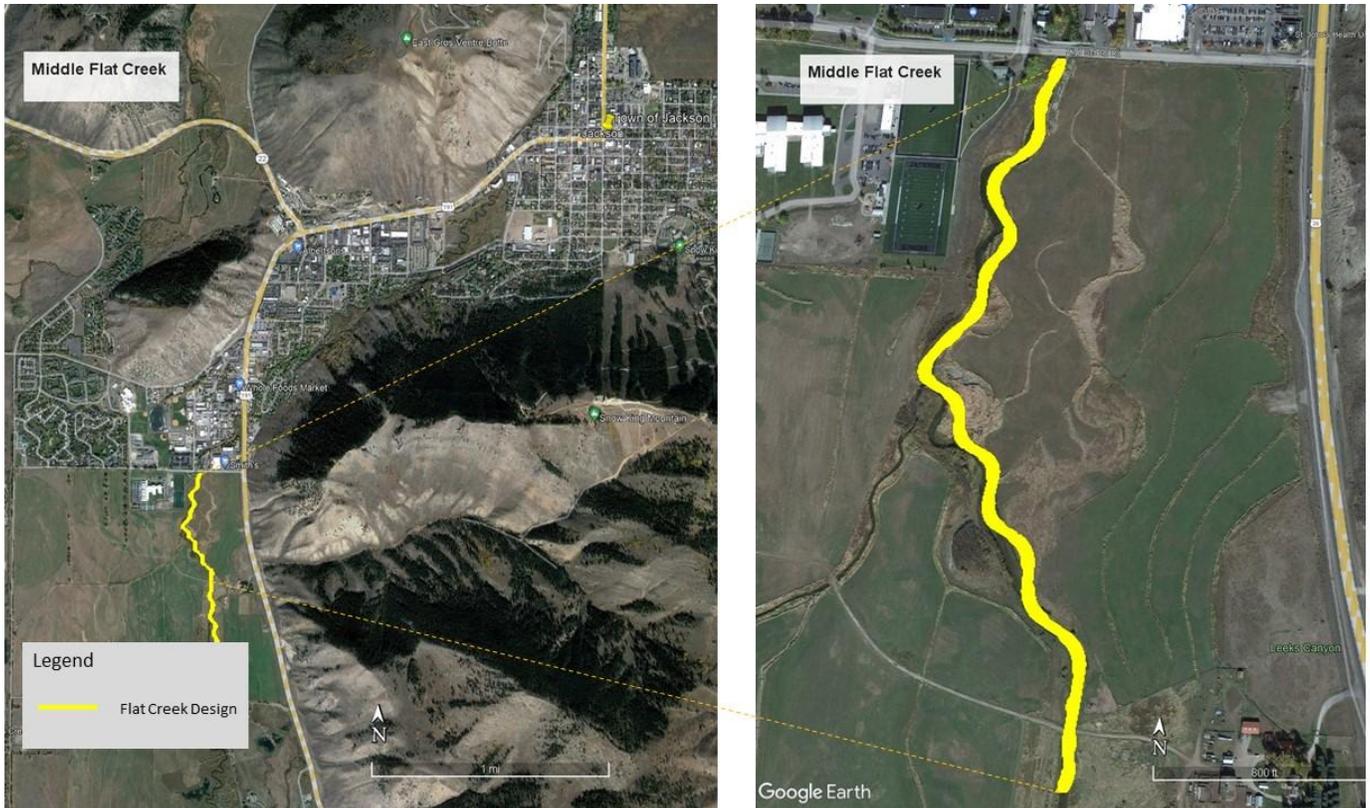
Figure 1. Middle Flat Creek Stream Restoration location and restored creek planform. Flat Creek upstream from the ranch bridge bisecting the project area is the location for in-stream work October 2022 – May 2023.

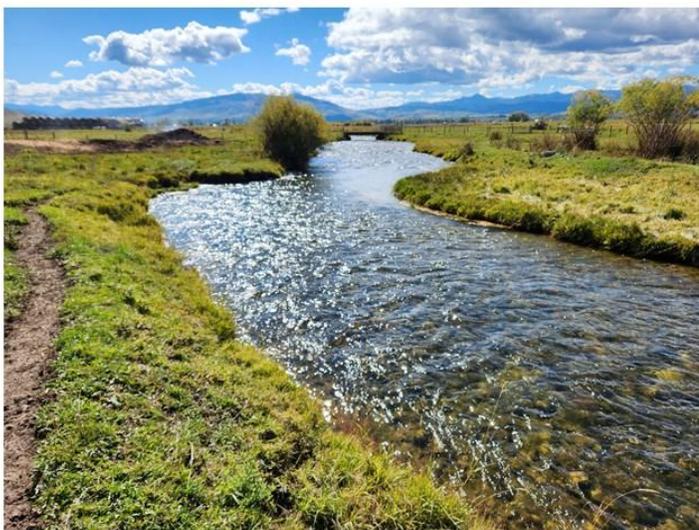
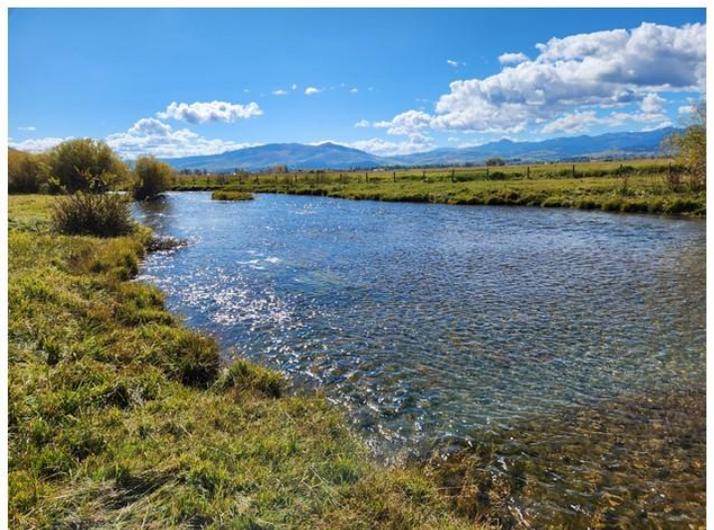
Photo1. Middle Flat Creek pre-construction. This reach was shallow and over-widened through the majority of the reach.

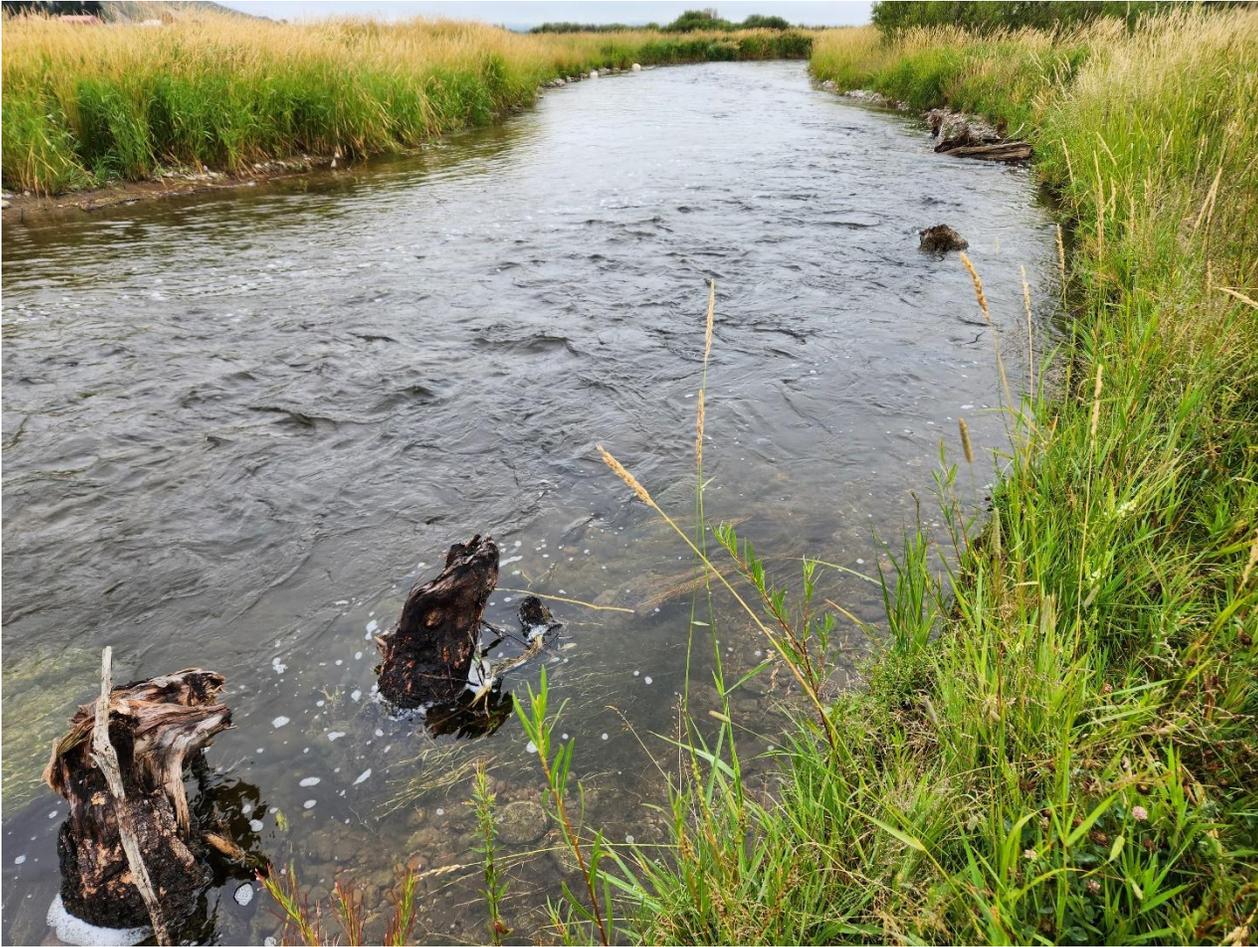
Photo 2. Post construction banks on Middle Flat Creek. A toewood bank with a soil lift on top.

From the completion of construction in spring 2023 until July 2024 we have watched the new channel adjust from two bankfull events. Outside bends stabilized with toewood have held well during high flow events. Sod mats remain intact and woody riparian vegetation is showing promising signs of recruitment, and grasses adjacent to the project area ranging from 4 to 6 feet in height. Spawning gravels were excavated from pools and deposited in glides at multiple locations throughout the Middle Flat Creek reach. Additional riparian fencing was installed May 2025. Additional cottonwoods (40) were planted to increase vegetation with deep binding root mass. Post-implementation repairs were evaluated post-runoff 2025. Structural integrity of toewood, bankfull benches, and rock vanes was very high throughout the project reach. Structures will continue to be monitored on a bi-annual basis.

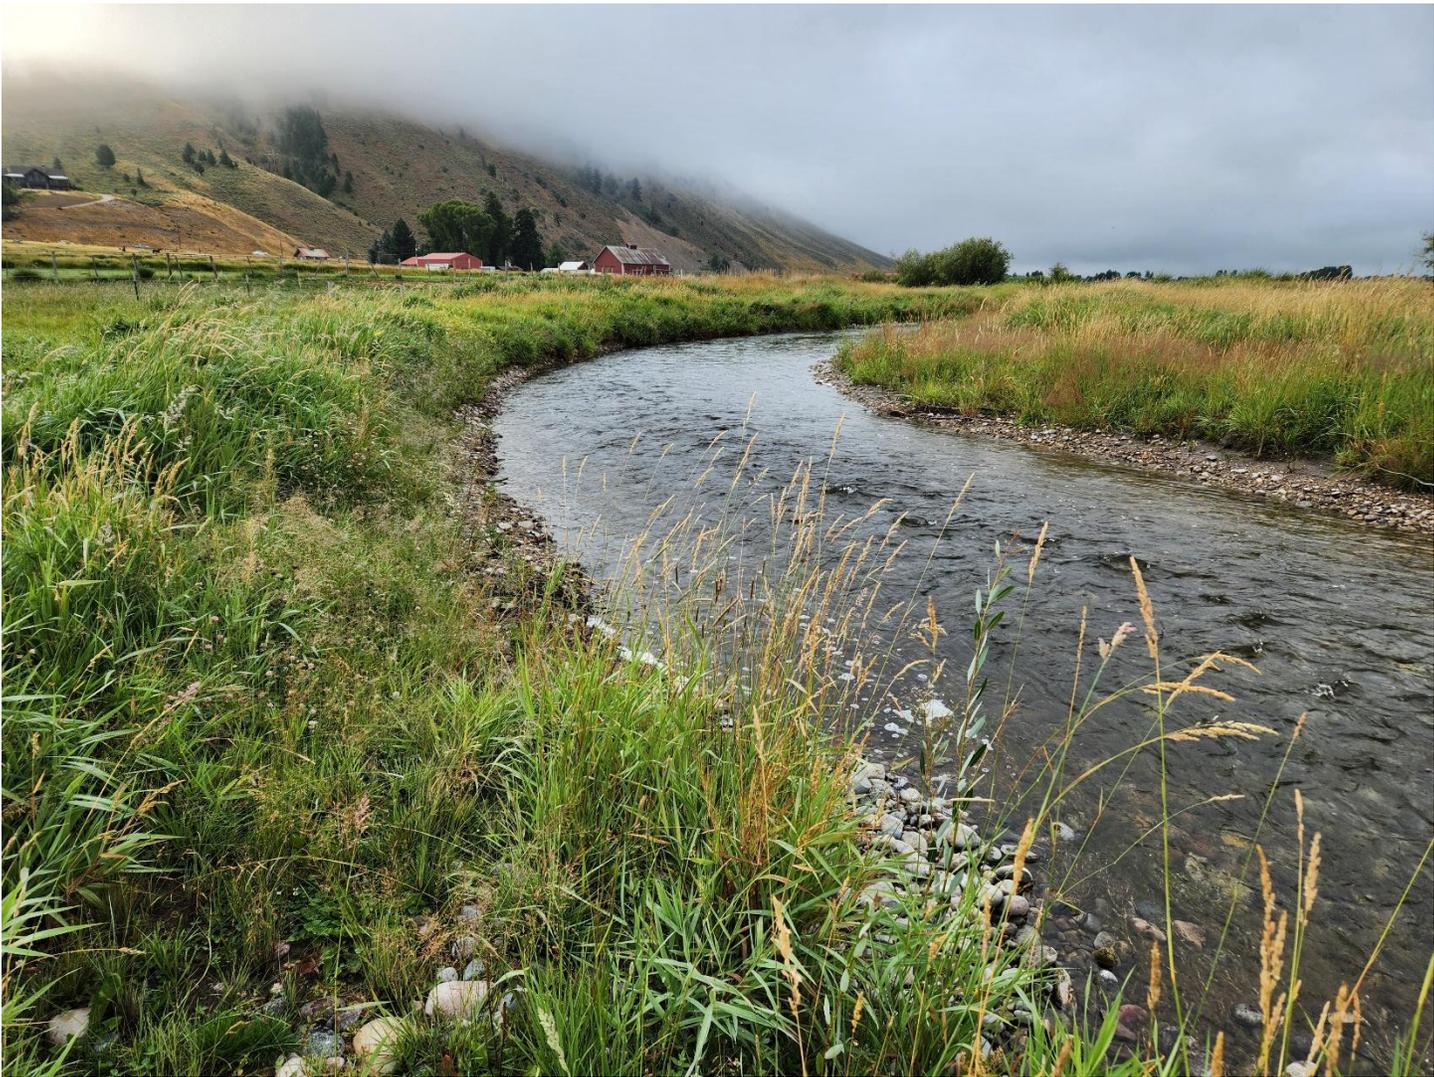
Photo 3. An outside bend with a rock toe below a point of diversion.

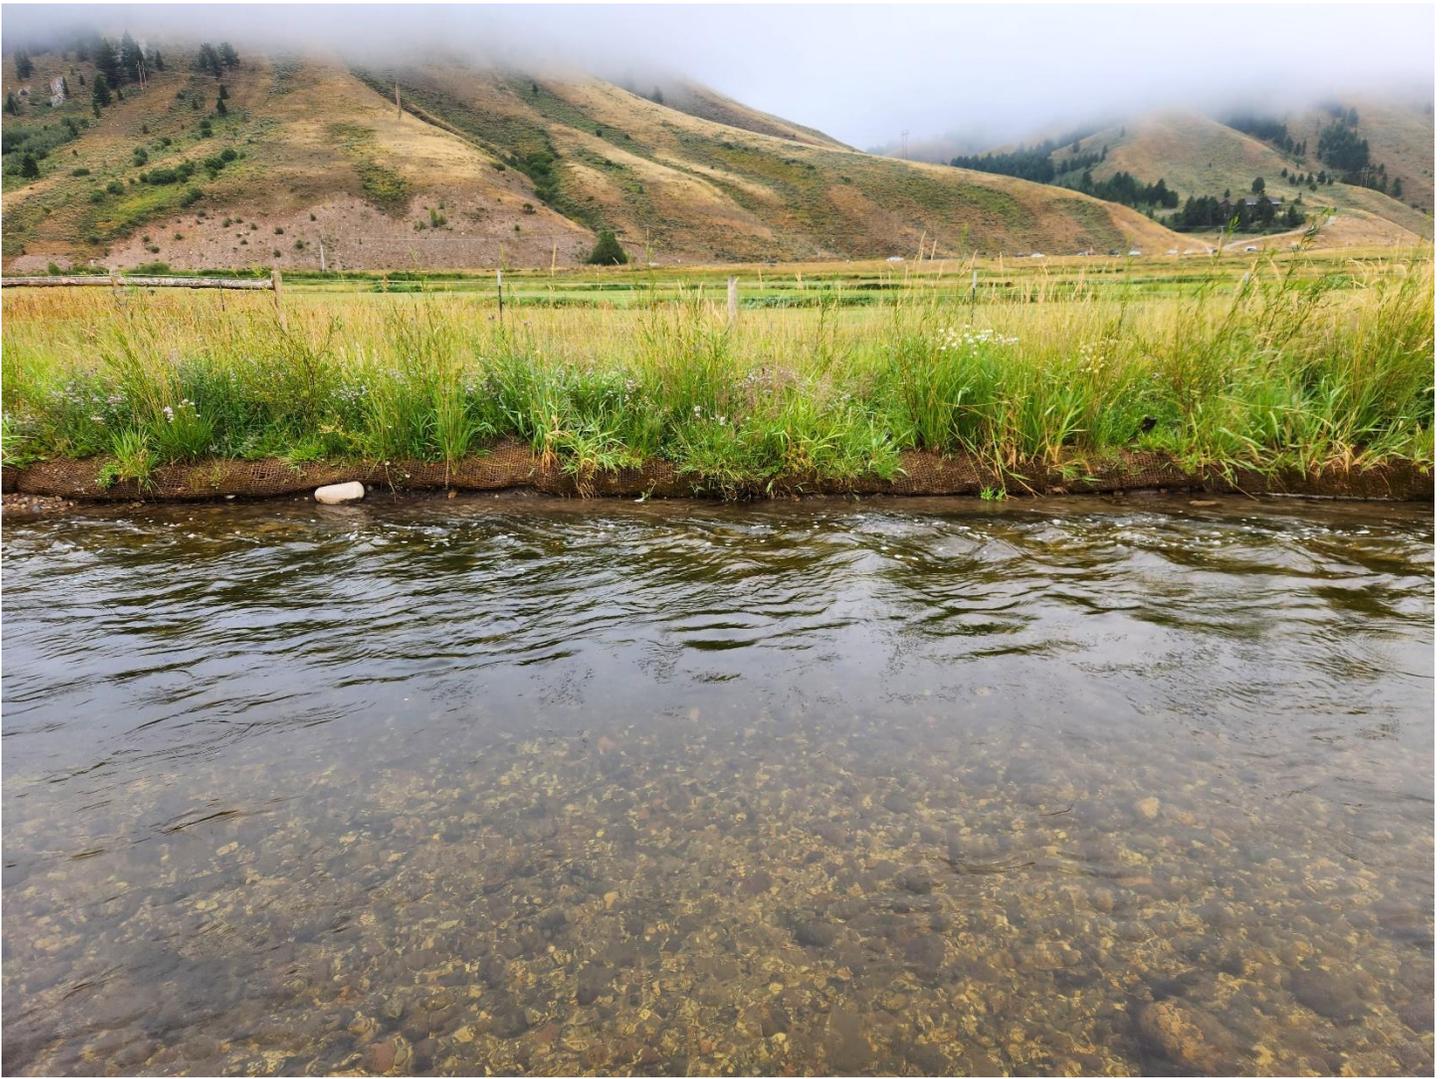
Photo 4. A soil lift shows a healthy vegetation response.
