Vermilion River Project #2

Miners Gulch Reach

2018 Post Run-off Monitoring Report

February 4, 2019

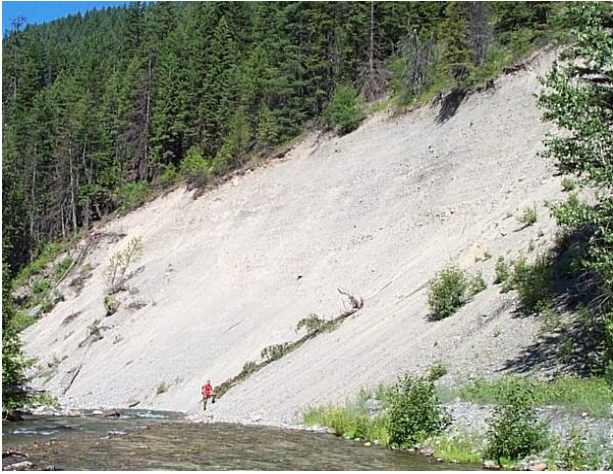
Figure 1.1 Chapel Slide 2005

Within the upper end of reach 6 was the Chapel Slide, a large (300' long, 140' high) mass wasting hillside that since 1997 has delivered roughly 700 tons per year of fine sediment into the Vermilion River. This site was the single largest source in the Vermilion drainage, accounting for over 80% of all bank derived sediment produced in Reach 6.

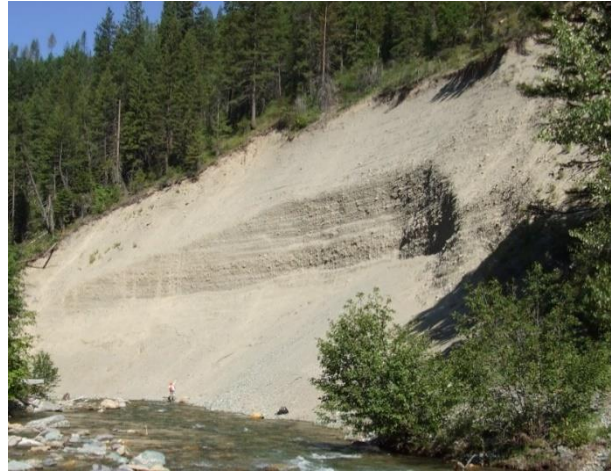
Figure 1.2 Chapel Slide 2009

Reach 6 had limited pool depth/frequency, poor substrate quality, and relatively little LWD. Sediment input from the Chapel Slide was thought to be adding to the altered spawning habitat in the next downstream Miners Gulch reach. In 2008, a year of above average runoff, approximately 7100 tons of fine sediment was lost from the slide area and thought to have partially deposited within the Miners Gulch reach below.

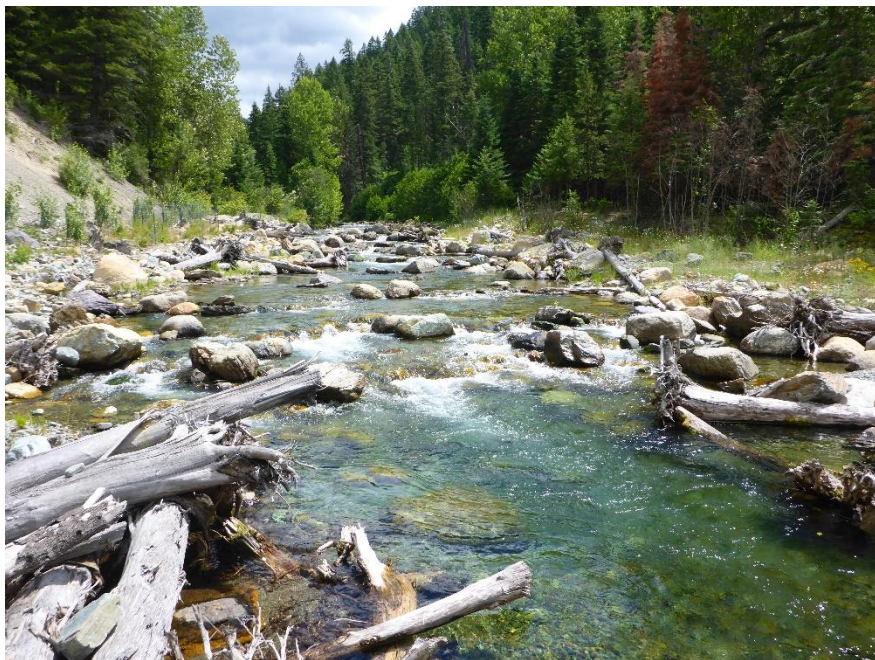
Figure 1.3 Chapel Slide restoration reach in 2018, 6 years post project.

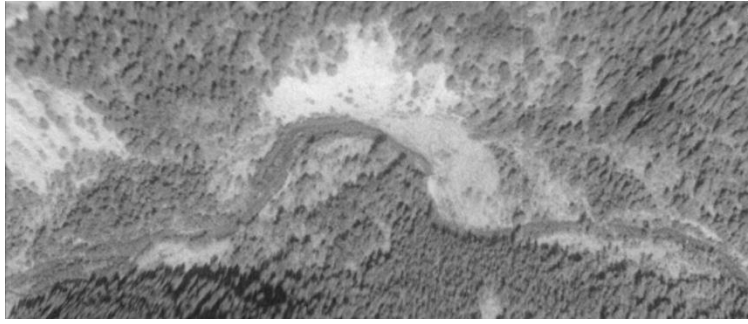
Figure 2.2 Miners Gulch reach 1995

The magnitude of flood flows of the 1996/97 season approached 60 year return interval flows in other gaged basins in the Lower Clark Fork (USGS, 2018). Runoff of this level was thought to have occurred within the project reach. During these events the majority of larger riparian vegetation was undermined and transported downstream. Historically it is believed that this site had a substantial amount of hydraulic placer mining which also removed riparian vegetation, in-stream wood and larger substrate. Figure 2.3 displays the Miner's Gulch reach in the summer of 2005. Figure 2.4 is a picture of the same area in the summer of 2009. Active lateral channel migration was noticed to be close to 400 feet during this period. The largest event within this time compared to a 6 year flood event with most flood peaks averaging 1.5 year bankfull flow or slightly larger (Figure 2.1). These types of flood flows are considered maintenance flows within reference watersheds in and around the Kootenai National Forest. Floodplain vegetation consisted of 12 year old cottonwood and willow saplings. Prior to these events, this vegetation was thought to be reestablishing the floodplain area and naturally providing for bank stability. These more recent lesser events allowed for the majority of this vegetation to be undermined, displaced and transported downstream, repeating the cycle that occurred 20 years prior by way of lower magnitude flows.

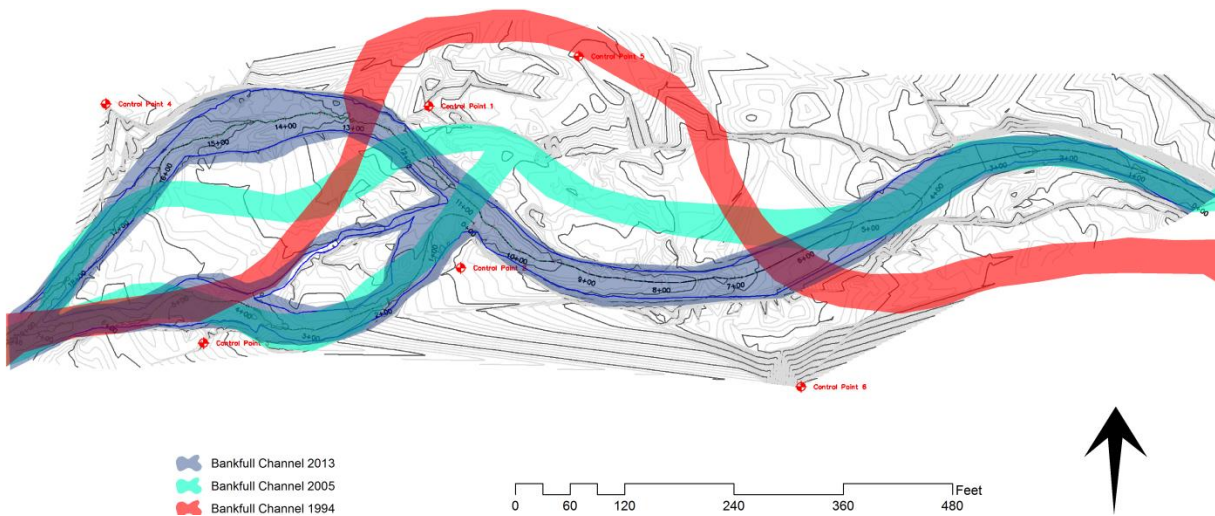
Although the pre-restoration channel dimensions within the Miner's Gulch reach, in terms of morphological variables such as radius of curvature (R_c) and meander wavelength (L_m), were within tolerable limits, other channel metrics such as the entrenchment and width to depth ratios, which are often used to evaluate sediment transport and floodplain accessibility, were not. These values displayed a departure from stable reference conditions. Where high w/d exist, such was the case within portions of the Miner's Gulch reach (Figure 2.0), a decrease in stream power added to channel aggradation and accelerated lateral channel migration.

Figure 2.5 Changes in channel geometry over a 19 year period in the Miner's Gulch Reach

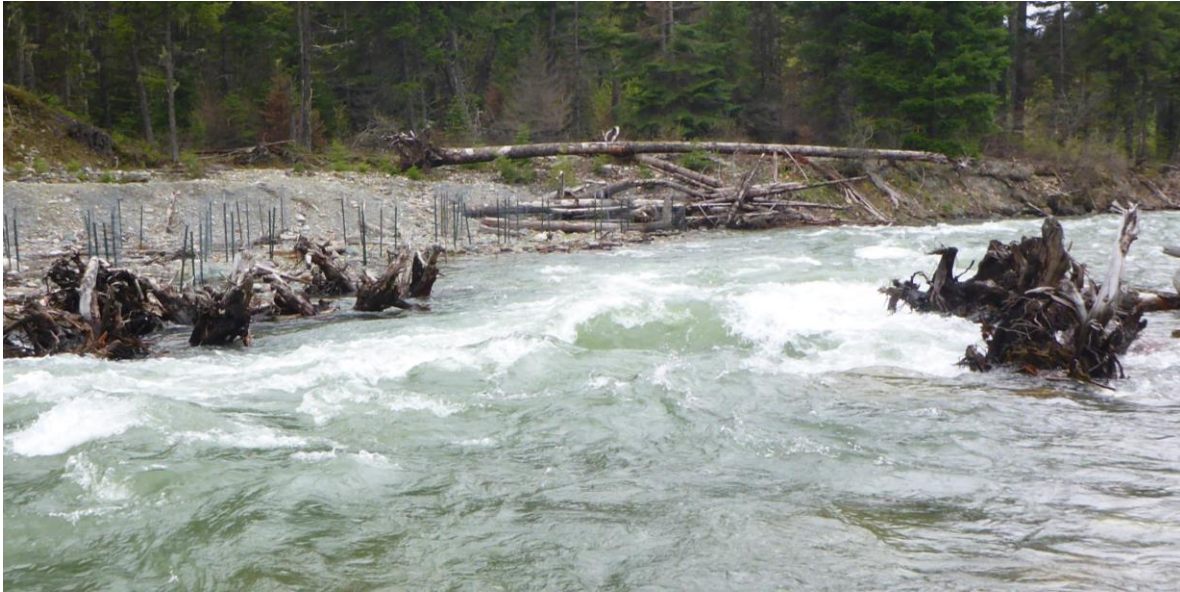
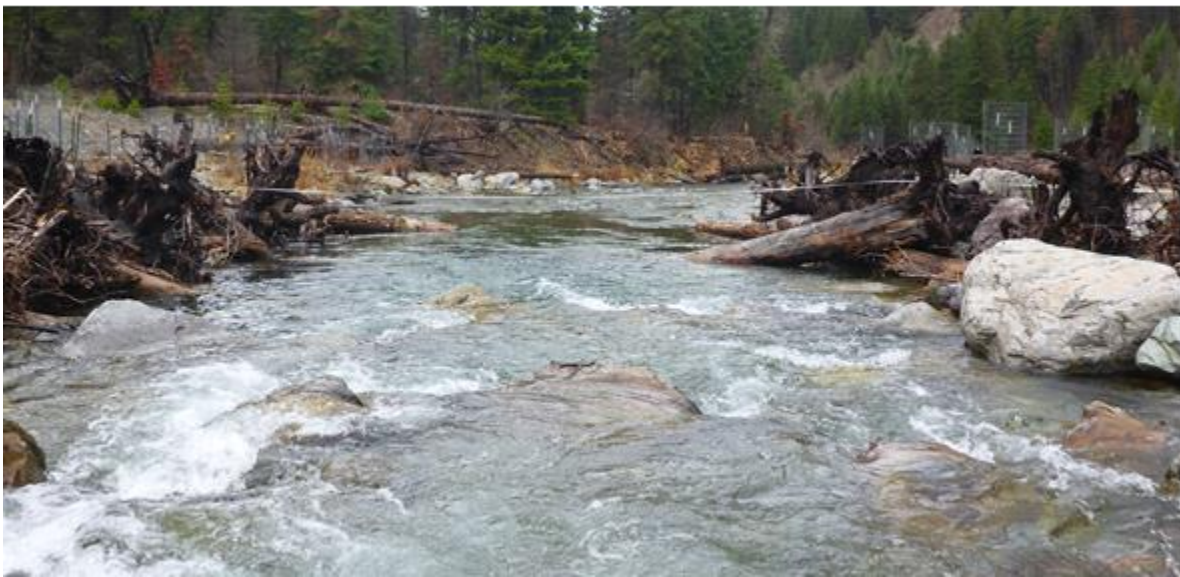
Toward the end of November a rain on snow event occurred that elevated baseflows to roughly half bankfull. A similar event occurred towards the beginning of February. For the remainder of the year an average runoff occurred. Peakflows related to the highest event surpassed the bankfull discharge for approximately 5 days. The peak flow of 2018 at the gaging station was 1,430 cfs, which equates to the approximate 3 year return interval flow ($Q_{2.1}$). Flows above the bankfull discharge were sustained for roughly 1 week in May within the project site. Peak flows at the project site approached roughly 850 cfs.

Figure 6.1 Peak flow runoff (top – May 2018) and low flow runoff (bottom – October 2018) at station 4+00

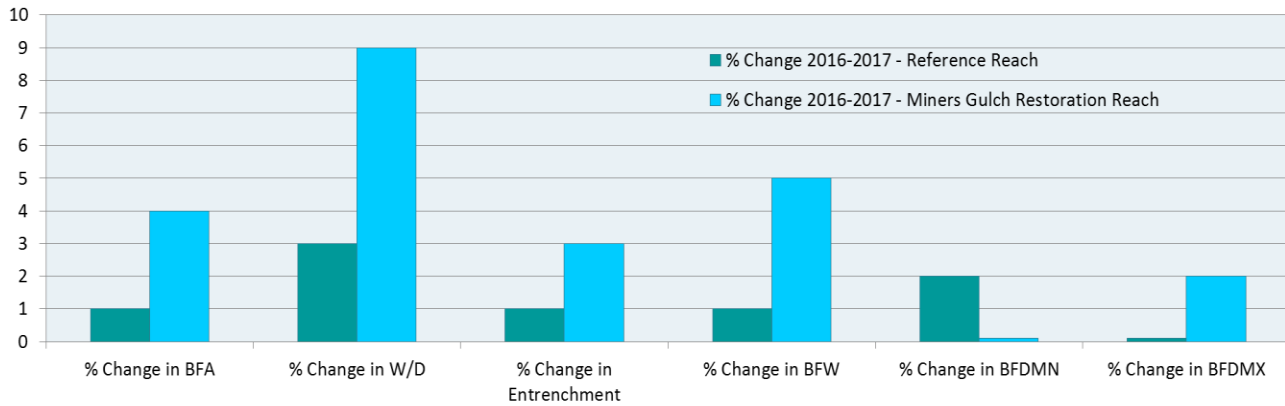
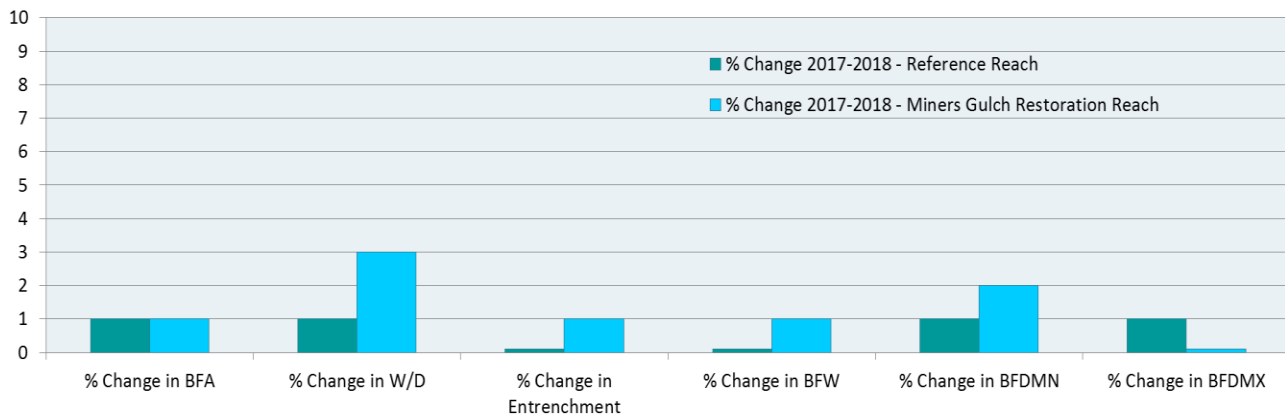
Figure 7.0. Dimension variable percent change within the project and reference reaches from 2016 to 2018.

As Table 7.6 suggests, no active channel succession is or has occurred within the project reach. In terms of channel dimensions the restoration techniques employed have proven effective in terms of maintaining a stable channel as designed that display minimal signs of premature transitions through two average runoff seasons. Pending no short-term high intensity flood damage, the planted riparian vegetation should continue to flourish and add to floodplain function and bank stability.
