WASHINGTON WATER PROJECT

Lower Wenatchee Instream Flow Enhancement Project

Final Narrative Report

July 31, 2013

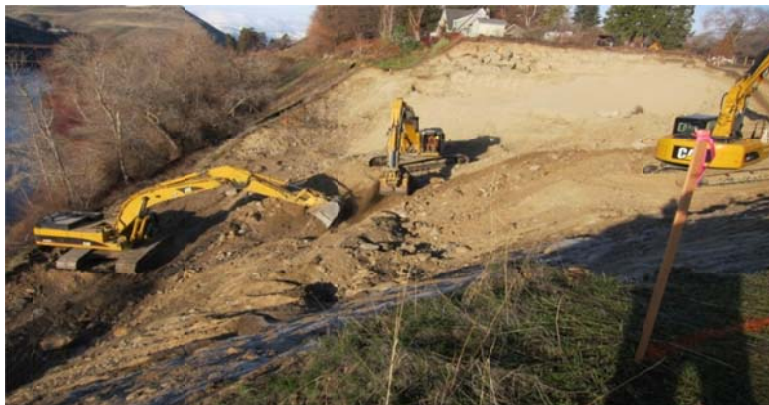
POW decided the first order of business on the Project was to prepare the pump station site and the mass excavation; with at least 7,500 cubic yards of dirt and rocks to move, POW kept four to five dump trucks moving through November. Often, the material was relayed with three excavators, moving the dirt and rock up the hill to be loaded into the trucks.

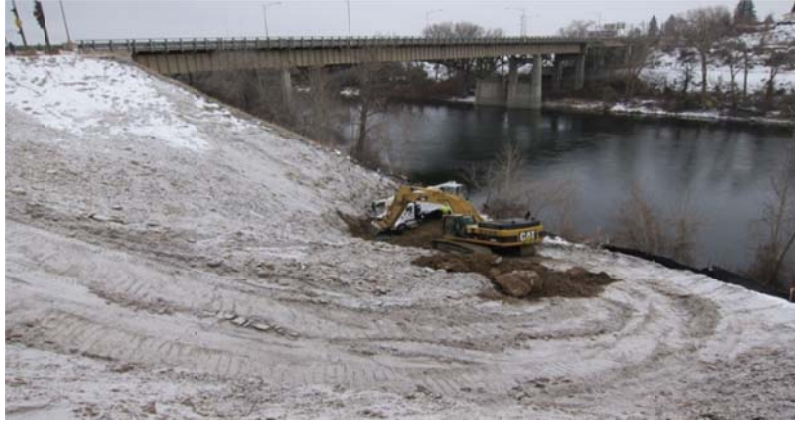
To keep the dust down, POW would use water trucks to spray over the work area. Every one worked very hard at keeping the surrounding neighbors happy and that included keeping the dust down and the mud off the roads. The material at the top of the mass excavation was sandy loam dirt, left from the last glaciation. As POW moved towards the bottom of the site and closer to the river they started to encounter larger cobbles and sand. At the bottom of the site they encountered some larger boulders and sandstone. The sandstone could have created a problem, but we were lucky and POW was able to work around it and get to the proper elevations and depth. The mass excavation came along very nicely and by December 14th, 2012 POW had an access road down to the river.

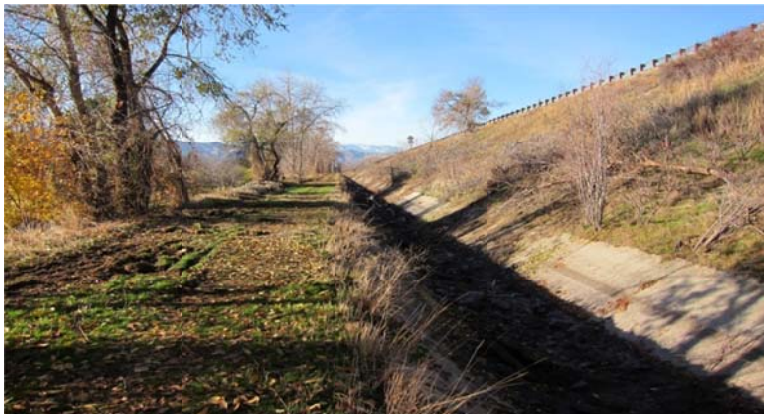
Concurrent with the mass excavation, POW had a crew working on grading and backfilling the existing earthen channel along the entire six miles of ditch on the North River. This included removing some concrete sections of the ditch and a few sections of pipe.

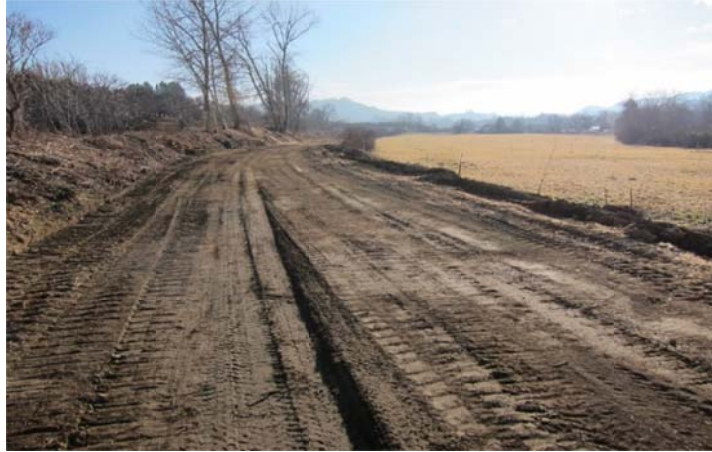
POW graded the ditch first to create room to work. This work included being able to stage HDPE pipe and the extra room was valuable for running the HDPE welder and other equipment on PWUA right of way.

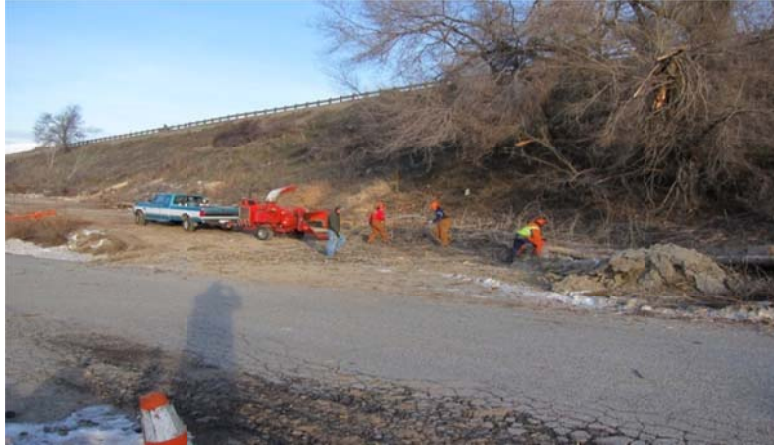
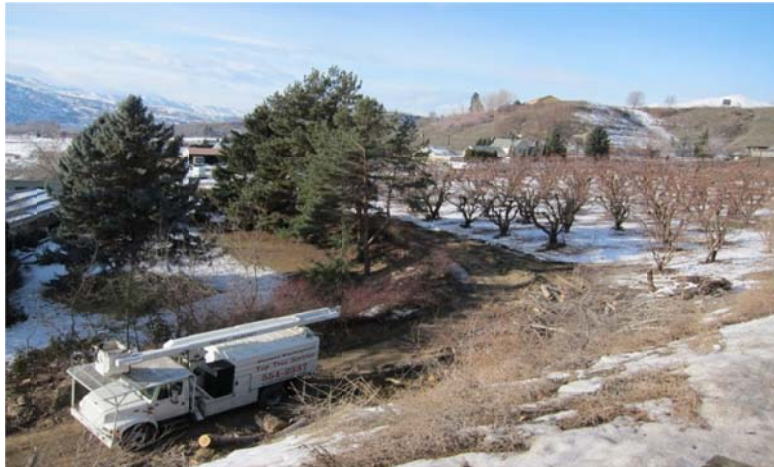
HDPE pipe was the preferred product for this application and was used on the entire Project. With the ditch graded and the trees removed, POW was able to start welding the HDPE pipe. The first 2,500 feet of pipe would be pulled through the existing 3-foot by 4-foot concrete box culvert. The box culvert was utilized on the first section of the new mainline because of issues with bank stability and steepness of the adjacent slope. The recommendation was made by the hydrogeological consultant on the Project, who ultimately determined that disturbing the slope would cause unnecessary harm. This made more sense when the pipe could be sleeved through the culvert instead. In preparation, POW had a crew go through the entire length of box culvert and clean out all rocks, debris and any other sharp objects. This was a precautionary measure to insure that while sleeving, the pipe there would not be damage; HDPE is heavy-duty stuff but it was better to be certain no damage would occur during the long sleeving run.

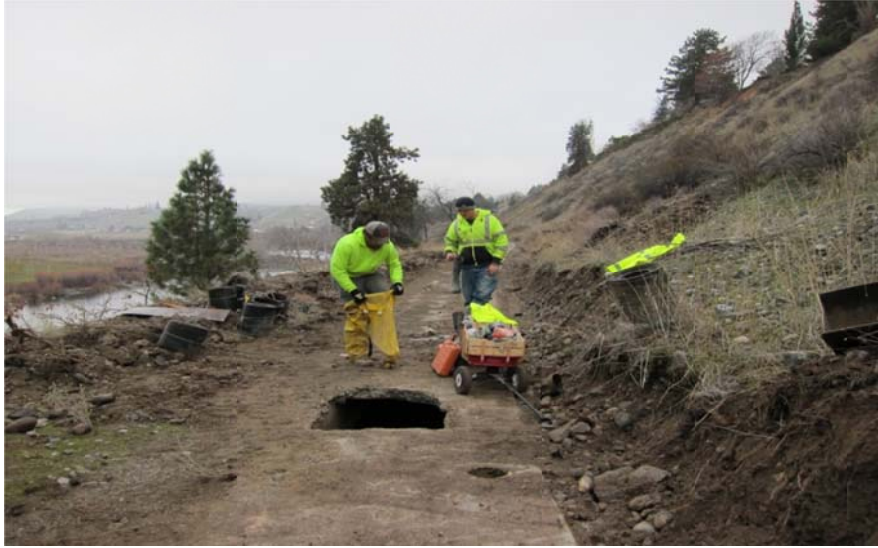
After this was complete, the crew would push 700 feet of pipe through the culvert at a time, using an excavator with a large strap around the pipe. Incrementally, they would push the pipe 15 feet at a time then readjust the strap and push again until they were completely through.

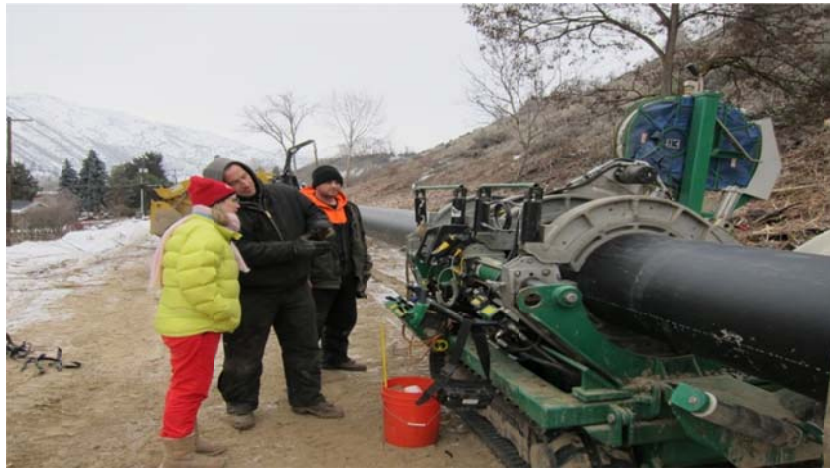
The five miles of pipe beyond the box culvert was installed in a similar fashion; the crew welded 700 feet at a time and then, moved and dragged the pipe into place with a track-hoe. The bulk of the welding started in January and with this amount of pipe to weld together POW had two welding machines going at the same time. The pipe sizes ranged from 24 inch at the pump station and scaled down to 8 inches toward the end of the system, near Monitor. After it was all complete and welded together it was one continuous piece of pipe from start to finish.

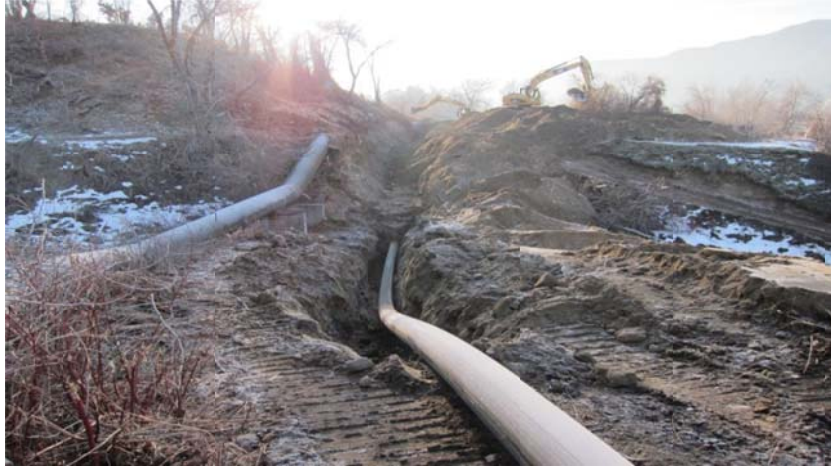
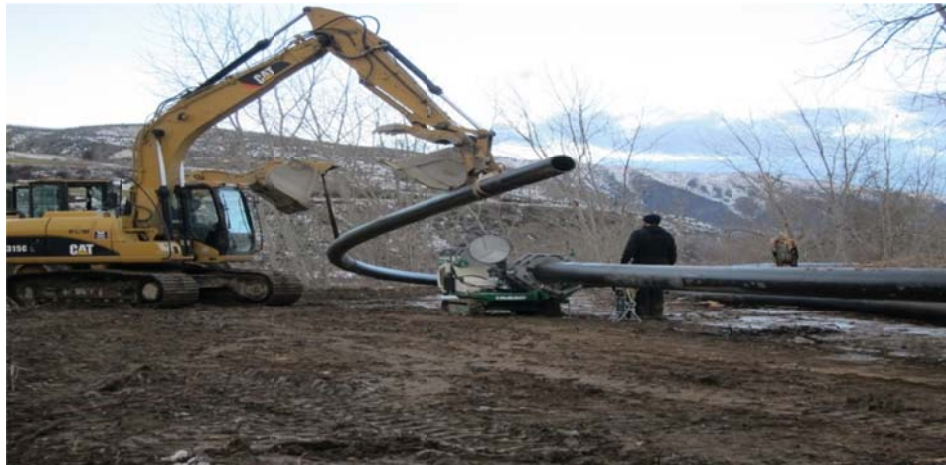
On the left- 3 foot steel pipe from the old gravity canal system, on the right is the new 14 inch HDPE pipe being installed.

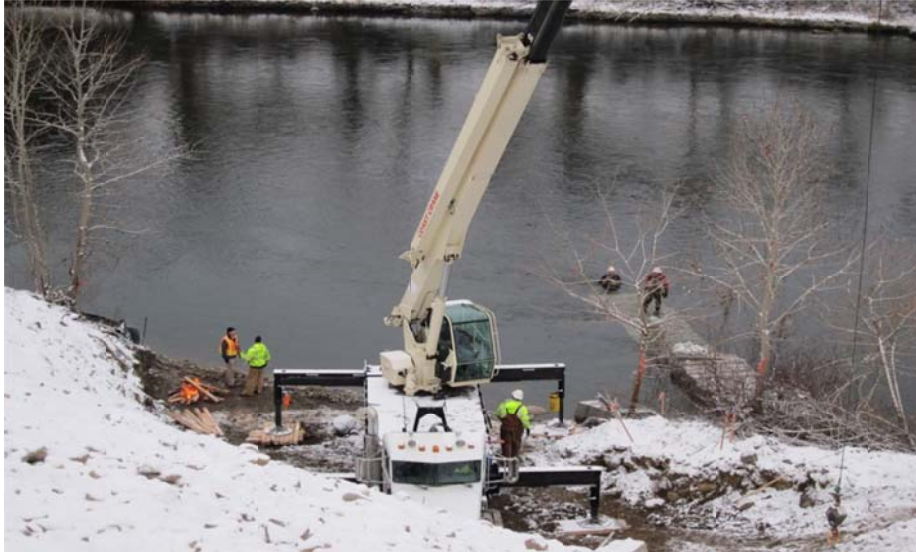
Initially, POW was going to use a product called Porta Dam. Porta Dam uses plastic sheeting and steel bracing to construct coffer dams. For multiple reasons, POW decided to go with ecology blocks to build the coffer dam. To accomplish this they brought in a 30-ton crane to set the ecology blocks, 275 of them in all. After the ecology blocks were set, they used landscape fabric as the inner shell to protect the 12 millimeter plastic sheeting that was placed as the outer shell. This proved to be effective in keeping “most” of the water out of the work area.

With the mass excavation done and the temporary road down to the river, it was time to start the construction of the coffer dam. The coffer dam was needed to install the fish screen, the suction line and suction header.

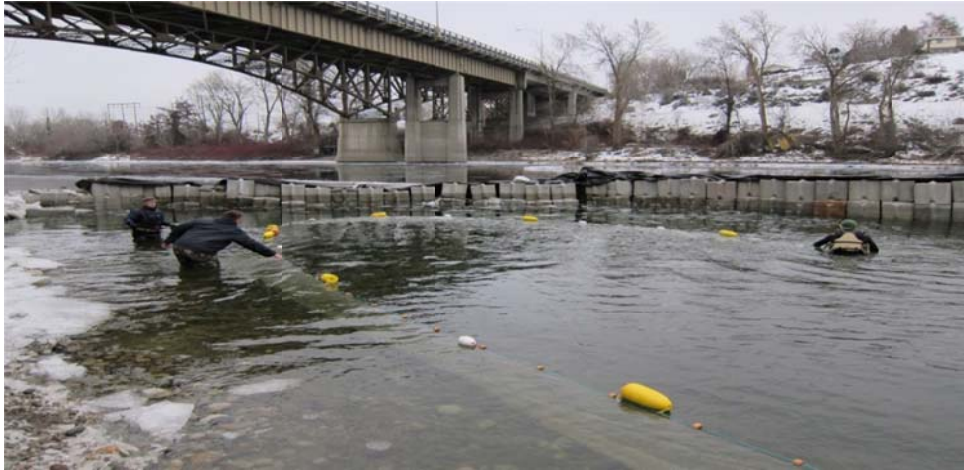
As you can see in the above photo, the crew was working in some pretty challenging conditions; the temperature was in the low to mid 20's. Three biologists were onsite and conducted the fish removal with assistance from divers working on the coffer dam. Fish capture gear onsite included beach seines, various sized fish nets (long handled and small mesh minnow nets), and buckets.

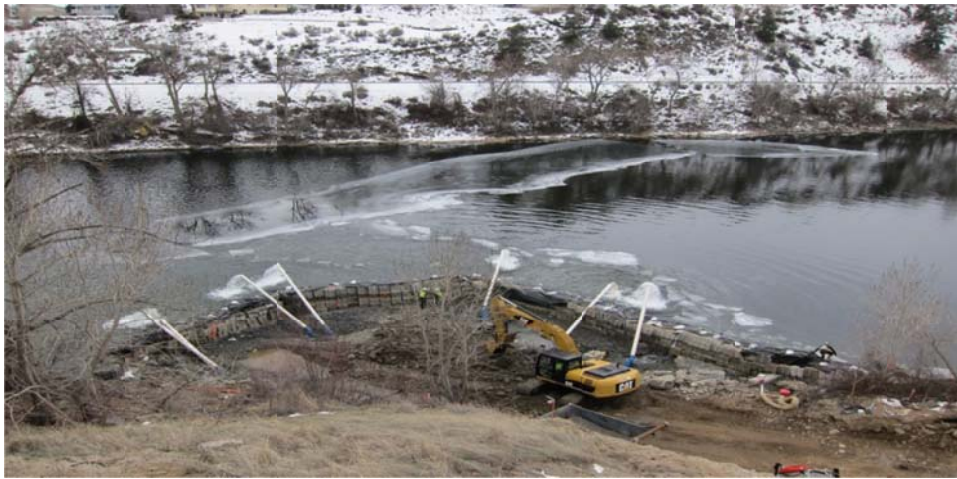
With the fish removal done the dewatering of the coffer dam could take place, for this POW used eight submersible pumps to accomplish the dewatering. POW chose to go with temporary power from the local PUD instead of diesel generators for two reason; the cost of diesel and the noise that the generators would make. It was challenging getting the pumps in the right location and POW took sometime to evaluate locations of the incoming wate; in the end it was a success.

The isolated area required 8 pumps to keep the work area dry and to insure a manageable work environment. Each pump was capable of pumping 1500 GPM, totaling approximately 12,000 GPM. The pumps ran 24 hours a day for about 12 days; POW would check the system twice in the middle of each night to insure there were not any problems.

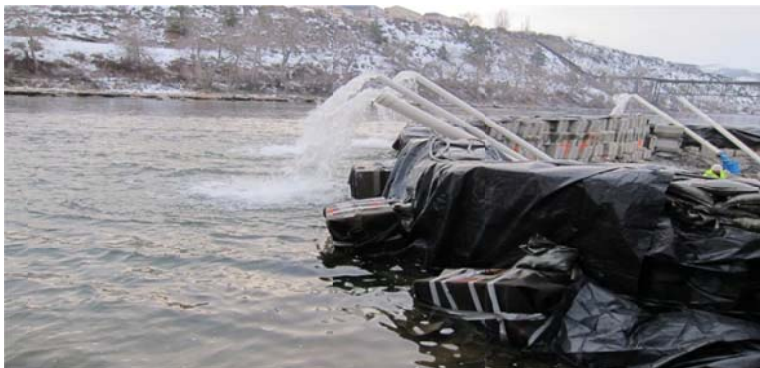
After the dewatering was complete, it was time to set the fish screen, suction line and suction header. This proved to be a very time consuming process, due to the depth of the suction line and the rock that POW was encountering during the excavation of the fish screen and suction line trench. POW, Forsgren and TU-WWP worked well into the night to set the fish screen. The team accomplished the task at 1:30 am Saturday morning January 19th, 2013. We were working against fluctuating water levels of the Wenatchee/Columbia Rivers due to Chelan Co. PUD dams water use/power demand during winter months and the work had to be conducted after 5 pm. This is when folks head home and crank up the heat, which begins the release of water for power each day/night.

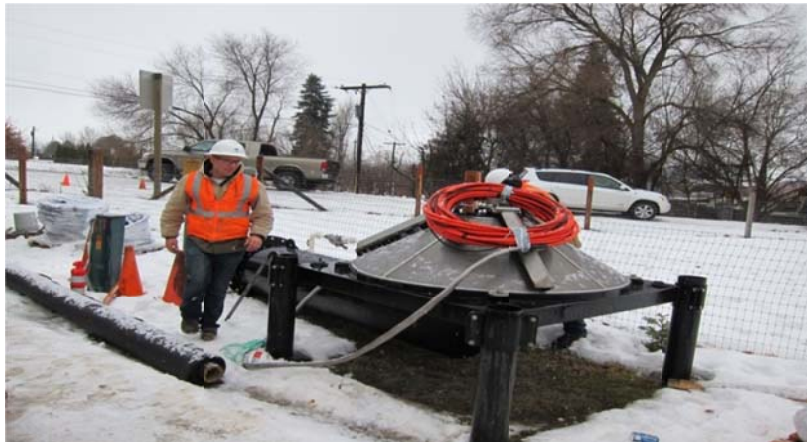
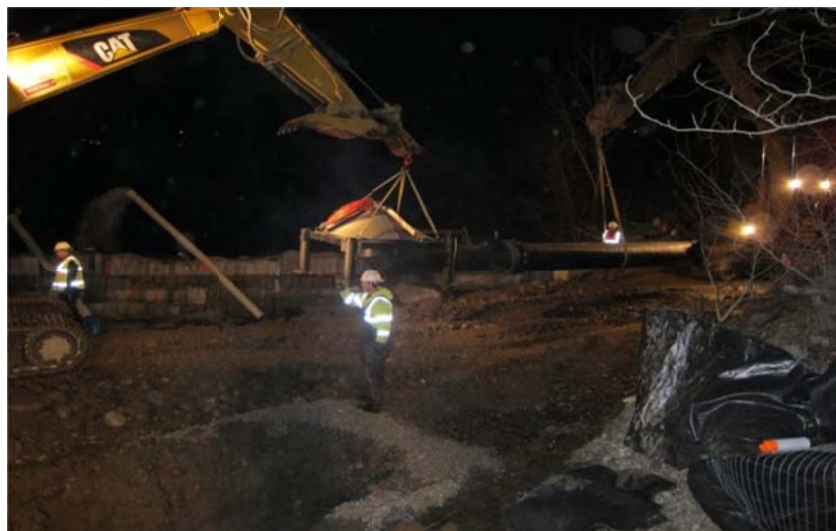
The fish screen is a low profile cone screen manufacture by Intake Screens, Inc. of California; a hydraulic driven motor is used to turn three rushes to keep the screen clean. The cleaning cycle is set on a timer you adjust to whatever is necessary to keep the screen clean (see **Appendix G**).

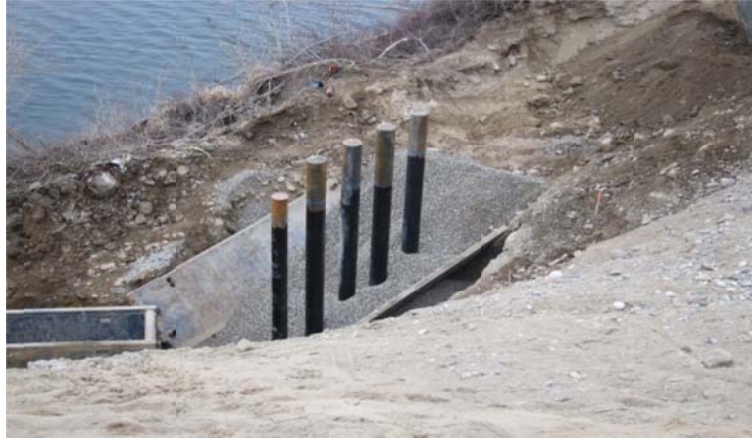
Near the beginning of March, with the fish screen and suction line installed, the pump house was next on the agenda. The construction of this went quickly, in no time POW had the footings and floor poured and the framing done.

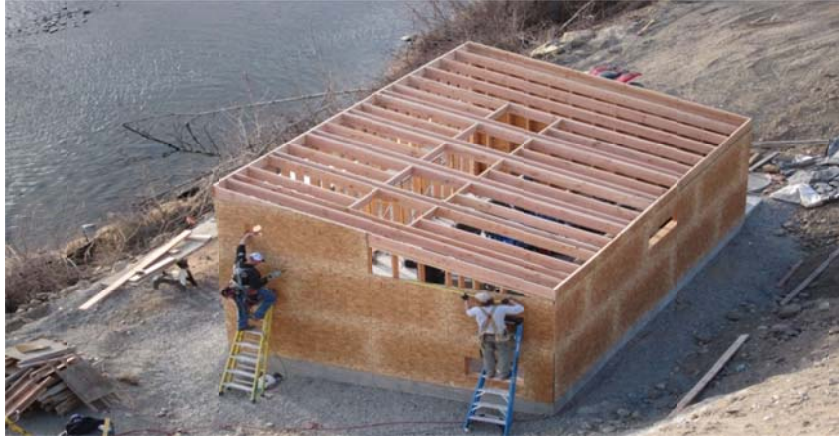
At the same time the construction of the pump house was being done, the heart of the system was also being installed; this consisted of all the electrical, including five VFD aqua drives (one for each motor, four 75 hp and one 25 hp); along with five vertical industrial turbine type Gould pumps. The 25 hp was installed to take care of low water use times when demand is under 250 gpm. Once the demand exceeds 250 gpm, a 75 hp will come on-line and the 25 hp shuts off.

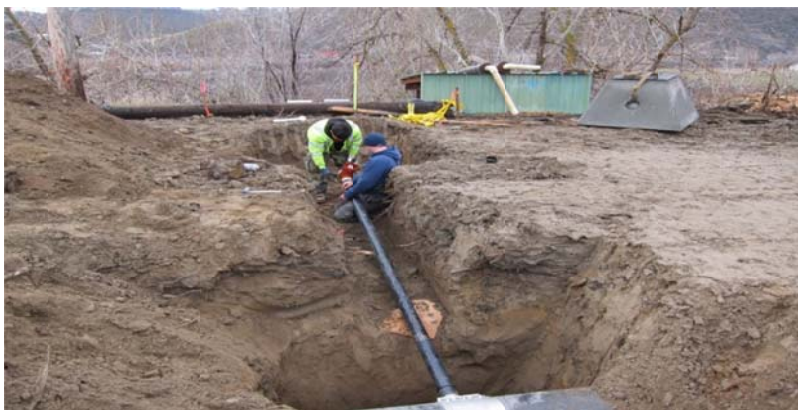
POW also kept a crew busy installing pipe along PWUA right of way. When close to 20,000 feet were installed, POW started a crew installing service connections right behind the pipe installation. In order for the system to work correctly, each service connection had to have a restrictor pipe installed. The restrictor pipe size was determined by the number of shares the property owner had; this was a way PWUA could control the amount of water each shareholder could use. This was a pretty straight forward process and POW crew worked through it in no time.

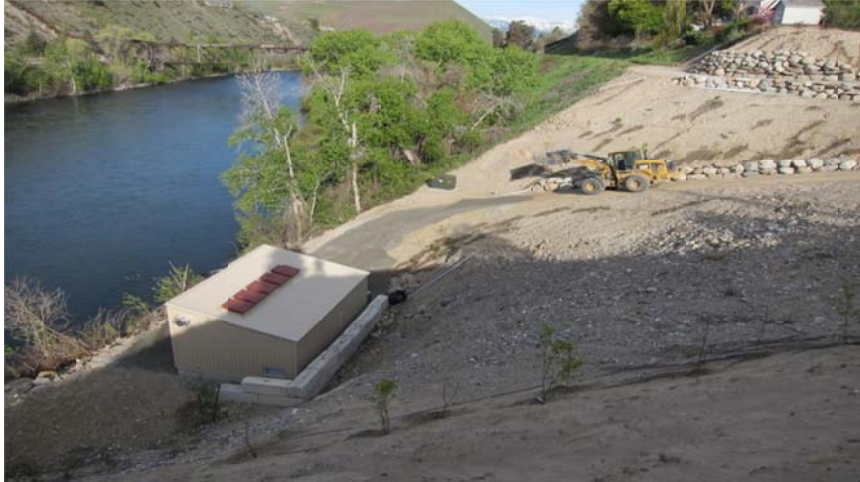
By the middle of March the pump house building was nearing completion, all the HDPE pipe was installed, and the services connections were close to completion.

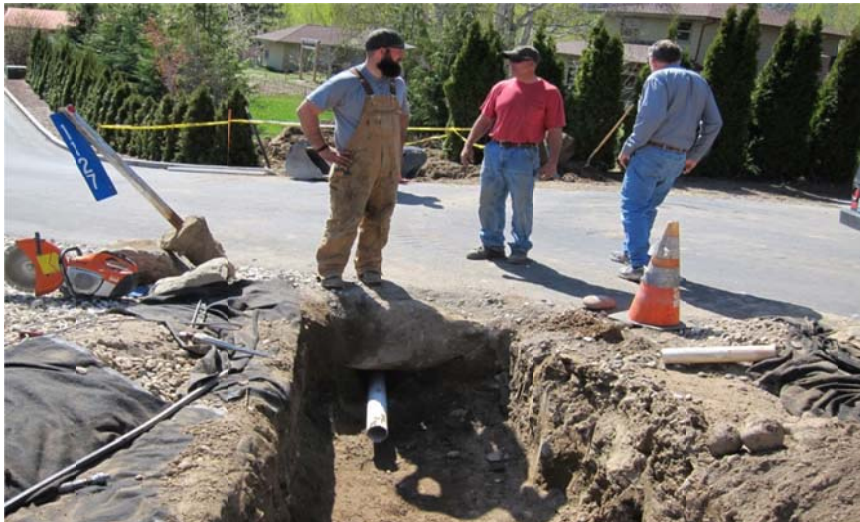
With the April 1st completion date just around the corner, POW had a few more things to accomplish. The road crossings for some service connections were one of the last pieces of the Project to complete and they created some challenges. Locating existing water lines was time consuming along the county road right-of-way but in the end the necessary four main road crossings were completed.

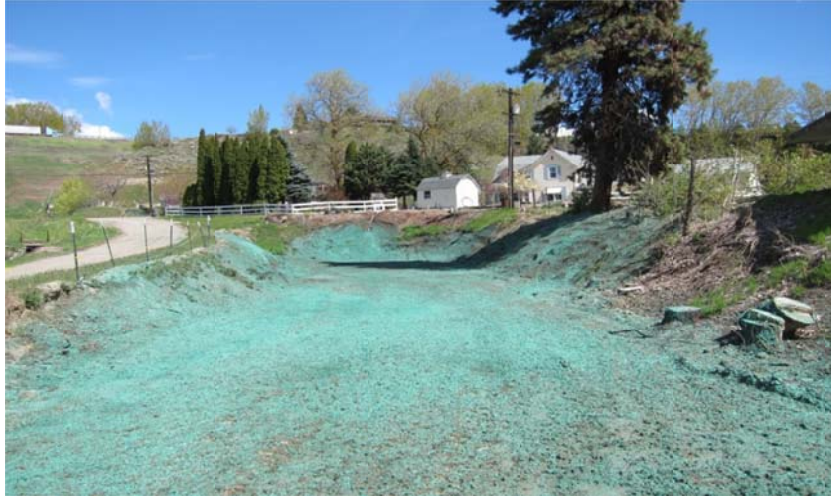
One of the last phases to be completed on north river side was the landscaping. Landmark was the sub-contractor for this work, which included hydro-seeding installing drip irrigation at the pump station. 230 trees and shrubs of 12 different varieties were planted at the pump station site. Along with the landscaping, a drip irrigation system was installed to keep everything watered. The crew then hydro-seeded the entire north river system from the pump house to Monitor; any ground that was touched by the construction of the new system was hydro-seeded.

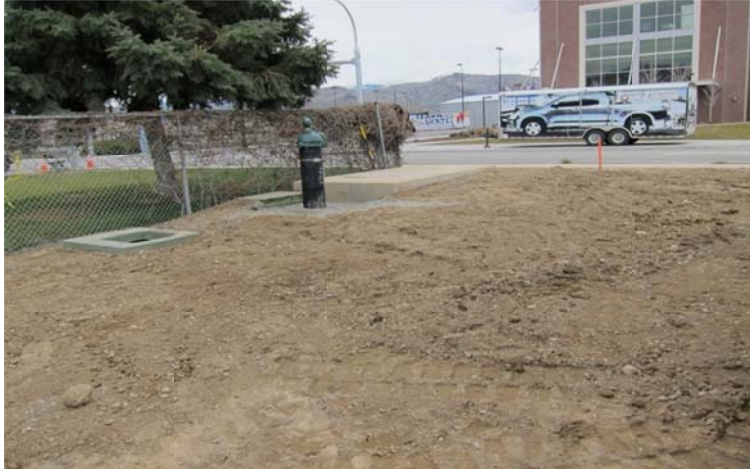
The Walla Walla satellite system was designed to take care of PWUA shareholders on the south side of the Wenatchee River, along Walla Walla Avenue. There are 29 shareholders on this system, which consists of an 84 foot well with a 25 horse power submersible pump. Alongside the well is a 11' x 5' concrete vault where the electrical panels, the VFD, aqua drive and the Siemens flow meter, with a total of 3,713 feet of 4-inch main-line.

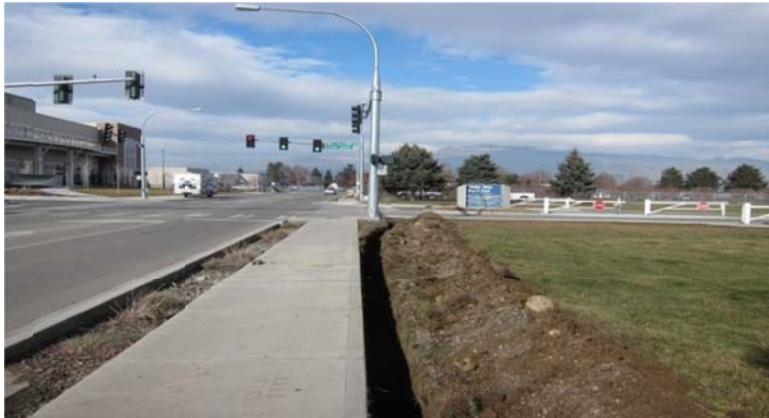
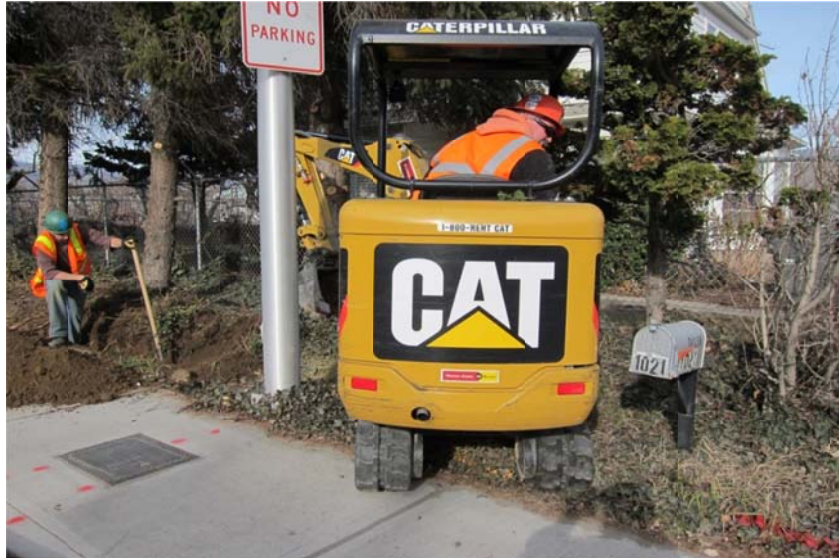
For the most part, the main-line was installed right behind the sidewalk at a depth of 18-inches. POW used a mini excavator to do all the work installing the main line, and hand shovels in the tight fit places. There was a lot of landscape, light poles and other objects to work around.

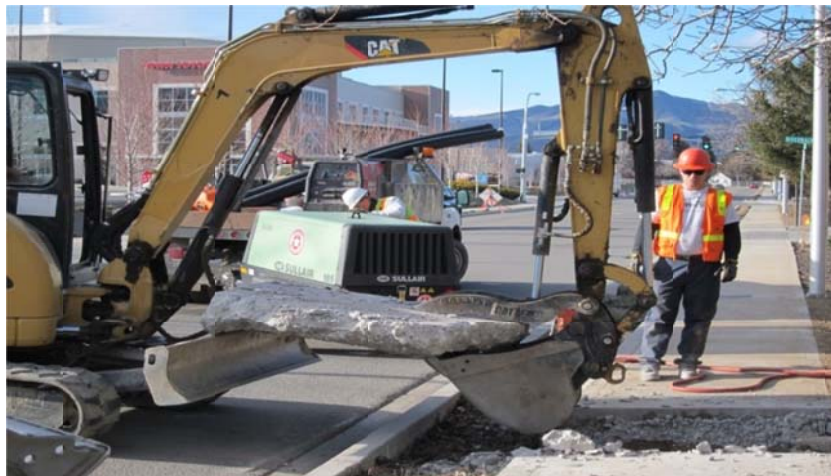
One of the challenging issues the crew faced on the Walla Walla project were the 10 road crossing. They were time consuming, particularly with consideration of the traffic on Walla Walla Avenue. POW would do half of the road at a time and then move the traffic to the opposite side while working. Once one side was completed, they moved over to the other side and changed the traffic lane. This proved to be an effective way to accomplish this part of the project. Every road crossing had a carrier pipe installed, which the mainline was placed through; this will help if PWUA ever needs to replace the pipe under the road.

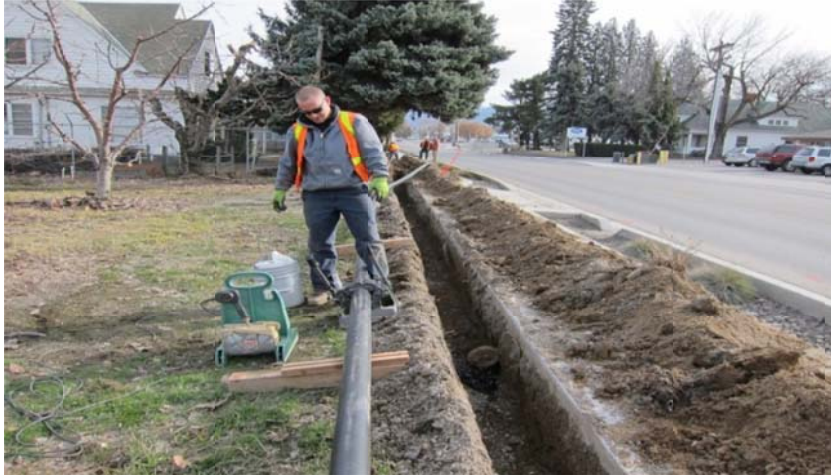
The Walla Walla HDPE was welded the same way as the North River project, except on a smaller scale. Basically, the crew welded the pipe in place, then put it in the trench and back filled. This worked out very well and the crew made good progress.

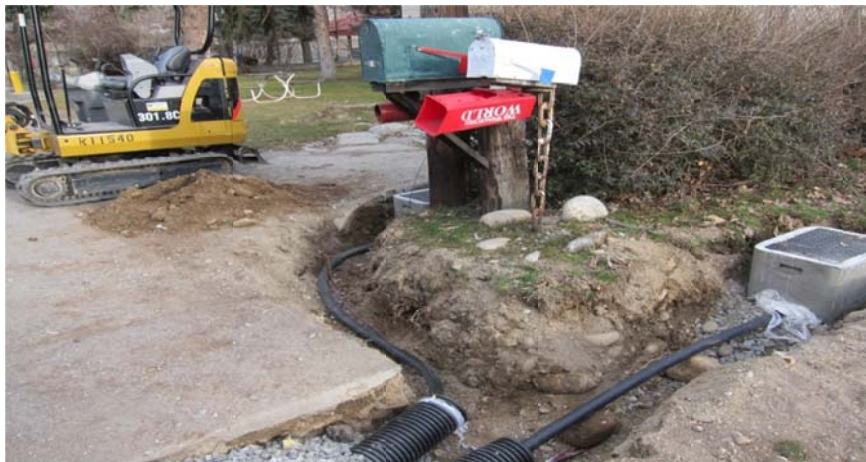
All service connections were installed in an irrigation box with a 2-inch gate valve with a restrictor pipe at each property owners' parcel. Like the North River project, the sizes of the restrictor pipe were based on shares, which correlates to irrigated acres.

TU-WWP was asked by the owners of the property where the pump vault is located to keep everything, including all the electrical panels, below ground in the vault. This meant the team had to install a larger vault to fit everything in, in which it was still a tight fit, but did effectively contain all the pieces.
