UPPER DESCHUTES
WATERSHED COUNCIL

**Re: Final Report for Whychus Canyon Restoration Project – Phase II
Award Number F17AP00508**

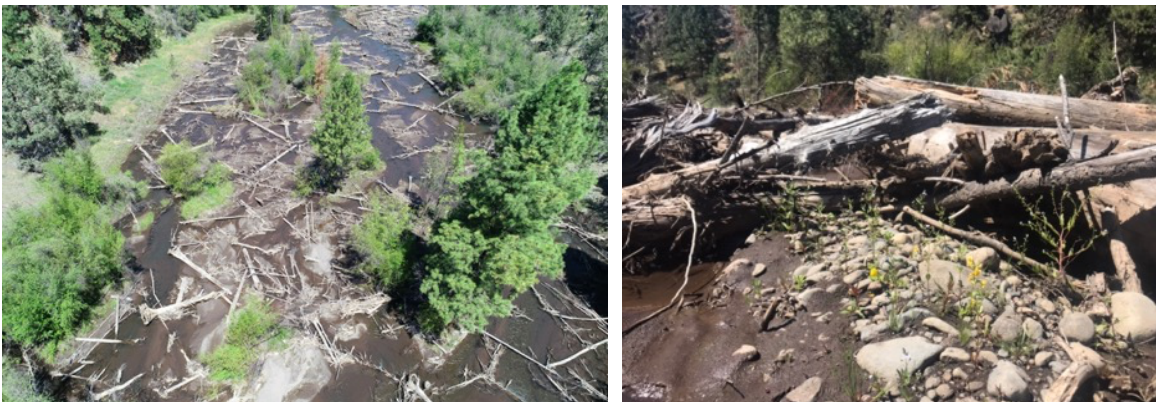
Figure 2. Whychus Canyon Preserve Phase IIa Restoration Summer 2021

Habitat restoration work under this grant has occurred both on Whychus Canyon Preserve and at Willow Springs Preserve, both owned by the Deschutes Land Trust. At Whychus Canyon, a half mile of valley wide restoration was completed in August, 2021 with some additional planting work in Fall 2022. The project removed the berms that hemmed Whychus Creek into a straightened half mile channel. The existing channel was filled while high terraces were cut down to surrounding floodplain elevations. The project will continue to evolve as high flow events lead to preferential flow paths developing across the valley floor. Some of the work included:

- Over 1,200 trees were used to provide floodplain roughness across the valley floor until native riparian vegetation takes hold.
- 35 pools were constructed or left on site to provide deep water habitat for fish until other pools form and evolve over successive high flow events.
- Floodplain connectivity and flood accessible wetland and riparian habitat was increased from 2 acres to 9 acres and over 30,000 riparian trees, shrubs, forbs and grasses were planted.

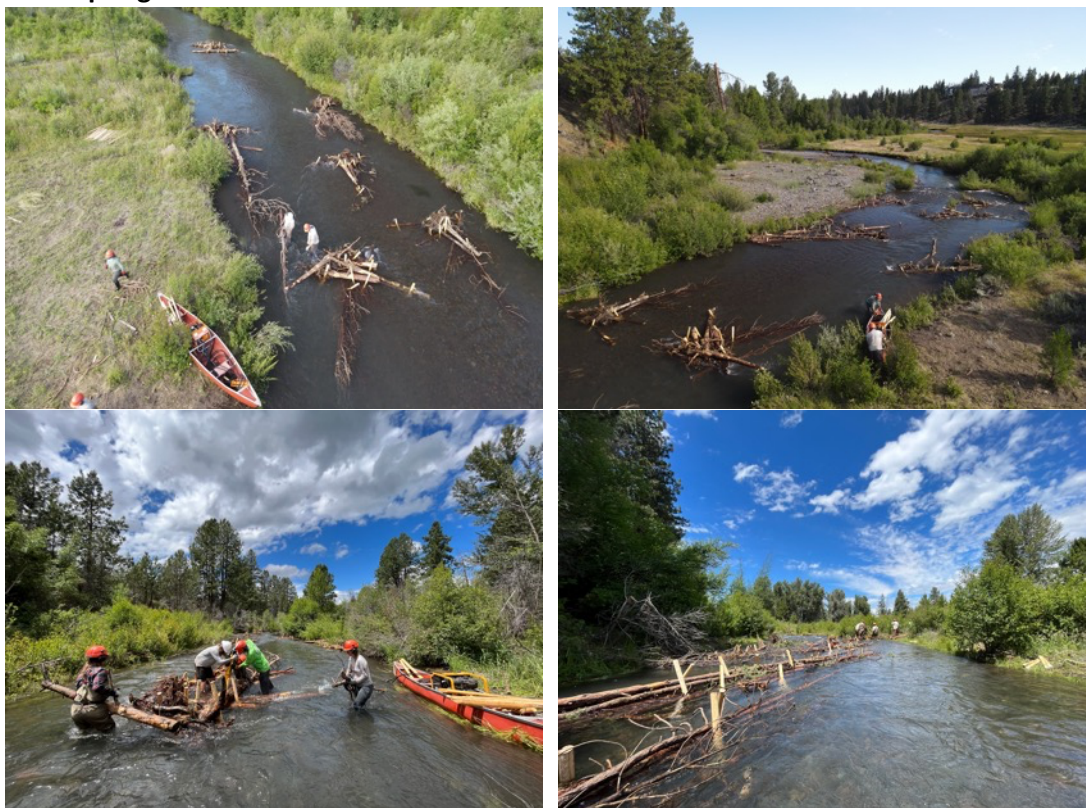
Figure 3. Willow Springs Preserve Phase I Restoration Summer 2022

- Over 900 trees were placed in stream and in the floodplain in hand-built structures pinned in by posts. 118 Pole Assisted Log Structures were constructed in stream and 28 Beaver Dam Analogs were constructed in the floodplain in 22 individual complexes.

- The channel length where this initial Phase I of restoration was completed was 0.75 miles.
- In Fall of 2022, over 3,400 riparian and wetland plants were planted within the project with additional plantings planned in successive years after high flow events affect change on the landscape as they interact with instream and floodplain wood structures.
