Final Completion Summary

The Middle Diversion Fish Passage Project is located is at RM 7.5 on Deep Creek near the town of Adel, Oregon. The goal of project was to address fish passage and habitat limiting factors leading to the recovery and delisting of Warner sucker, and population expansion for Warner Lakes redband trout. The transfer of four water rights from the diversion and the implementation of two necessary irrigation turnouts, provided the means to remove Middle Diversion concrete weir in its entirety. The removal of the Middle Diversion in October of 2022 was a strategic action to support a connected watershed as it marks four of six irrigation diversions addressed for fish passage on Deep Creek since 2019.

Deep Creek Middle Diversion

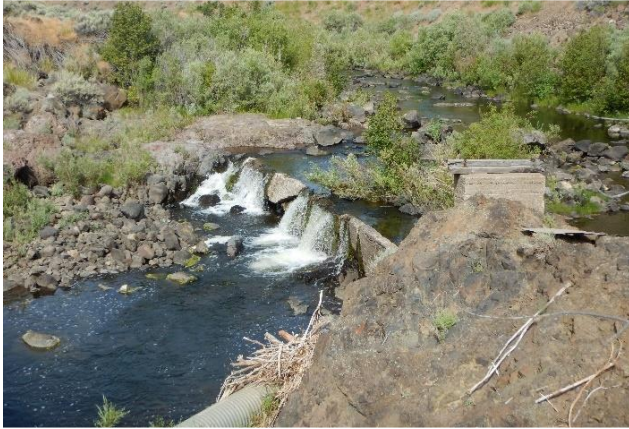
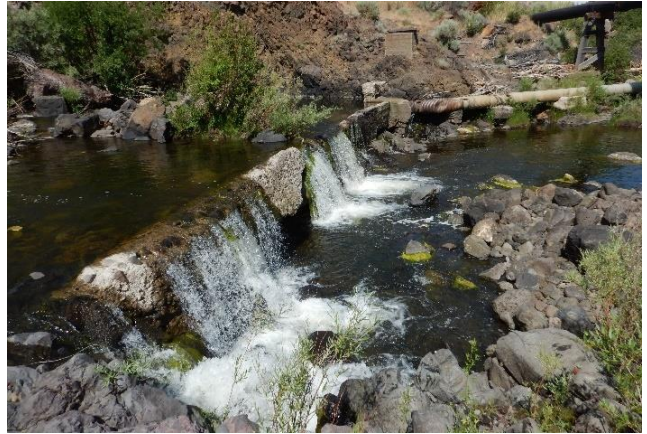
Figure 1. The Middle Diversion from the river-left bank (left), and the river-right bank (right) taken during the 2019 survey.

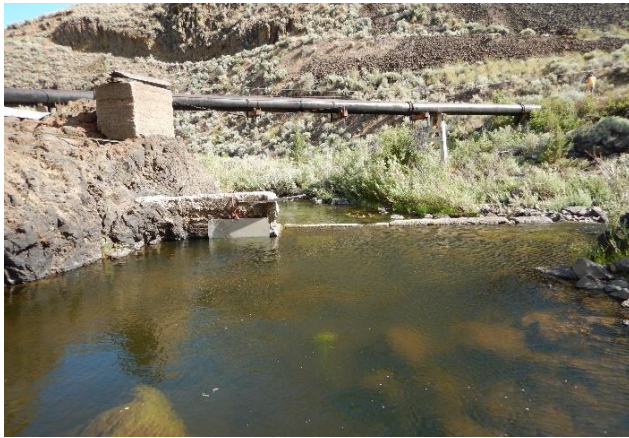
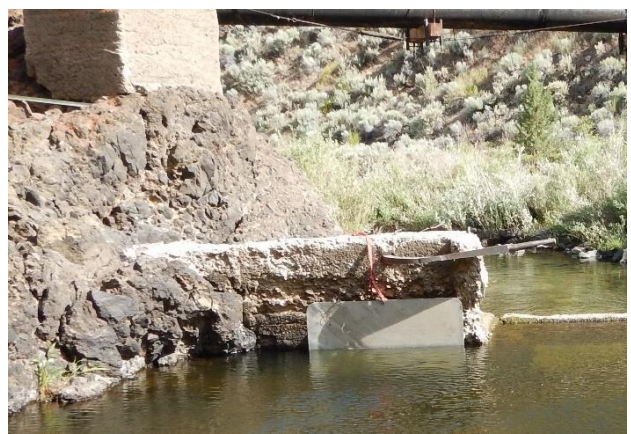
The Middle Diversion was an instream concrete weir with a fixed crest, and an intake on the river left side of the weir. The existing headgate was difficult to operate and functioned poorly. The gate did not fully close, which resulted in leakage and loss of flow from the stream. The Deep Creek Middle Diversion Fish Passage Project completion was another step towards a connected watershed and Warner sucker recovery.

Figure 2. Distant (left) and close-up (right) views of the Middle Diversion intake headwall with road sign in front of the intake for controlling flow into the pipeline.

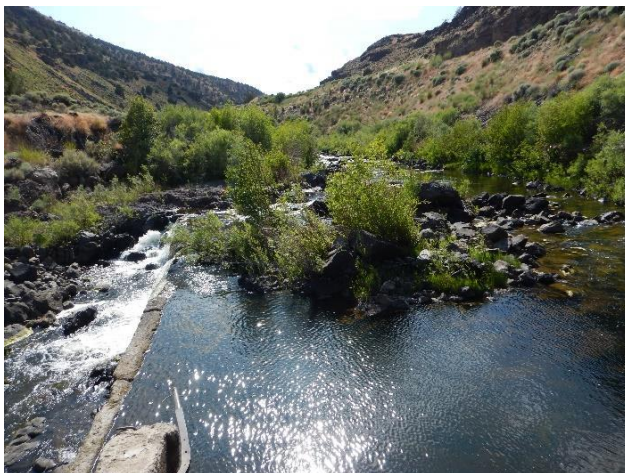
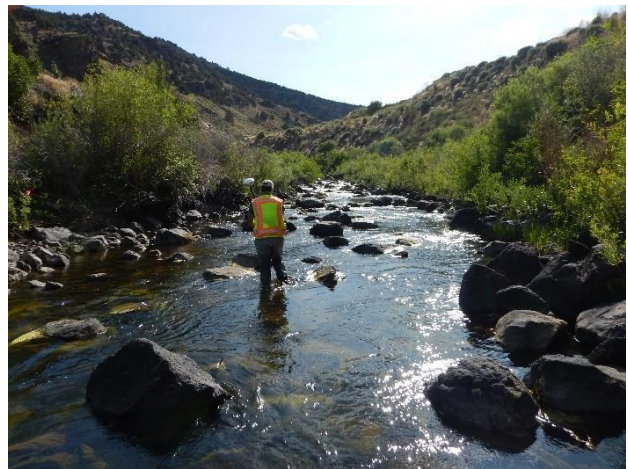
Figure 3. A view across the Middle Diversion weir from river-left showing the bedrock outcrop on the left bank (left), and a view of coarse bed materials upstream from the weir (right).

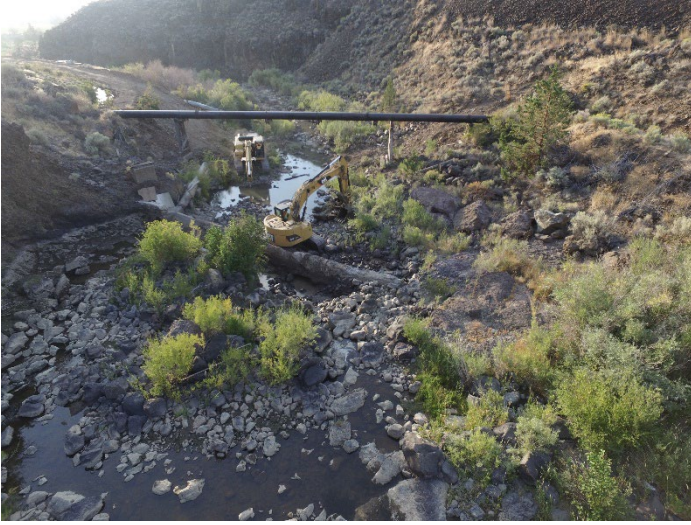
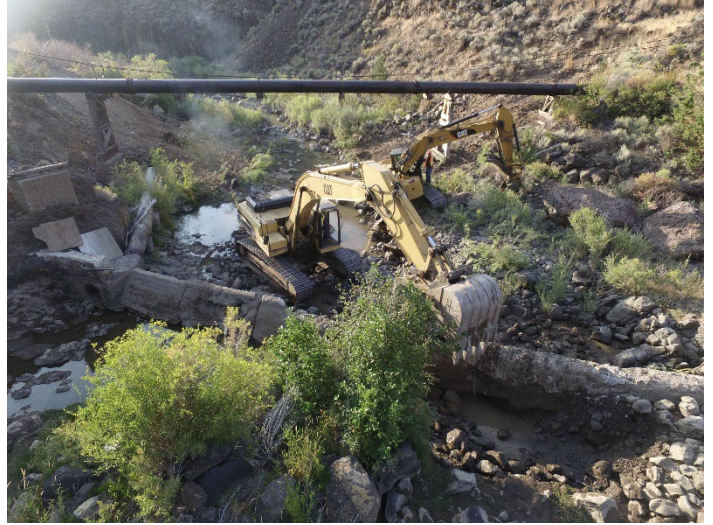
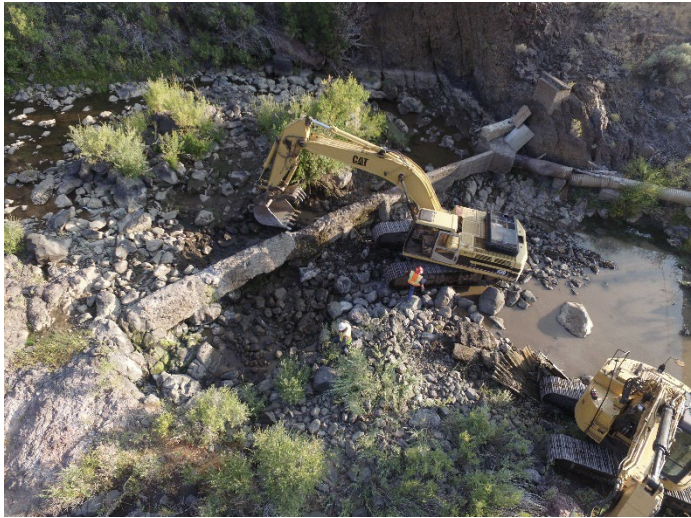
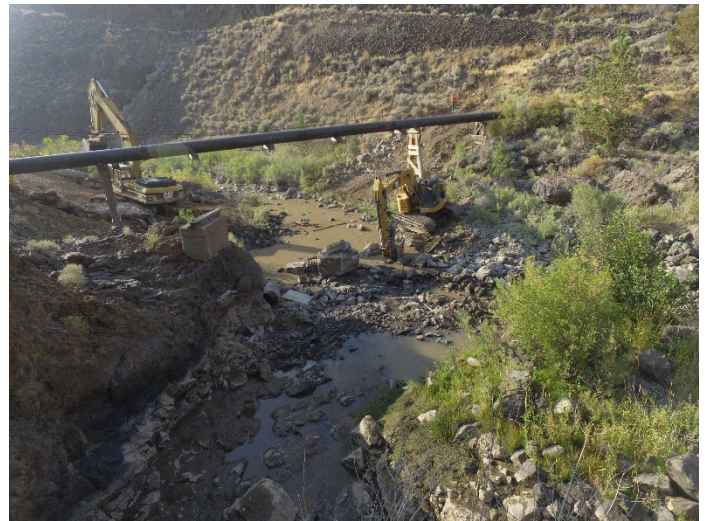
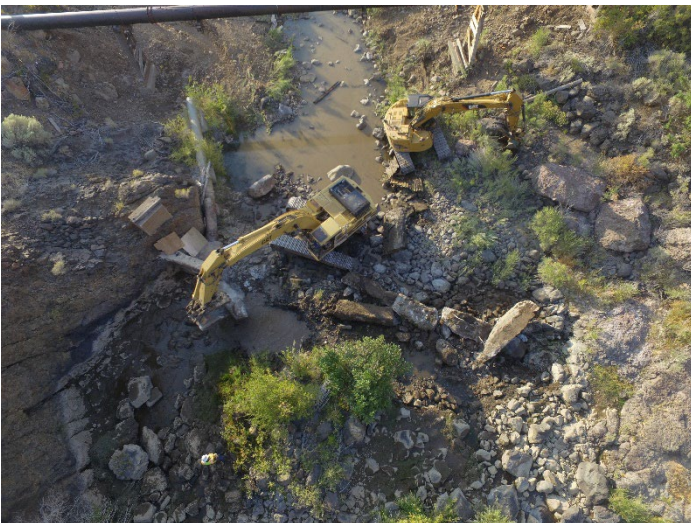
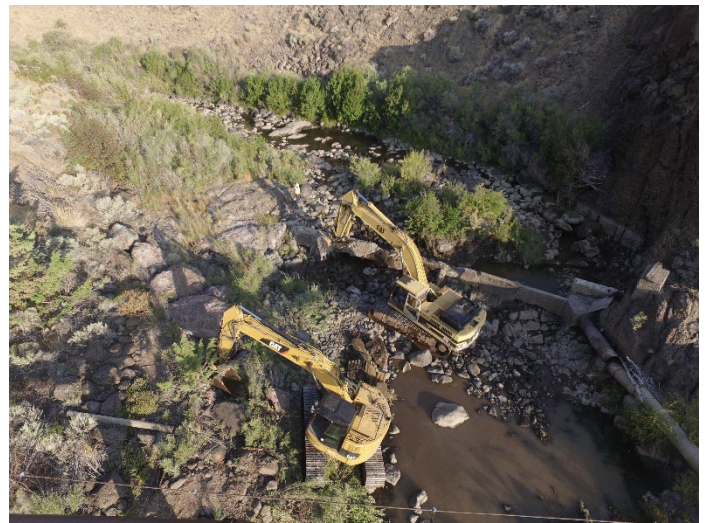
Deep Creek Middle Diversion Removal Photos

September 14, 2022

1. The project supported the transfer of four water rights from the Middle Diversion to the upstream O'Keeffe Diversion which was necessary for the diversion to be removed. 2. Once water rights were transferred, two water delivery turn outs to serve irrigation water to Jones Ranch and Griener Ranch were implemented in September of 2022. To accommodate the changes in delivery point at the Greiner turnout - a precast twin track weir was installed at the inlet to allow water to connect to from the O'Keeffe ditch to the Greiner Middle ditch through 100 ft 8" pipe. To accommodate the changes in delivery point at the Jones turnout – a precast twin track weir was installed at the inlet to allow water to connect from O'Keeffe ditch to the Jones Middle ditch through a 140 ft (+/-) 8" pipe. The activities described are necessary steps to maintain the integrity of the water rights and irrigation operations as the Middle Diversion will no longer function once removed. 3. The Middle Diversion concrete weir was removed in October of 2022. The weir was approximately 3 ft to 5 ft high over the underlying bedrock outcrop. Restoring volitional fish passage at this particular project site was accomplished.

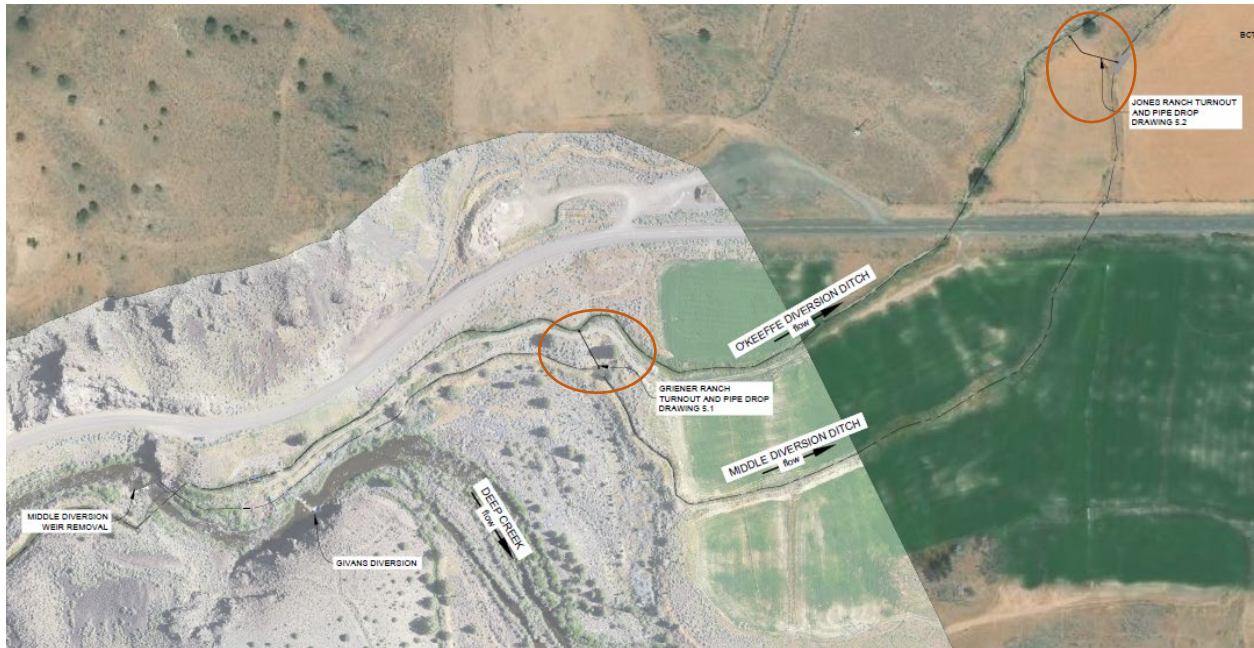
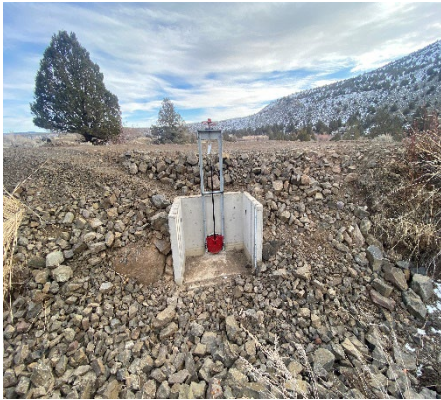
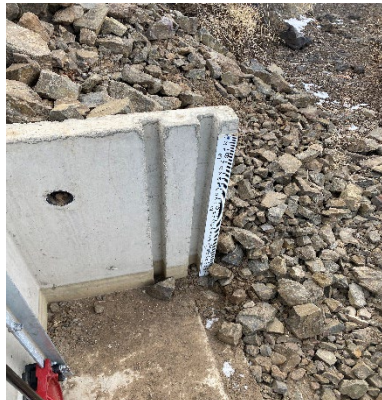
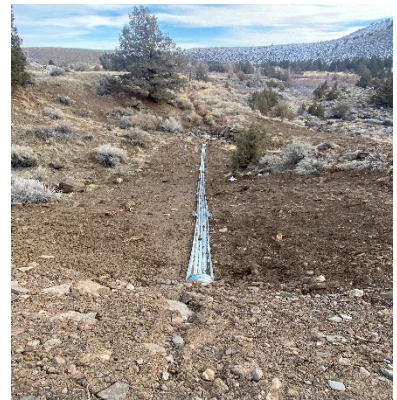
Irrigation Turnout Post Project Photos 2/1/2023

Two new irrigation turnouts were implemented as part of the project. The Greiner and Jones water rights were transferred upstream to the O’Keeffe Diversion POD and water is diverted through a different route on the upper ditch. The turnouts drop water from the upper ditch into the existing lower ditch to irrigate as before.

Photos above: Greiner Ranch turnout with staff gauge mounted on side to measure flow. Water exits through concrete turnout into open top flume to existing lower ditch. Photos below: Jones Ranch turnout with staff gauge mounted. Water exits through concrete turnout into an underground pipe to lower ditch where it enters pool and ditch system. The pool was created in order to convert flood system into a sprinkler system in the future.
