Re: Final Report – River Bend Ranch Restoration and Passage Project Phase 2

The River Bend Ranch Restoration and Passage Project Phase 2 was a multi-year, collaborative effort to improve habitat and passage for native Snake River cutthroat trout; stream, floodplain and riparian function; and bank and channel stability on the upper Hoback River outside of Bondurant, Wyoming. The project is located on a mix of working cattle ranch, bison ranch, and Bridger-Teton National Forest (BTNF) lands and is the site of the Wyoming Game and Fish Department's (WGFD) McNeel elk feedground and a Jackson Hole Land Trust conservation easement. Habitat degradation as a result of instream disturbances from two gravel push-up dams were addressed through the project's first phase in 2018-2019 through the installation of a fish passage-friendly rock diversion and headgate structure at a stable location. The project's second phase addressed the entire 2.5 mile river corridor from the new diversion to the Highway 191 bridge through an innovative approach that works with the river's ecological processes. Together, these improvements will over time benefit fish habitat, fish passage, stream stability, and a

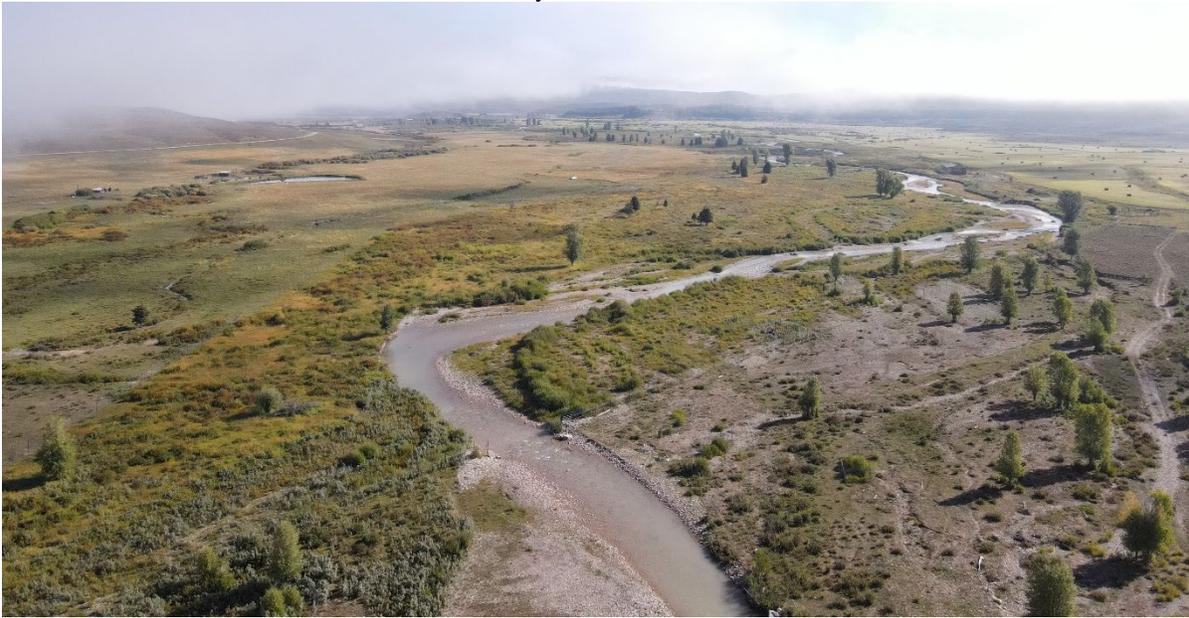
Photo 1: The Upper Hoback river is an actively anastomosing channel, with a naturally wide braid-plain that has become more dynamic and erosive due to the removal of riparian vegetation from land management practices and elk feeding.

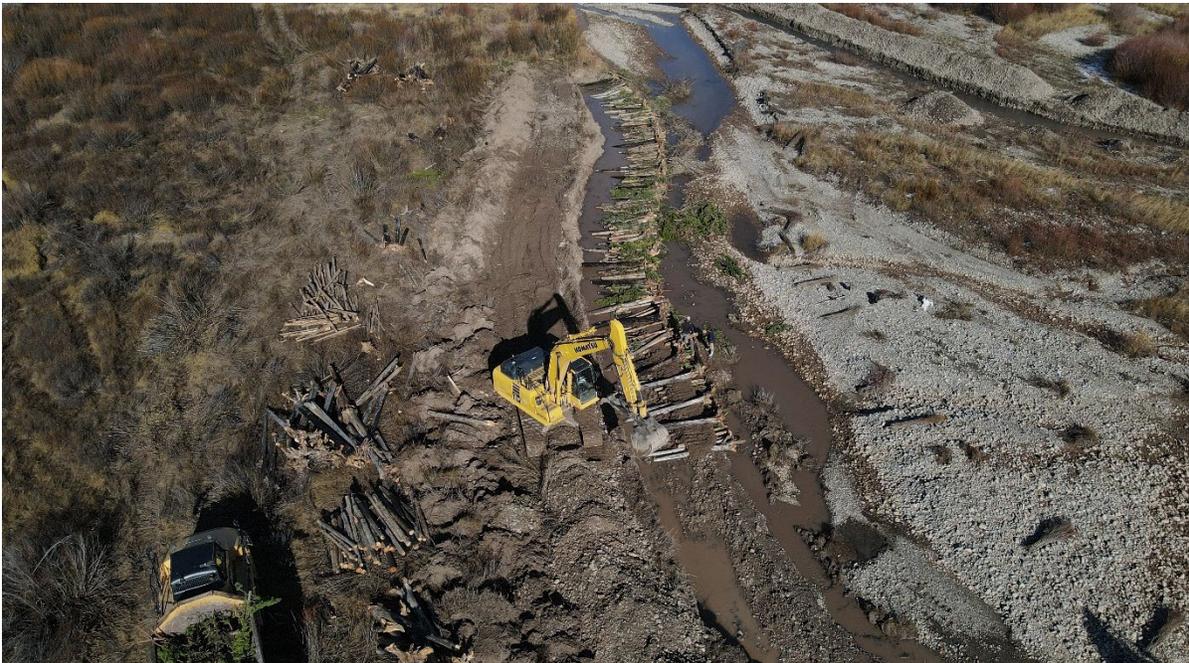
Photo 2. Bioengineered brush bank structures using a combination of medium logs with rootwads, small logs, brush, and willows were installed from October-November 2023.

- Materials procurement began in summer 2023 and was completed in fall 2023. The project required an immense amount of materials to build the brush bank structures – 2,194 medium logs with rootwads, 6,632 small logs, 14,191 pieces of brush, and 26,325 willow cuttings. At the outset of the summer, logs had been sourced from the Hoback Rim close to the project area and brush had been sourced from a BTNF forest thinning unit in the LaBarge Creek drainage. Unfortunately, by late summer, we were informed that the logs were now being sourced from the Middle Piney area, therefore requiring much more hauling time and associated cost, in addition to being more time consuming to harvest. Also, we were informed that only about 3,000 pieces of brush were able to be staged by a BTNF fire crew before they had to leave for fire assignments. In addition, we contracted several Montana Conservation Crew hires, with the intent of having them work on cutting willows and installing fencing as time allowed. Due to several factors on their end, they did not cut as many willows as anticipated, and did not have any remaining time to install fencing. As a result of all of the above materials sourcing issues, a lot of time and effort was spent throughout the fall to line up new sources of brush as well as additional funding to cover the unexpected additional hauling costs. While we were ultimately

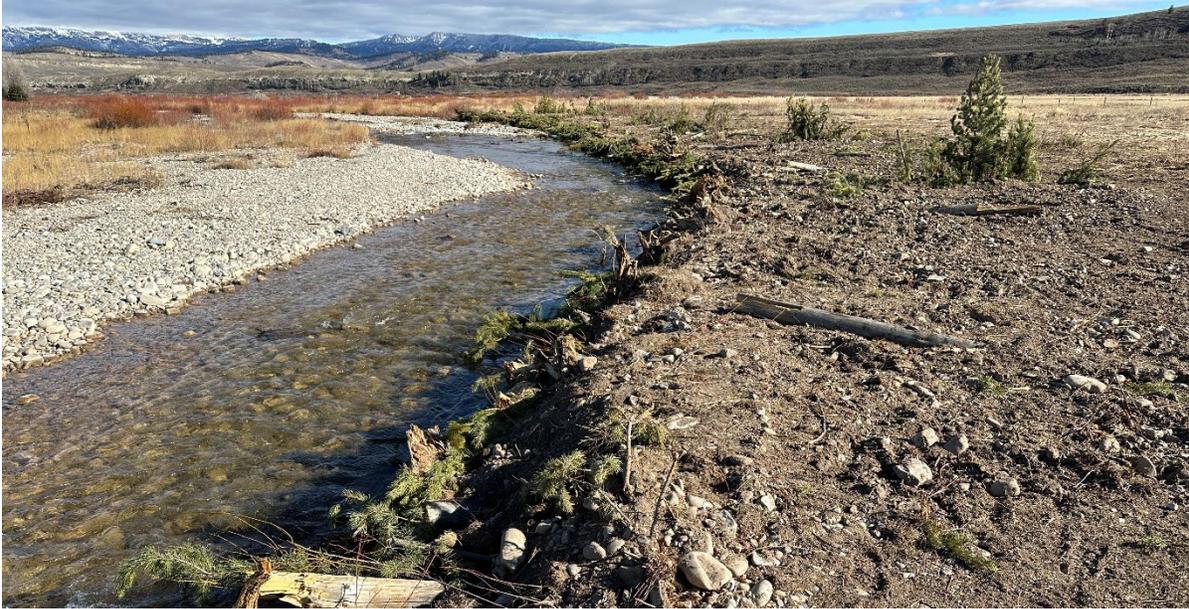
Photo 3. A representative example of a completed brush bank structure with floodplain roughness treatment. In total, 4,247 linear feet of brush bank were installed in 2023 (140 feet remain for 2024).

- Construction mobilization and implementation for earthwork and brush bank structures began in early October 2023 and was completed by November 2023. A total of 4,387 feet of brush bank structures, 878 feet of willow trenches, and 1.01 acre of floodplain roughness treatments will have been installed when the final 140 feet are completed in 2024.

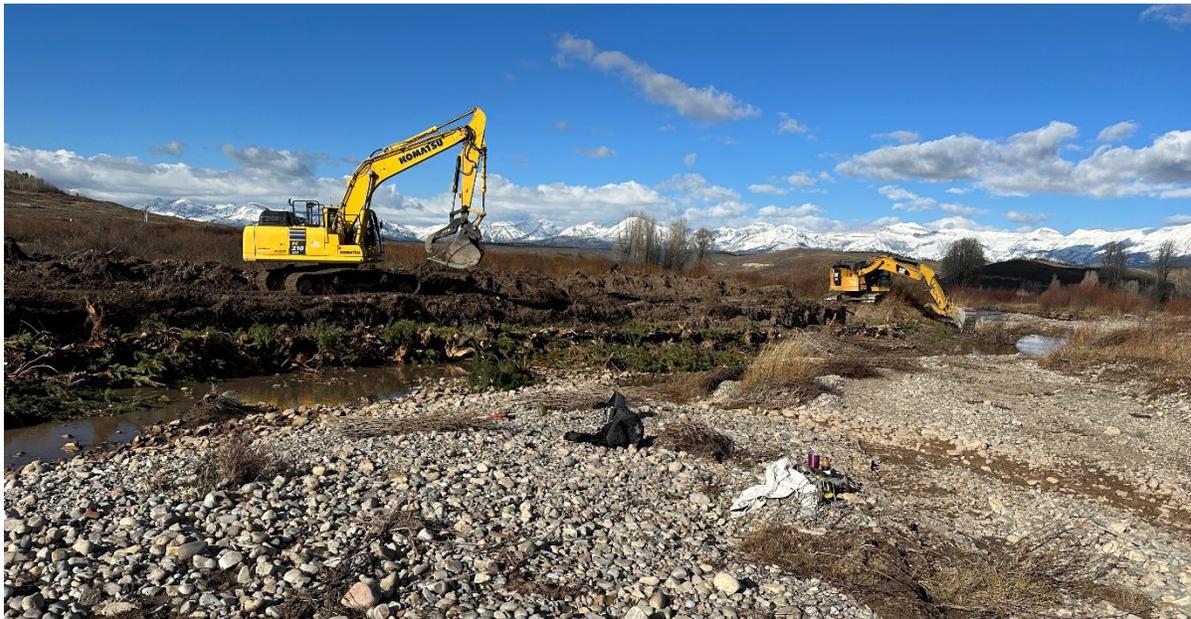
Photo 4. Excavators work to place logs with rootwads into a brush bank structure.

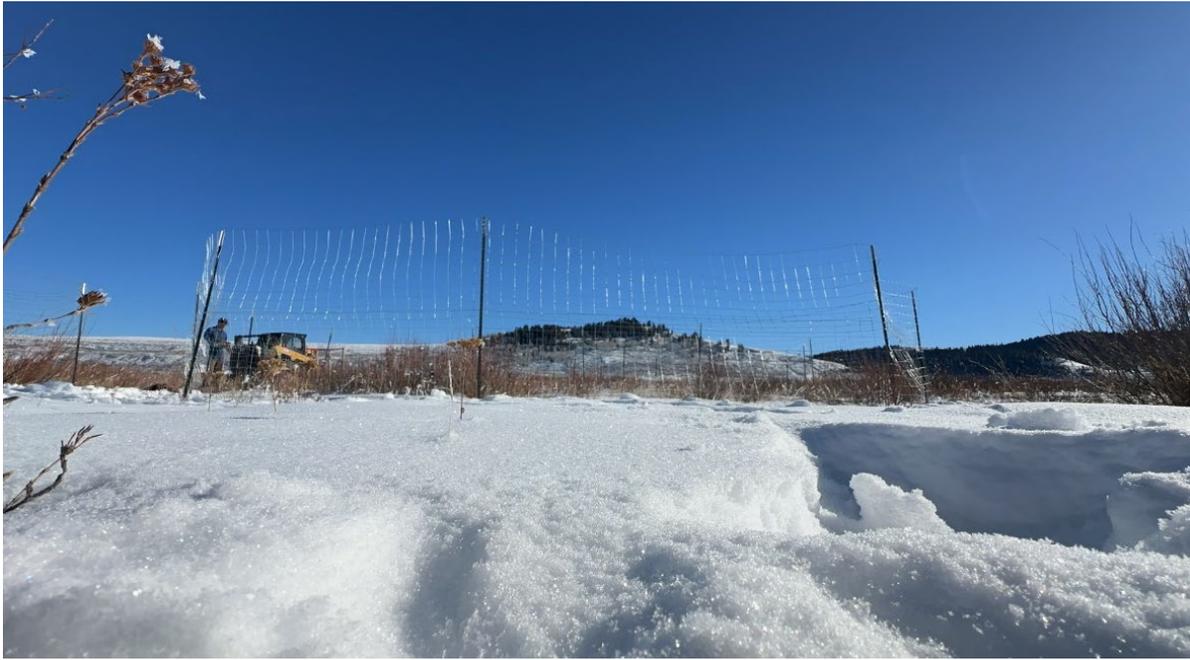
Photo 6. Floodplain revegetation fencing units being completed in December 2023. Fencing units were sited around existing cottonwoods and willows. Once protected from grazing and browsing, they are expected to mature and root, and provide stability and habitat complexity. A total of 26 units were fully installed in 2023, with an additional 41 planned to be completed next year.

- T-posts for 67 floodplain revegetation units were staked out and installed in September 2023. Wire fencing was installed on 26 of the 67 revegetation units in December 2023. In previous years, 11 units were installed in 2020, 10 units were installed in 2021, and 20 units were installed in 2022. A total of 108 units will have been installed when the remaining units are finished in 2024. A couple of notable adjustments to the original fencing plan for the project were made. The first is that the riparian fencing planned for cattle exclusion at the lower end of the project area was determined to be unnecessary after speaking with the River Bend Ranch manager, who pledged to not graze the riparian pasture in question. The second is that the Jackson Fork Ranch installed new bison fence on an 11-acre section at the upper end of the project area to further encourage floodplain and riparian vegetation growth.

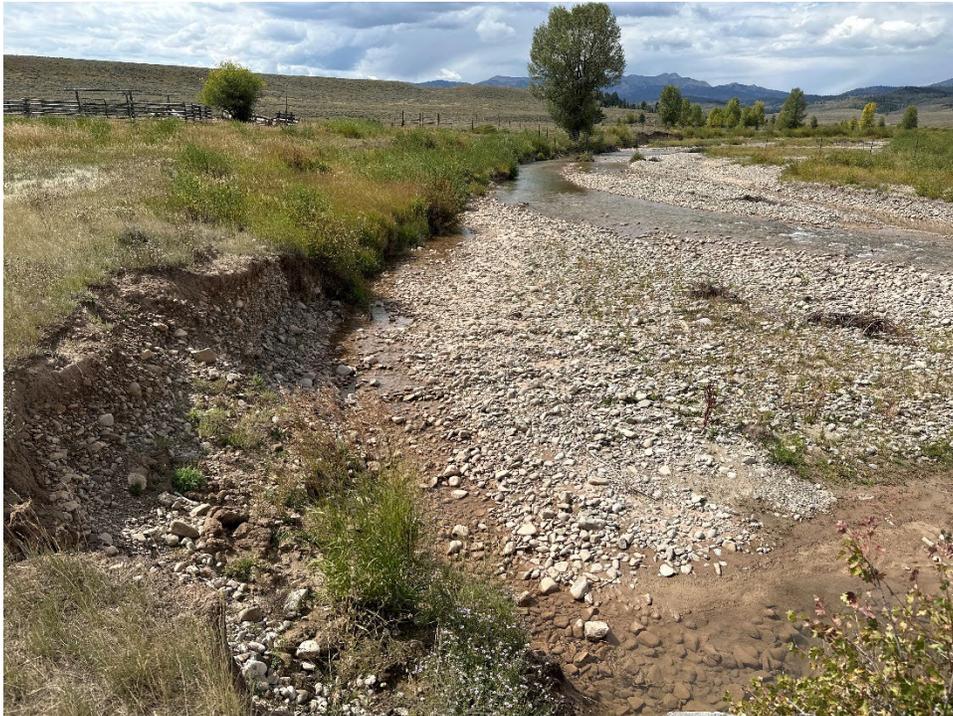
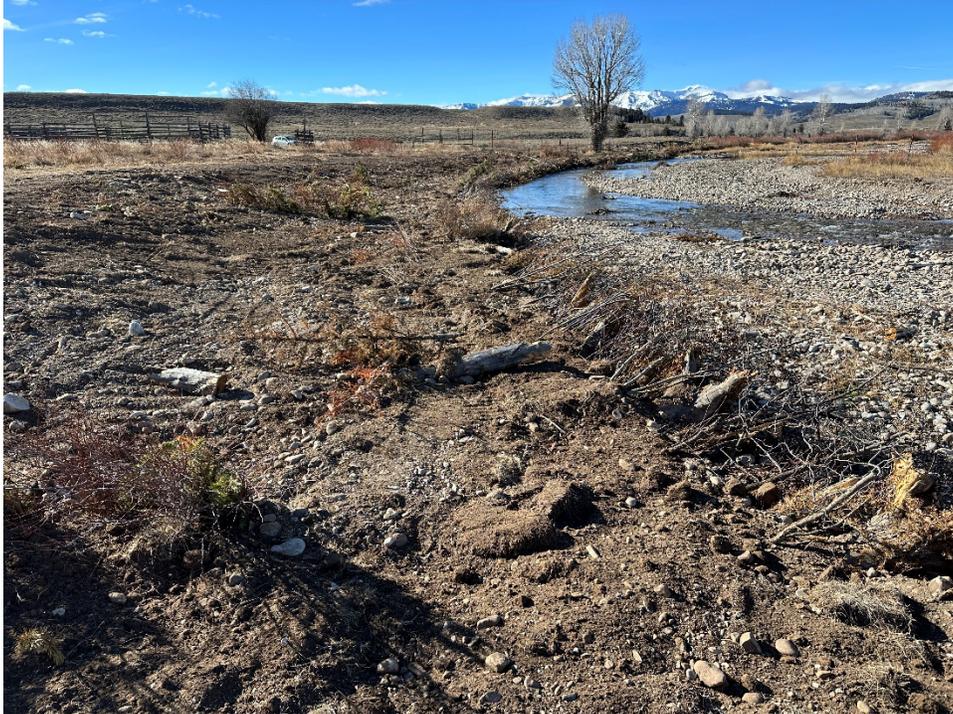
Photo Set 7. High, eroding outside banks lacking floodplain connectivity (above); brush bank structure with floodplain bench and floodplain roughness treatment (below).

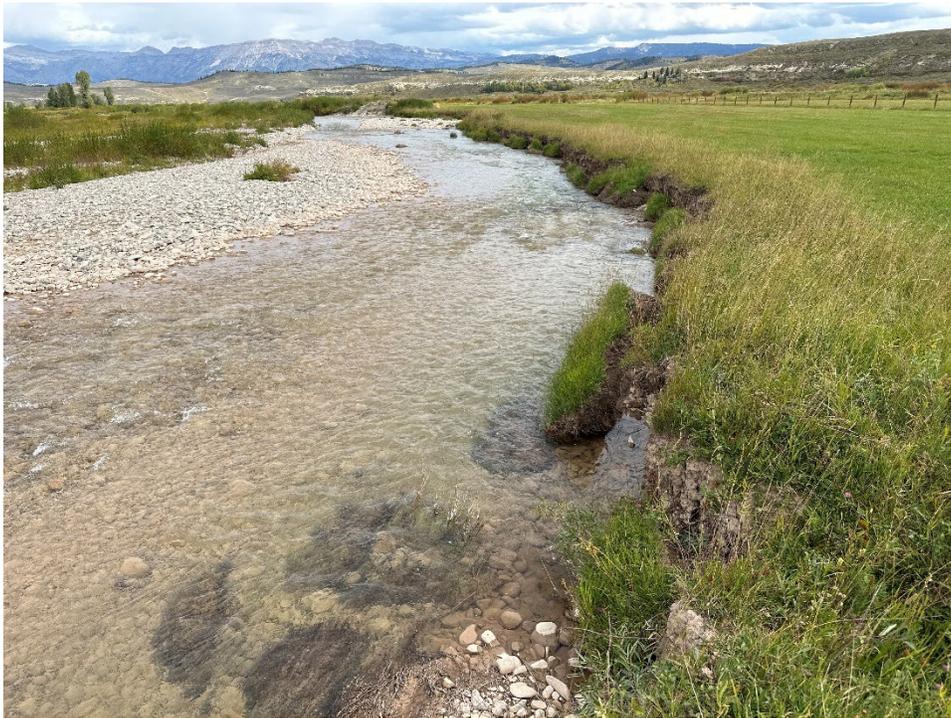
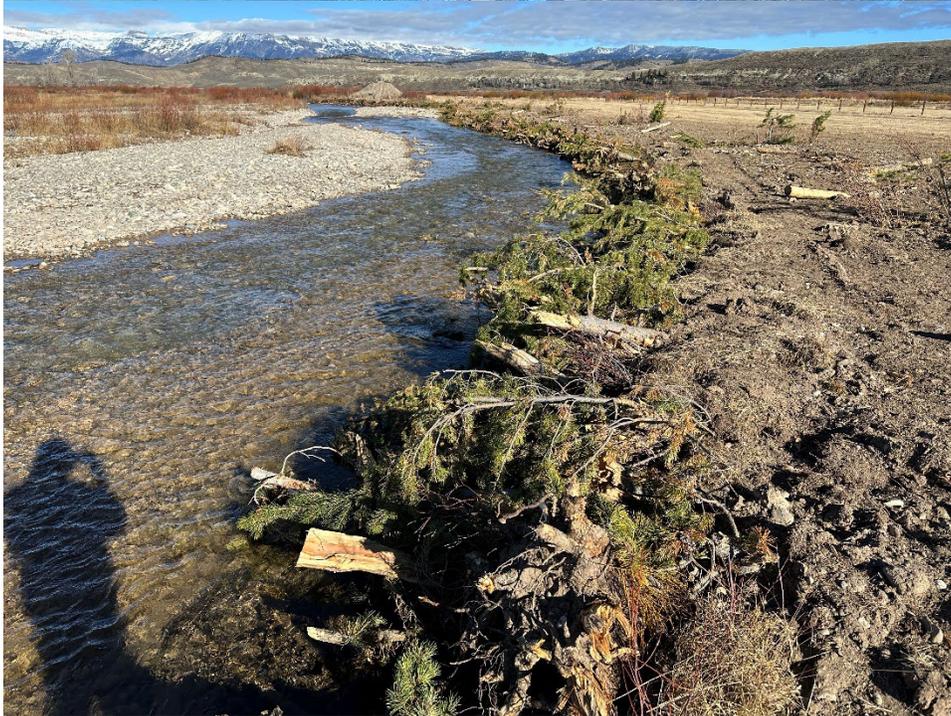
Photo Set 8. Eroding bank along pasture with little vegetative protection (above); brush bank structure (below). Brush banks along outside bends are expected to create good undercut bank habitat for trout.

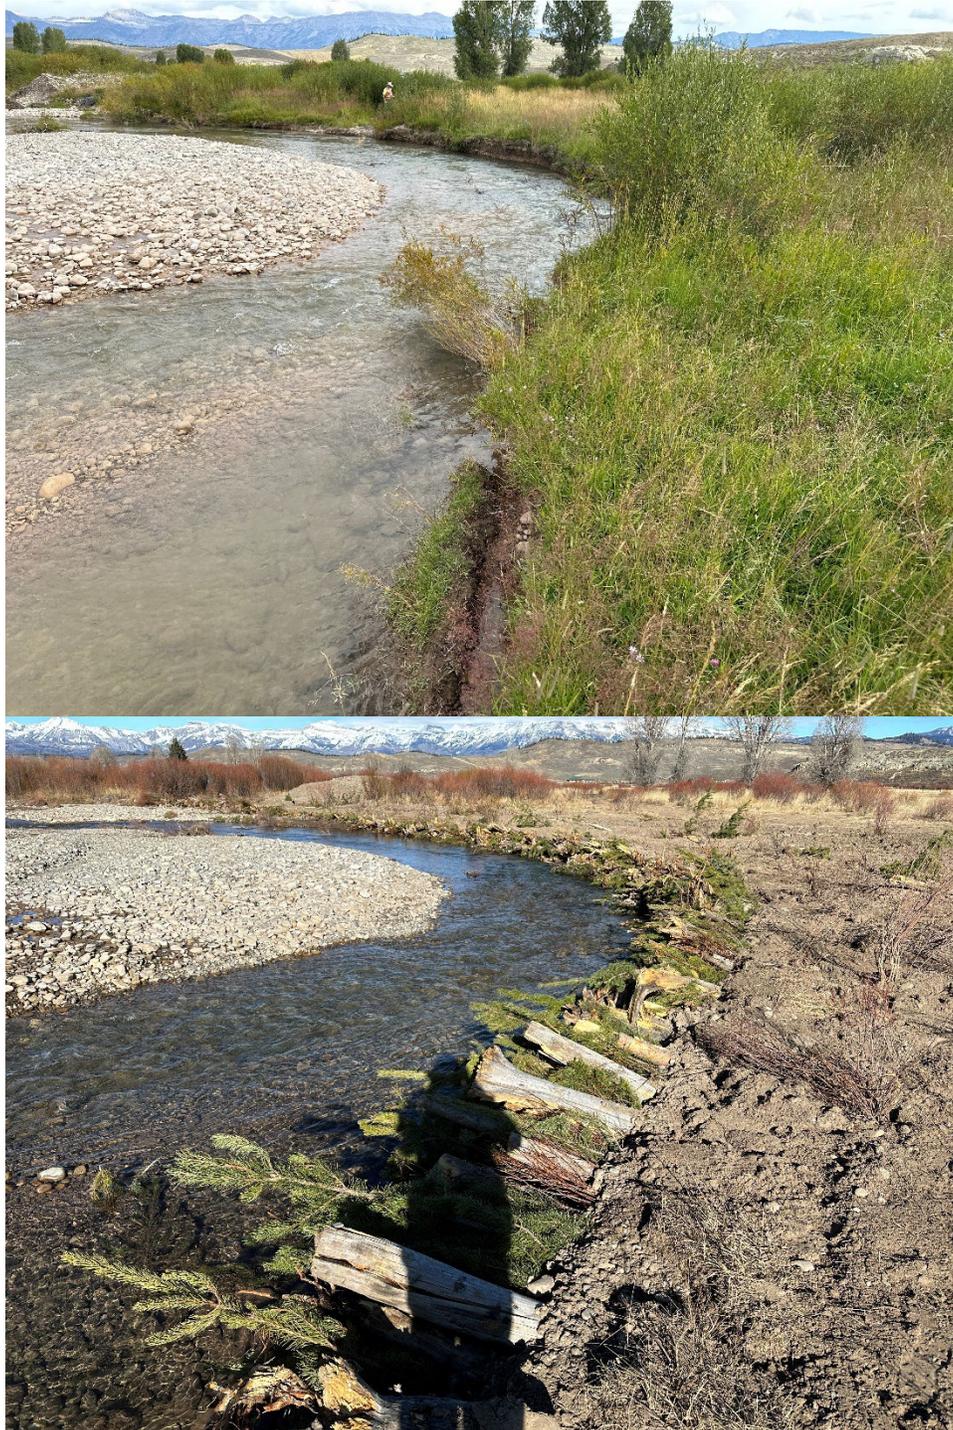
Photo Set 9. Steep eroding bank with poor fish habitat (above), regraded bank with logs with rootwads, brush, and willows (below).
